From concept to reality, combining a rockfall barrier with a retaining wall to protect railway tracks

Andi D Buechi, A.Sc.T.
Geobruigg North America LLC., Kelowna, BC, Canada
Edward Wu, M.Eng., P.Eng.
CN Design & Construction, Concord, ON, Canada
Darren Wiebe,
BAT Construction Ltd, Kamloops, BC, Canada

ABSTRACT

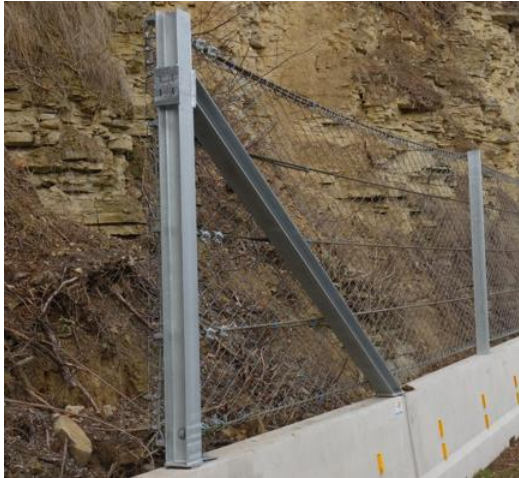
Figure 4. Rigid end post of a Geobrugg rockfall barrier braced by a compression member

There are many ways to transmit these forces. Sometimes the outside lateral post are braced with a compression member. (Figure 4) Other times the posts are secured by a tension member or post support rope. A third option is to stiffen the outside lateral post. This was the choice made for the CN site. (Figure 5)

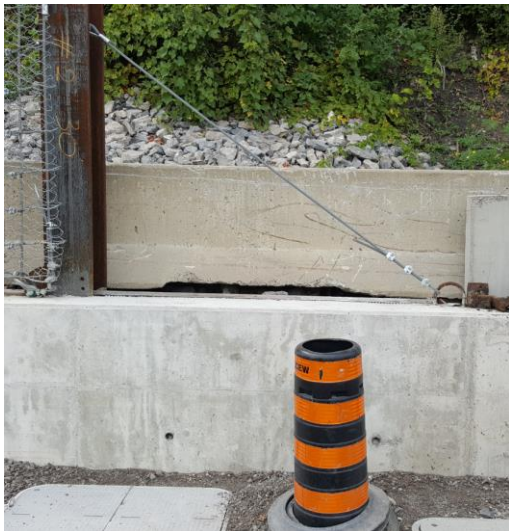
Figure 5. Robust 'H' pile stiffened to prevent buckling during impacts. Additional lateral post ropes also were utilized

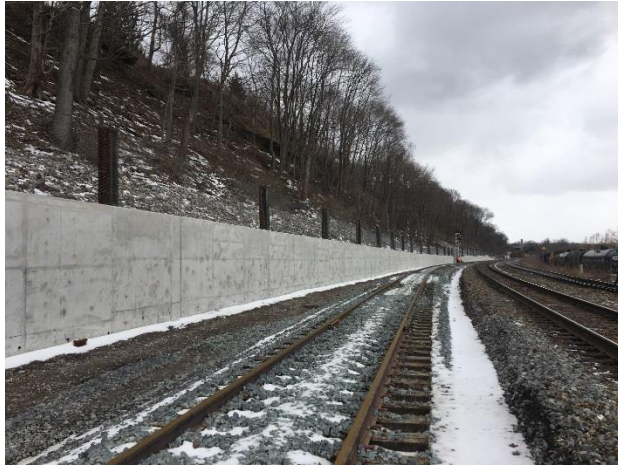
Figure 7. Completed Hybrid 'H' pile and concrete retaining wall view downslope of the barrier

The overall solution appears clean and simple and will function as intended. (Figure 7)

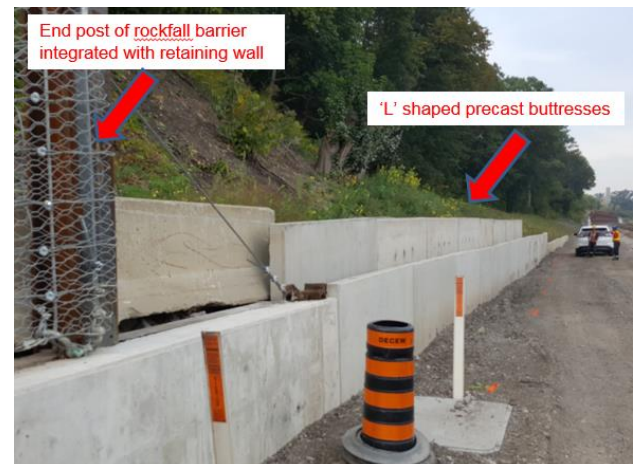
Figure 8. Precast 'L' shaped concrete buttresses used to prevent soil from raveling onto the track expansion

As progress continued on the track widening, it was apparent that the combination retaining wall and rockfall barrier should be longer. As the elevation of the slope north of the retaining wall dipped, a tall retaining wall was no longer required and simple pre-cast concrete barriers were installed. They were placed to prevent soil from raveling onto the new tracks. (Figure 8)

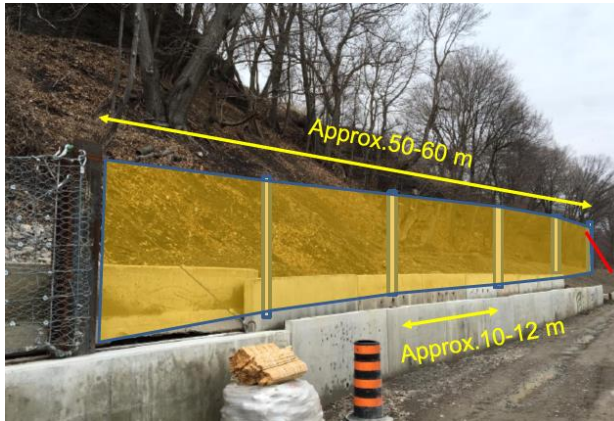
Figure 9. New 500kJ rigid post rockfall extension concept attached to previously installed system viewed upslope

Five post locations were chosen and with the sixth post being the last 'H' pile utilized from the earlier installation. (Figure 9 and 10)

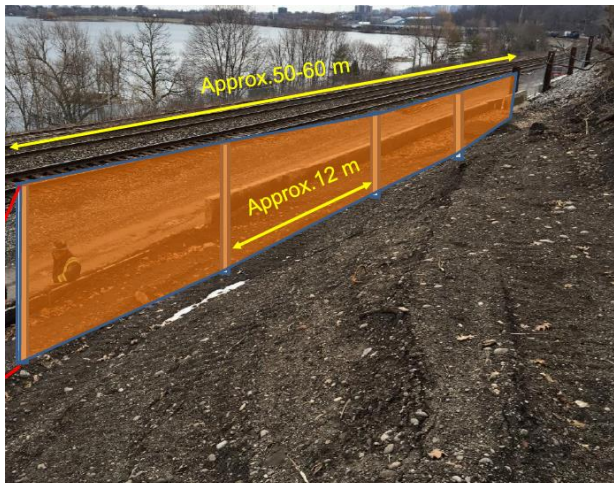
Figure 10. Proposed rockfall barrier extension viewed downslope

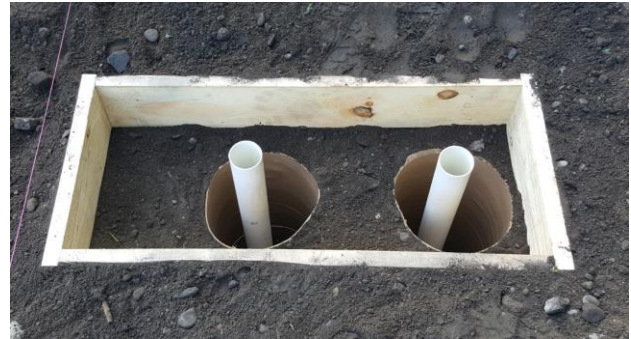
Figure 10. 12" sonotubes, 8" thick concrete pad and 3" PVC sleeves

The 50m rockfall barrier was installed in just nine working days including mobilization and demobilization. A 30 inch hole was augered 4-5 feet down through soil to bedrock. Two 12 inch sonotubes were placed in the augured hole, backfilled and compacted. Eight inch tall formwork was

used to create a concrete leveling pad around and to cap the augered holes. 3 inch diameter PVC sleeves were installed within the sonotubes to create a block-out to ease later drilling through to bedrock. Sonotubes and the 8 inch concrete pad were installed into the looser embankment material to provide a pedestal style support for the soil anchors. (Figure 10)

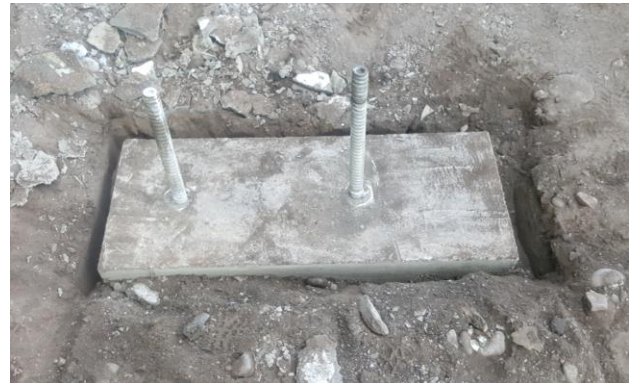
Figure 11. Concrete leveling pad with hollow core anchors visible prior to testing and installing rigid barrier posts

Posts locations were assured by using a template that fit snugly over the form work with holes cut into it that the PVC block outs extended through. The sonotubes and pad form work were filled with concrete, vibrated and troweled by using the form work jig to ensure that anchor placement was accurate. Hollow core self-drilling anchors were drilled through the PVC sleeves and drilled the prescribed embedment depth well past remaining soil and into bedrock in some cases. (Figure 11)

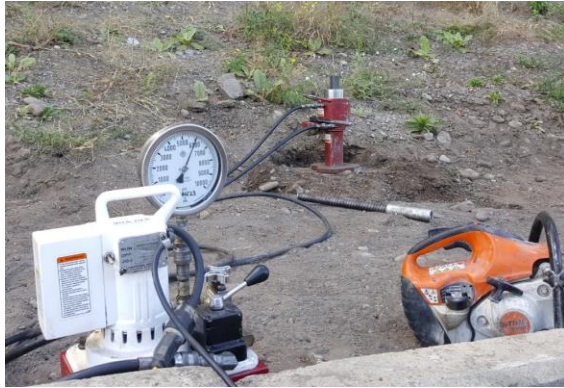
Figure 12. Confirming pull-out resistance with jack stand

A clean installation was achieved by using string lines and levels. Additional vertical and shear support for the anchors was provided. All anchors were verification tested as required by the geotechnical engineer. (Figure 12)

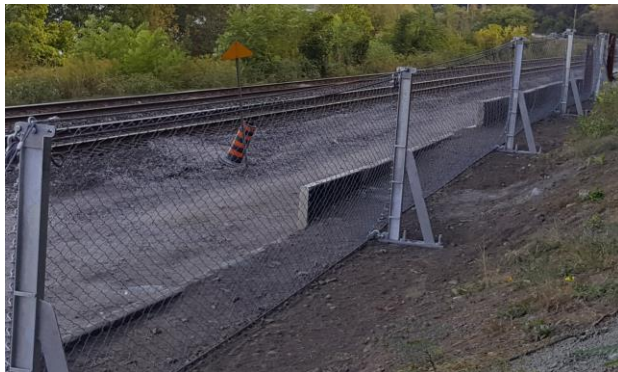
Figure 13. Rigid post barrier extension viewing downslope

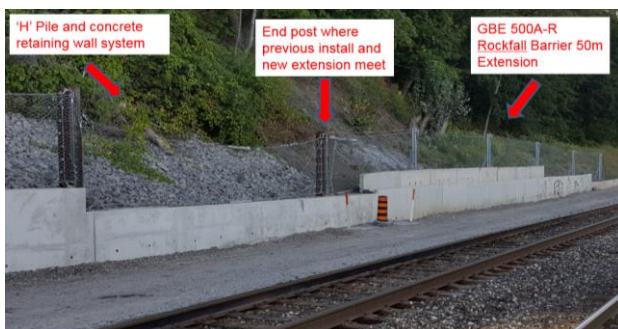
Figure 14. Transition area where the previously installed system is connected to the 50m long new extension

The grade between each post was graded to eliminate gullies or mounds in order to allow smooth anchor drilling and placing the posts. The anchor nuts and washer were used on the underside and topside of post base plate in order to achieve optimum compressive and tensile resistance. The overall installation of the posts and the nets went quickly and had a good overall appearance. (Figure 13) The transition area between the two systems went smoothly as contractor knew what was expected in order to prevent any gaps vertically or horizontally at the transition post. (Figure 14)
