# Mitigating pavement shoulder cracking in northern, low volume highways by incorporating Tencate Mirafi® H<sub>2</sub>Ri wicking geotextile

Papa-Masseck Thiam, M. Eng., M.Sc., P.Eng., PMP® & Allan H. Bradley, R.P.F., P.Eng., *FPInnovations. Roads and Infrastructure*  
René Laprade, P.Eng.  
*TenCate Geosynthetics*

Muhammad Idrees, M.Eng., P.Eng, Stuart Drummond & Paul Murchison, P.Eng.  
*Yukon Government, Transportation Engineering Branch, Highways and Public Works*

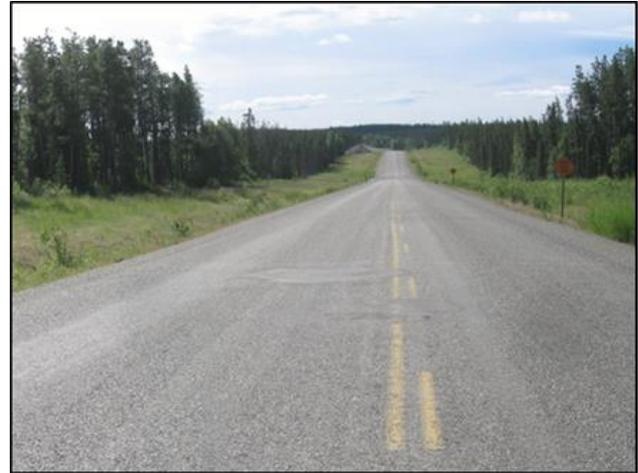
Figure 1. Looking south from site 6 towards site 4 (from Bradley et al. 2016)

In October 2015, FPInnovations, HPW, and TenCate established two instrumented sites with which to test the effectiveness of a new geotextile product to mitigate edge cracking and control roadbed moisture in a northern highway. The two test sites are located approximately 40 km north of Watson Lake, along the Campbell Highway (Figure 1). The two test sites are referred to as “site 4” and “site 6”. Site 4 is located on a tangent near KM 40.5. Site 6 is located on a tangent near KM 40.9. Prior to study, edge cracking extended for the entire 43-m length of site 4 along the eastern shoulder, and two parallel 15-m-long cracks were in the western shoulder. In site 6, edge cracking extended for the entire 43-m length of the eastern shoulder, and one 9-m-long crack was along the western shoulder.

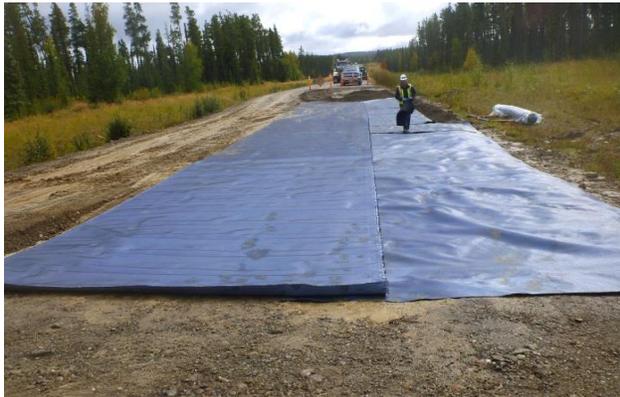
The wicking geotextile at both sites was installed within the subbase (69 cm and 79 cm down from the road surface at site 4 and site 6, respectively) as shown in figure 2.

Figure 2. Wicking geotextile installation (Bradley et al. 2016)

After installing the Wicking geotextile and instrumentation, the road was reconstructed by placing and compacting in-place lifts of “Granular E” specification subbase material. Over this, a base layer of 150 mm of “Granular A”-specification base material was placed, shaped to a 4% crown, and watered and compacted in-place (see table 2). BST was applied to gravel surfaces in June 2016.

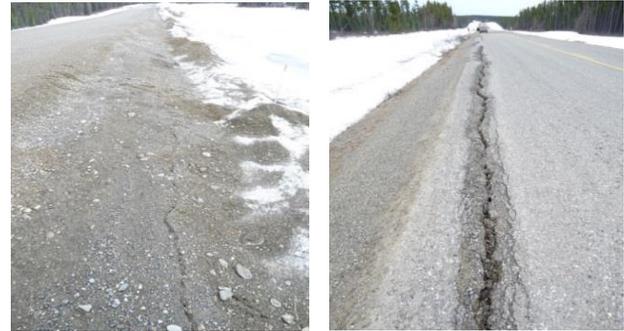
General observations from site monitoring between September 2015 and January 2017 showed minor edge cracking at sites 4 and 6 in May 2016. Severe edge cracking (up to 10 cm wide) was found approximately 40 m north of site 6. Some of the edge cracking noticed outside of sites 4 and 6 was deep enough to have reached the subbase layer (i.e., 15+ cm deep). Figure 3 illustrates edge cracking on sites 4 and 6, as well as edge cracking north of site 6. The edge cracks on treated sites 4 and 6 appear less severe than the edge cracks north of site 6, outside of the test area.

Figure 3. Edge cracking at sites 4 and 6 (left), and outside of site 6 (right) (from Bradley et al. 2017)

The observations from the site monitoring during summer 2016 triggered a field density study with a nuclear density gauge to document roadbed density differences between the road running surface and the road shoulder and have a better understanding of the observations presented in figure 3.

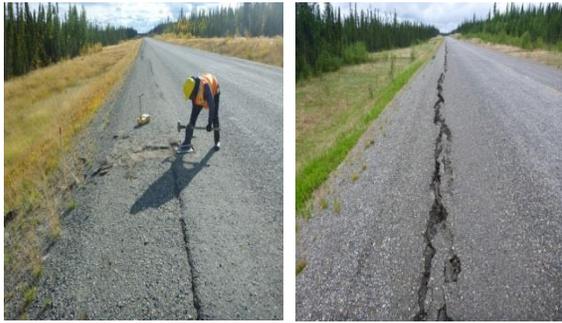
Monitoring, conducted by HPW and FPIInnovations, continued during spring and summer 2017. Similar to the observations from 2016, more minor edge cracking was observed at sites 4 and 6 in spring and summer 2017. Those cracks were less significant than the ones observed outside of the test sites. The edge cracks observed in 2016 at sites 4 and 6 did not appear to increase in size in 2017, however, cracks observed outside of sites 4 and 6 increased in size in 2017 as a comparison to 2016. Figure 4 illustrates the progression of edge cracking at sections outside of the test sites, at KM 66.275, which is untreated, has steeper slopes and differential compaction at the edges.

Figure 4. Pronounced edge cracking at KM 66.275 in spring 2017 (right), as a comparison to spring 2016 (left)

The most advanced state of edge cracking was noticed on the fill slope side of the road section located at KM 66.275 (outside of test sites). This area had dramatically reduced soil density (55%-59%) outside of edge cracks in the top of the subbase. The road had steeper sideslope than at KM 40 where the test sections are located.

of edge cracking was noticed at KM 66.275 which had steep side slopes of 2:1 and had dramatically reduced soil densities (55%-59%).
