# Performance Of Mine Waste Earth Fill Dumped Into Deep Standing Water

Scott Martens, Sajid Iqbal, Raisul Hoda, Michael Graham  
*Canadian Natural Resources Limited, Calgary, Alberta, Canada*

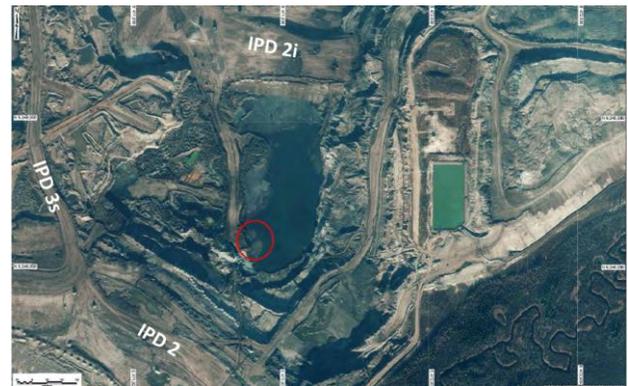
Figure 1. Satellite image from November 4, 2010 showing saline water inflow locations (within red circle)

On October 16, 2010 an inflow of saline water occurred from discrete seepage points on the southwest side of Cell 2a. A satellite image from November 4, 2010 clearly shows two main inflow locations and two possible additional locations (Figure 1).

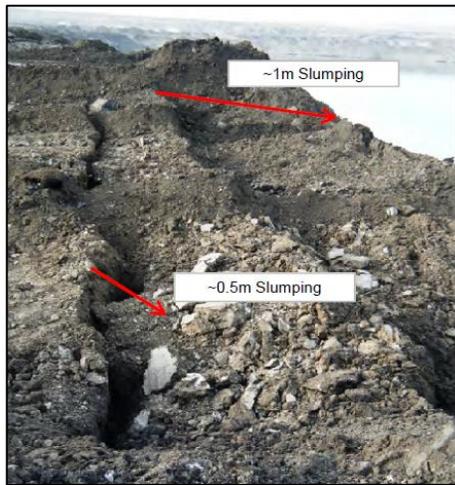
Figure 6. Pad slumping during construction – cracks observed ~ 2m behind the crest, August 2011

Some cracking and slumping of the advancing pad occurred while the pad was advancing over the submerged 220 m bench (Figure 6). Once the crest advance ceased, further fill placement into the water by dozers pushing fill over the edge of the crest resulted in no further cracking or slumping of the pad.

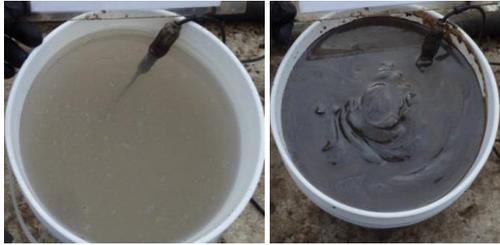
Figure 11: Saline Water (1 m above mudline) and slurry (1 to 2 m below mudline)

The PBM consisted of a slurry zone that was 0.5 to 1.0 m thick with an undrained strength of less than 2 kPa. The slurry zone was underlain by more competent soil that transitions within about a 1 m interval to an undrained strength of about 10-20 kPa and contains zones or blocks of material with a strength around 100 kPa. Within the soil column the typical lower bound strength was about 10 kPa, and the rate of strength gain with depth followed a mean trend of approximately  $S_u/\sigma_v' = 0.4$ , and a minimum trend of  $S_u/\sigma_v' = 0.2$ , with the high values influenced by the sand content of the fill. The transition zone from the slurry to more competent PBM is evident from the CPT and BPT data in Figure 10, which also shows the mudline from the sonar and gamma-CPT results that corroborate the transition from slurry to solid material. Photos of samples taken throughout this transition zone are shown in Figures 11 and 12.

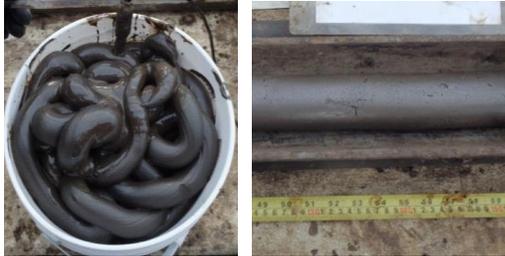
Figure 12: Transition from slurry to PBM (2 to 3 m below mudline) and PBM (7 m below mudline)

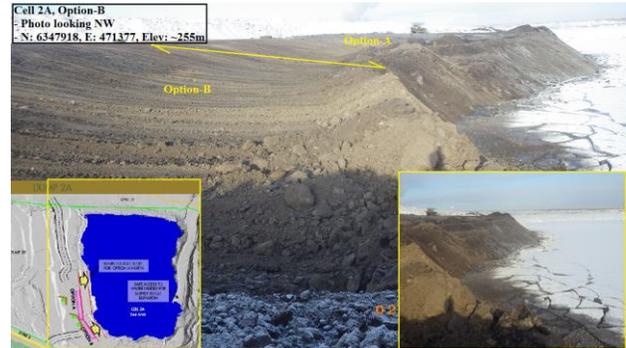
Figure 13: Pad ramp-down and safety berm

The initial step was to ramp down from the 260 m pad so that there was 5 m difference between the pond elevation and the pad crest, as shown in Figure 13.

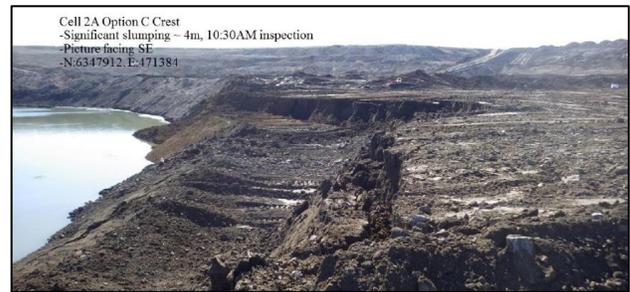
Figure 15. Slumping was typically preceded by cracking, and the slumping occurred slowly. Note the 4 m drop with significant extents. Photo from May 2015.

During Phase 2, cracking and slumping was typically within 3 to 15 m from the advancing crest, but there was occasionally slumping up to 25 m and cracking 75 m from the advanced crest. During the early stages of Phase 2 fill advance, the cracking alignment was mainly concentrated very close to the initial crest line established at the end of Phase 1 construction (Figure 14). Essentially no cracking occurred to the west of the January 2012 crest, indicating that the cracking and slumping was due to the weak PBM that the new fill was stepping out onto. A larger slump is shown in Figure 15. A minimum 5 m thickness of fill was maintained above the water level, to reduce the risk that a slump block would become submerged in the pond before any equipment could back up behind the slump zone. Throughout the operation, no rapid slumps occurred that would have endangered equipment or operators. Slumps as shown in Figure 15 took several hours to progress.

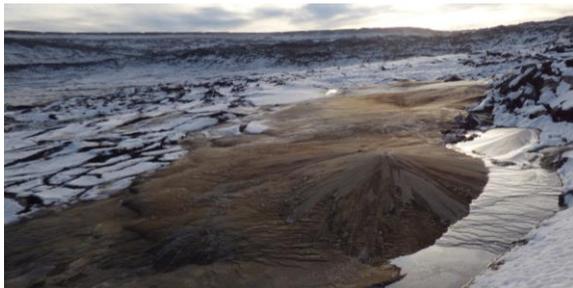
Figure 19. Mud boil during drawdown

Several mud boils were observed during drawdown and slumping. These were interpreted to be from undrained shearing of the loose fills that were placed into the standing water. A typical mud boil is shown in Figure 19. In a final phase of fill placement in January 2016, after the saline water was pumped out of the pond, the pad was again extended to cover these boils to prevent them from partially compromising the integrity of the seal.
