Geotechnical Challenges in the Construction of the Niagara Wind Farm, Niagara Region, Ontario, Canada

Bruce Polan, M.A.Sc., P.Eng.
GHD Limited, Waterloo, Ontario, Canada

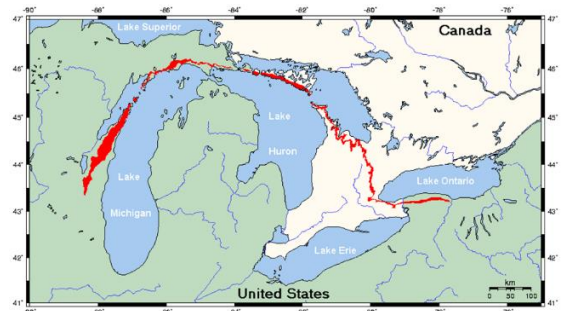
Figure 1- Geographic extent of Niagara Escarpment

The Formation extends across Lake Ontario and creates the world famous Niagara Falls. Figure 1 shows the geographic extent of the escarpment. Figure 2 shows the typical features of the Niagara Escarpment dolomitic limestone outcrops.

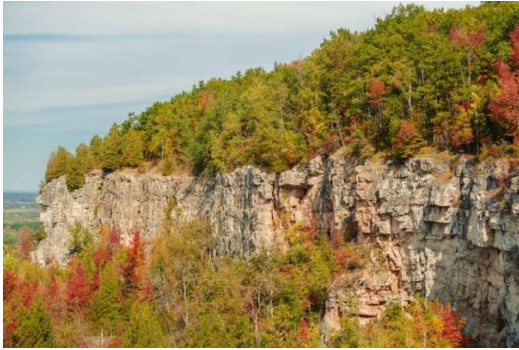
Figure 2- Typical image of Niagara Escarpment, showing dolomitic limestone outcrop.

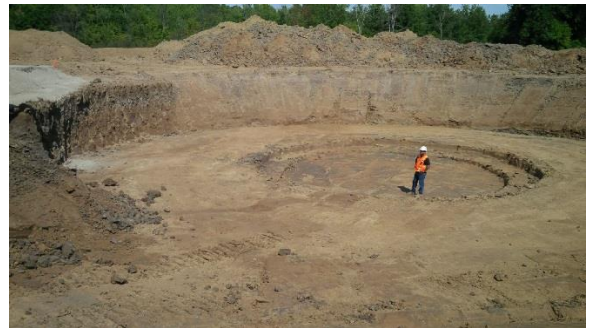
Figure 3- Competent Foundation Subgrade.

GHD was retained to verify the bearing capacity of the wind turbine foundations subgrades. In some cases, the design of the foundations had to be changed based on our subgrade inspections. Assumptions made based on the boreholes were found to be incorrect once the actual foundation excavations were exposed. Figures 3 and 4 show the visual difference between a competent foundation subgrade, and a soft clay subgrade. Where these soft clay subgrade soils were encountered, the design was changed to allow for the construction of an engineered fill pad, or a deep pile foundation.

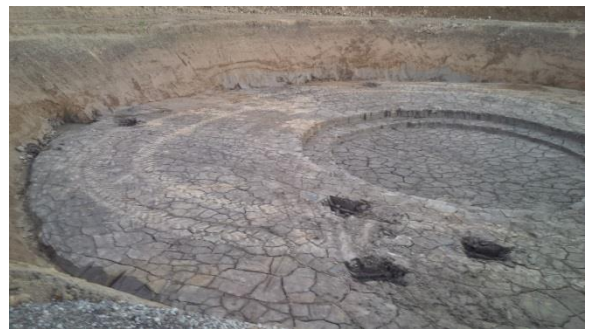
Figure 4- Soft Clay subgrade, showing desiccation cracking.

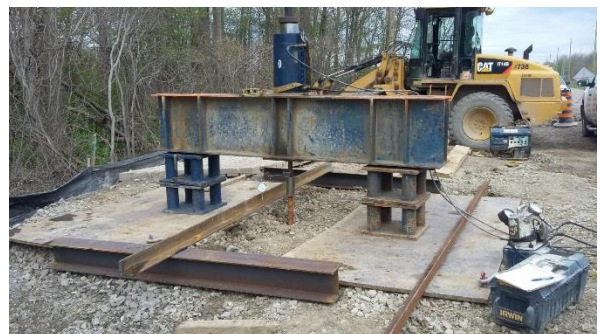
The load testing configuration consisted of a conventional jack pulling on the anchors uses a reaction beam, as shown on Figure 6.

Figure 6- Sacrificial Rock Anchor Pull Test Configuration

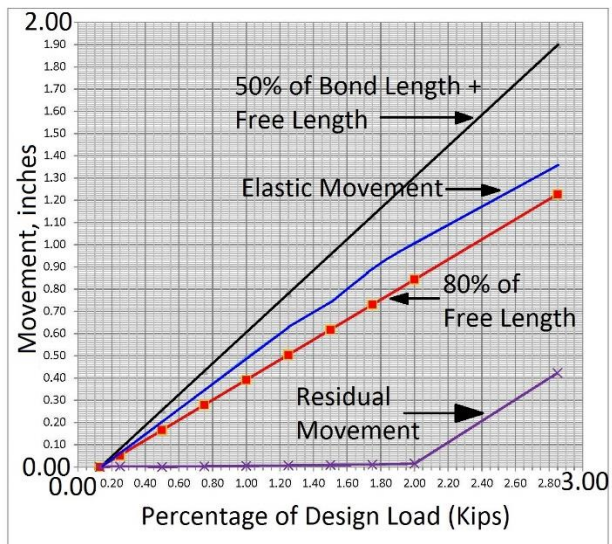
The pull-testing was performed following using the guidelines provided in the Post-Tensioning Institute's document "Recommendations for Pre-stressed Rock and Soil Anchors". As these anchors were not pre-stressed, or post-tensioned, modifications to the procedures for calculating the results and evaluation of the measured grout to rock bond strength were required to properly assess the results of the tests. A typical result for a successful rock anchor test is shown in Figure 7.

Figure 7- Plot of Successful Rock Anchor Test Result

Twenty four anchors were tested, in two rounds of testing. Based on the working loads supplied by the structural engineer, the test anchors were typically tested to at least two times their working load. Nine load cycles were used to load and unload the anchor, and a creep test was performed for 30 minutes at two times the production load. For the performance criteria, the following criteria was considered acceptable:

- Total displacement of less than 13 mm at 2.5 times the working load
- Creep of less than 1.0 mm after 10 minutes, at 2 times the working load
