Geomembrane puncture protection for tire derived aggregate

Bryce Marcotte, Ian Fleming
University of Saskatchewan, Saskatoon, Saskatchewan, Canada

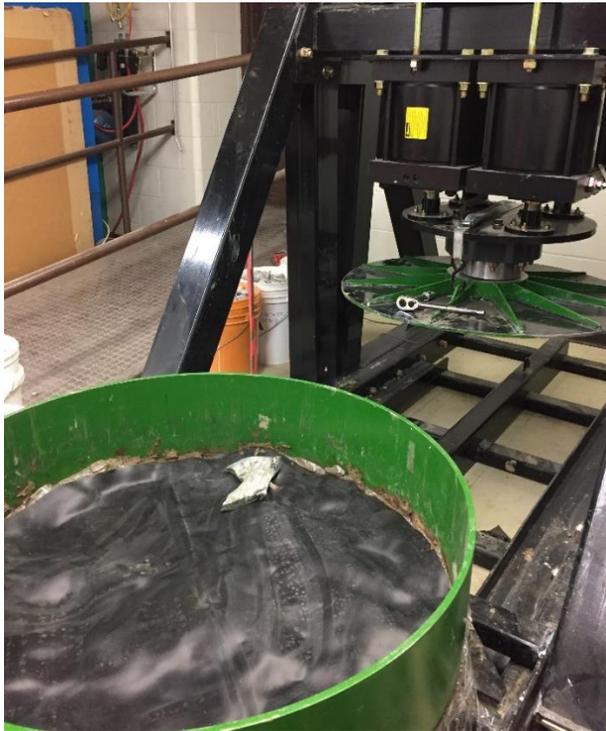
Figure 1: Large pneumatic simulated landfill loading testing device

A large pneumatic testing apparatus, as shown in Figure 1, was designed to accommodate the large size of TDA. The diameter of the test specimen is 900 mm. Pressure is applied by four pneumatic cylinders and monitored through a low-profile load cell placed in the centre axis between the piston rod plate and the load platform.

Due to the large vertical strain (>60%) TDA undergoes when subject to high vertical loads, Pistons capable of large stroke were selected. A swivel joint was designed between the load plate and the load cell to ensure no eccentric forces on the load cell occurred and to account for any differential settlement of the TDA.

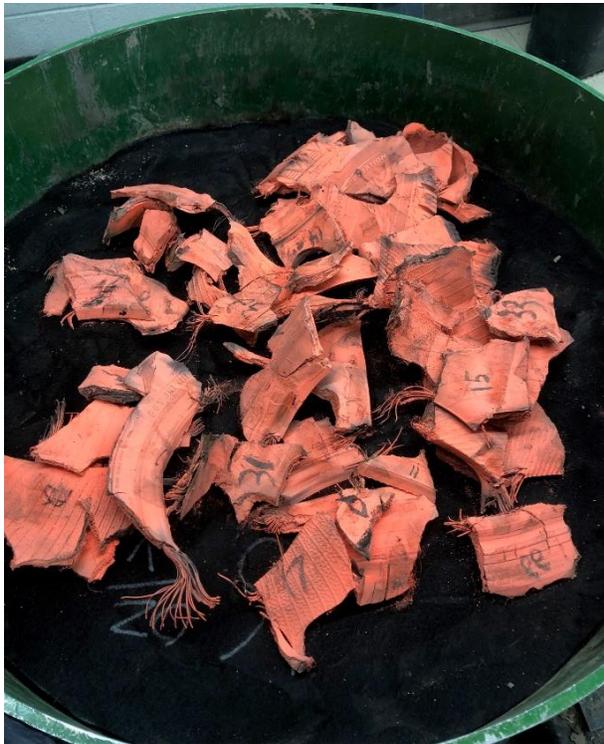
Figure 3: Pre-sorted TDA pieces from Sample 1 with unfavorable protruding wires placed intentionally on geotextile

A pre-sorted group of TDA pieces from Sample 1, as shown in Figure 3, containing significant protruding wires were selected for testing to increase the probability of puncture. Each piece was spray painted for easy identification.

For the first set of tests (1-5), only 15 unfavourable pieces were used. However, after no puncture occurred with heavier protection layers (tests 4 and 5), the number of pre-sorted pieces was increased to 40 as shown in Figure 3.

A summary of the tests is given in Table 2. The number of puncture pieces refers to the number of pre-selected pieces for puncture (orange pieces in Figure 3) that were intentionally placed on the liner.

After test 4 and 5 were complete, and no holes were observed, a larger selection of 40 pre-selected puncture pieces (as shown in Figure 3) were placed above a 1360 and 1624 g/m² geotextile protected geomembrane. Through subsequent tests (6 and 7) it was determined that the heavier geotextile protection layers were not capable of preventing puncture from TDA. Images from the puncture testing are given in Figures 4 through 10.

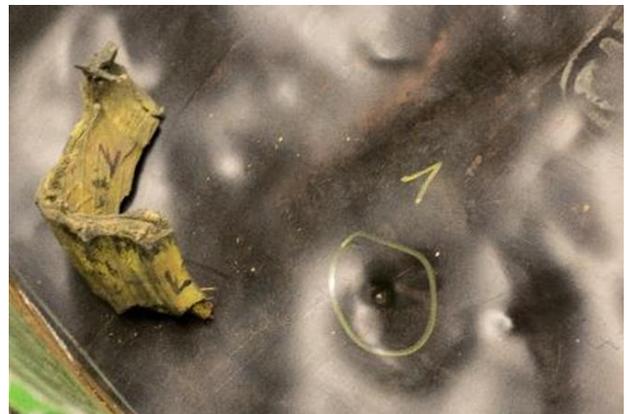
Figure 7: Puncture from test 2

Most of the observed punctures were due to small, 1-2 mm diameter wires as opposed to the thicker tire “bead wires”. A bead wire puncture was observed in test 2 as shown in Figure 7. The lack of beadwire punctures in tests 3 through 7 may indicate that the thicker geotextiles are sufficient in prevent puncture from the large diameter bead wires. The reduction in puncture with increased diameter would be consistent with the findings of Koerner and Koerner (2010) for a given applied load.

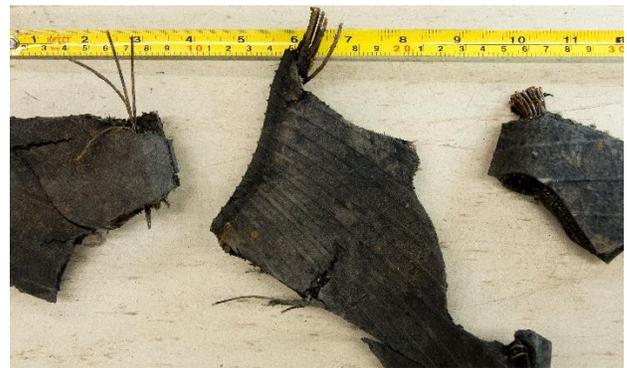
Figure 12: From left to right: high-risk, medium-risk, and low-risk TDA for puncture of geomembrane

A large selection of TDA pieces was acquired from a representative batch of TDA. Each piece was visually inspected and sorted based on wire puncture potential. Each piece that contained a rigid protruding wire was classified as high medium, or low risk for geomembrane puncture, as shown in Figure 12, based on the observed punctures from the previous large-scale testing.

Low-risk pieces contained bead wire protrusions (multiple wires close together to form a large diameter spike) as they were found not to cause puncture when heavier geotextile protection was used. High-risk pieces contained small diameter individual wires as they were found to cause numerous punctures, such as the puncture given in Figure 6, even when heavier geotextiles were used. The selection of high risk wire pieces is given in Figure 13.

Medium risk was defined as TDA pieces that had bead wire protrusions where the end of the group of wires split apart. For a conservative approach, TDA pieces were classified in the higher risk category for pieces that were borderline between two categories. A summary of the results is given in Table 3 and 4 for Samples 1 and 2 respectively.
