# William R. Bennett bridge – Ten years of performance monitoring

(Uthaya) M. Uthayakumar  
Stantec Consulting Ltd., Burnaby, BC, Canada  
Susan Balogh  
SNC-Lavalin OM, Kelowna, BC, Canada

The five-lane William R. Bennett Bridge across the Okanagan Lake in British Columbia was constructed and opened to traffic in July 2008. The bridge has an elevated-fixed-structure on pile foundations over shallow water and a floating structure on pontoons over deep water. Subsurface soils along the bridge alignment include very soft to soft compressible silts and clays and loose to compact sands. The bridge approach embankments were constructed following preload treatment. Settlement of the approach embankments was estimated using laboratory test data on soils, then updated using analysis of the preload settlement data. Settlement of pile foundations was estimated using consolidation parameters derived from laboratory tests. Post-construction settlement survey was conducted to assess the performance using shallow and deep settlement gauges installed on and within the approach embankments, on the bridge piers and on the abutments. Baseline survey for settlement monitoring was carried out immedi

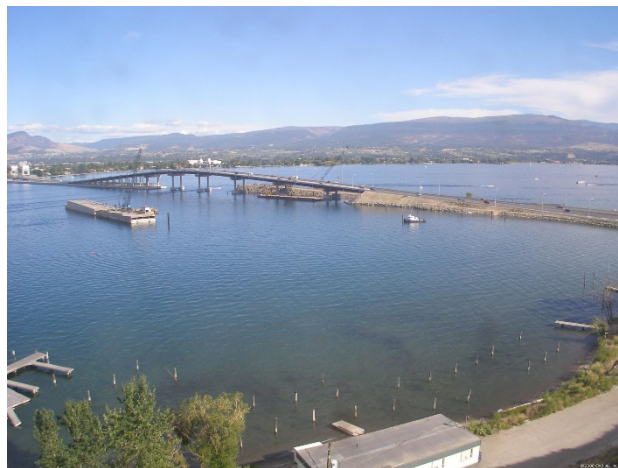
Figure 2. Photograph showing the bridge crossing

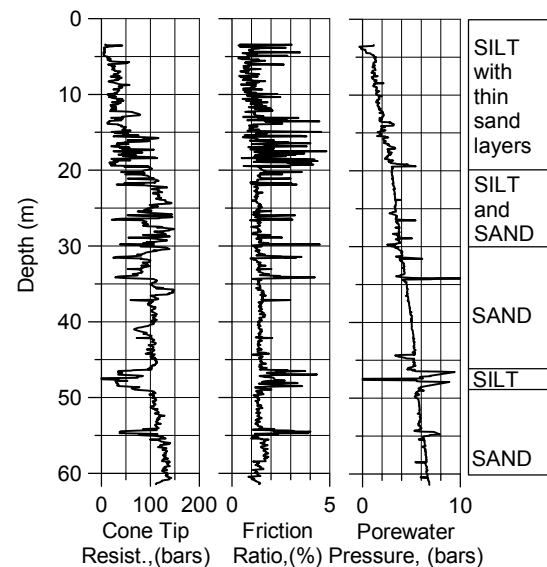
Soil conditions on the west side of the lake include soft to firm low plastic silt with sand layers and occasional layers of organic matter to an approximate depth of 20 m, firm to stiff low plastic silt with layers of sand and low to high plastic clay between 20 m and 30 m depth, compact to dense silty sand with inter-layered silt to approximately 45 m depth followed by dense silty sand. Record of a typical CPTu hole completed at the west approach embankment is shown in Figure 3.

Figure 3. Typical CPTu data from west side of lake

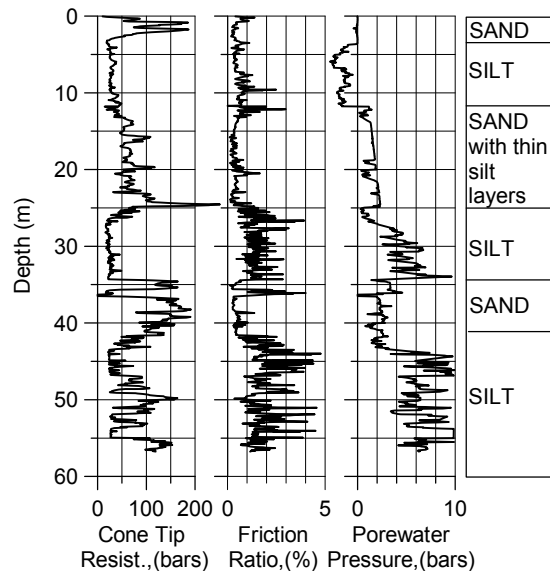
Soil conditions on the east side of the lake include inter-layered loose to compact sand and soft to firm silt and clay with organic matter to more than 45 m depth. Natural moisture content of the silts and clays varied from 22% to 94%, liquid limit varied from 35% to 87% and plastic limit varied from 24% to 38%. Record of a typical CPTu hole completed at the east side of the lake shore is provided in Figure 4.

Figure 4. Typical CPTu data from east side of lake

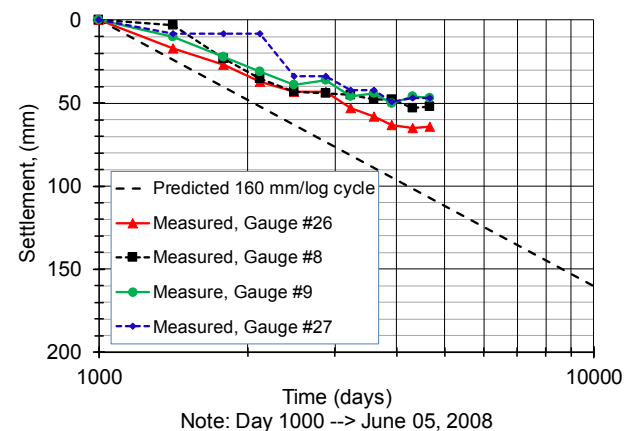
Measured post-construction settlement over a 10-year period, from 2008 to 2018 is summarized in Figure 8.

Figure 8. Post-construction settlement of the west approach embankment

Figure 8 shows that the measured settlement magnitudes are less than the predicted rate of 120 mm per log cycle. The measured data show settlement rate of 75 mm to 100 mm per log cycle, and the rate seems to be decreasing with time.

The post-construction settlement data in Figure 8 seems to indicate a change in slope at about 3000 days, supporting an alternative interpretation that the end of primary consolidation was about 3000 days, or

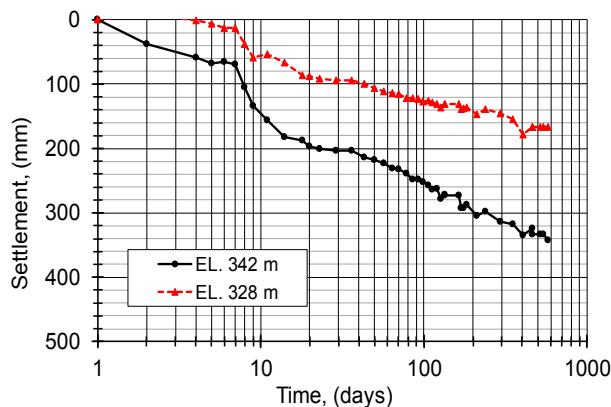
Figure 9 shows the measured preload settlement data from deep settlement gauges at two different elevations near the east abutment. It may be noted that the primary consolidation was essentially completed 30 days after preload construction.

The “secondary” part of the settlement curve shows a long-term settlement rate of 120 mm per log cycle at elevation 342 m. With construction completion in approximately 1000 days following fill placement, post-construction settlement at the end of the 30-year concession period was predicted to be about 130 mm near the west abutment. An additional settlement of about 25 mm is predicted at the end of 40 years.

Figure 9. Measured preload settlement near east abutment

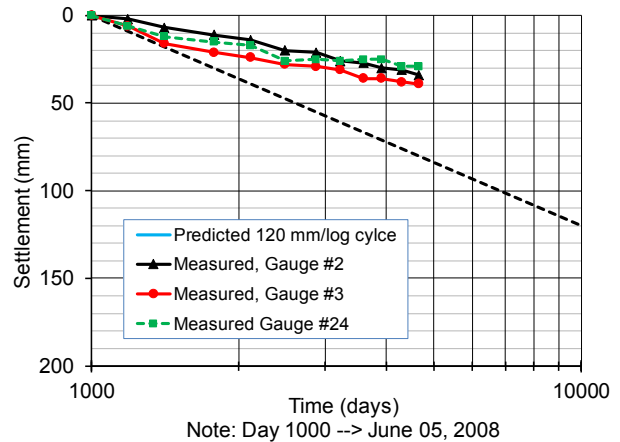
Post-construction settlement of the east approach embankment measured over a 10-year period, from 2008 to 2018 is shown in Figure 10. It can be seen that the measured settlement rate for the first year, from 2008 to 2009 is similar to the predicted rate of 120 mm per log cycle. However, the rate of settlement has decreased considerably since 2009 to approximately 50 mm per log cycle, and seems to be decreasing further with time, similar to the trend observed for the west approach embankment.

Figure 10. Post-construction settlement of the west approach embankment
