Full Scale Foundation Testing of Rammed Aggregate Pier® Supported Foundations in the Toronto Waterfront

Drevininkas, A., Creer, G. and Olshansky, D.
Toronto Transit Commission, Toronto, Ontario, Canada
Brown, J.
WSP, Toronto, Ontario, Canada
Tigchelaar, M.
GeoSolv Design/Build Inc., Vaughan, Ontario, Canada
Metcalf, B.
Geopier Foundation Company, Davidson, North Carolina, USA

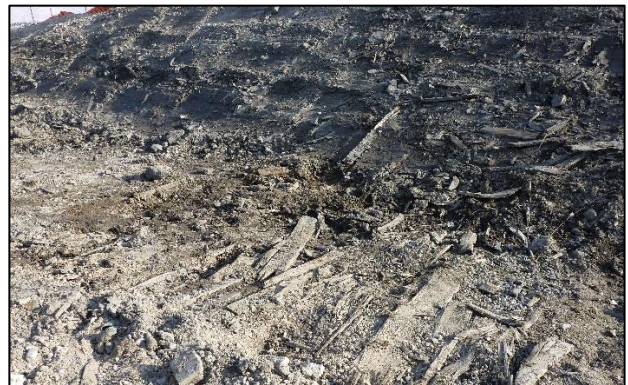
Figure 4. Photo of exposed fill subgrade with wood debris.

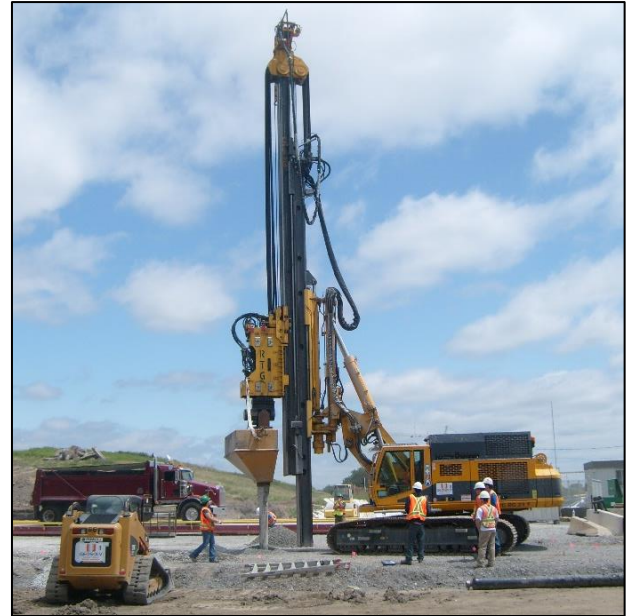
Figure 6. Photograph of the RAP installation.

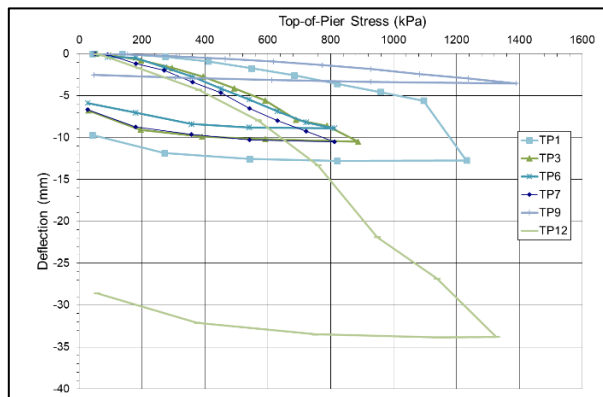
The modulus load tests were carried out on non-production elements loaded to 150% of the maximum load at various locations on the site. Typically the worst borehole locations are chosen and the highest representative top of pier stress is chosen for the design stress for the test pier. The results of the test are presented in Figure 8 and summarized in Table 1. It can be seen from the results that the maximum deflection at 100 % of the design load was under 12mm. The design modulus of the Geopier elements was 34 MPa/m for ungrouted RAPs and 82 MPa/m for grouted RAPs.

Figure 8. Modulus Load Test Results.

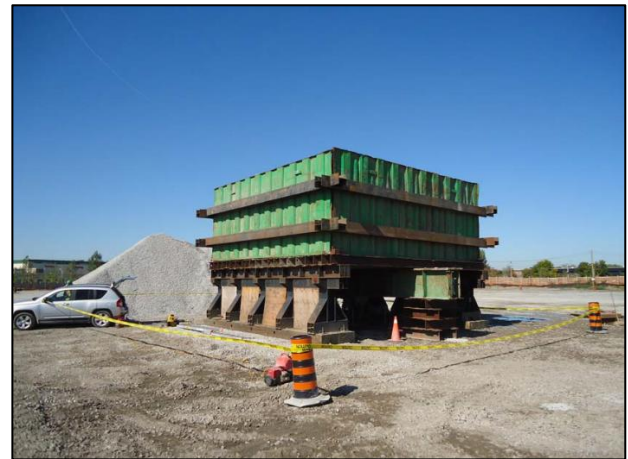
Results of the load tests are presented in Table 3, and Figures 9 and 10. Figure 11 is a photograph of the foundation load test frame, which consisted of a large gravel box reaction system necessary to generate the reaction force for the large loads applied during testing.

Figure 11. Photo of Foundation Load Test frame.

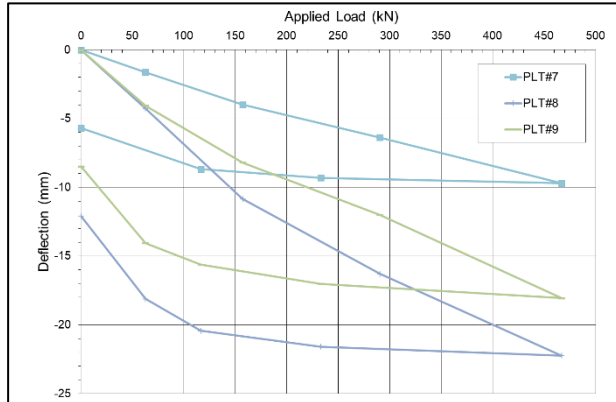
The large plate load tests consisted of loading 1.0m to 1.5m wide plates to loads of 467 kN. The plates were founded on 200 mm of compacted Granular ‘A’ and 100 mm of crushed stone over RAP elements as per the design described above. A summary of the plate load testing is provided in Table 4, and the results are presented on Figure 12.

Figure 12. Large Plate Load Test Results.

The plate load tests on engineered fill from Table 4 and Figure 12 demonstrate similar settlement results to the group footing tests done directly on the Geopier elements. In attempting to compare the modulus test results (from section 6.1), the plate and group footing test results (from section 6.2) and the large plate load tests on a layer of granular above the elements (from section 6.3), the site variability could play a negative role in drawing direct comparisons as the tests were done at different locations on the site and the site is heterogenous and variable by nature.

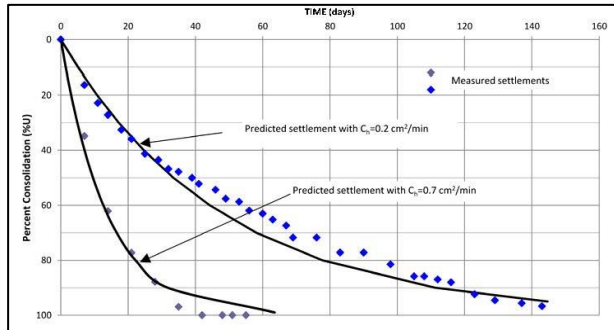
Twenty ground settlement rods were placed on the cut grade surface prior to the 2m high preloading or surcharging at the site. The settlement rods consisted of metals rods welded to a flat steel plate placed on grade and separated from the surrounding preload material by encasing the settlement rods in a corrugated metal pipe. Figure 13 presents the results of two typical ground settlement points at the site. The settlement plate over the organic soils resulted in 89mm settlement with an interpreted C_h of 0.03m²/day, while the settlement plate over the silty clays resulted in 66mm settlement with an interpreted C_h of 0.10m²/day. Soil conditions were variable in the north-south direction across the site.

Figure 13. Results of settlement monitoring for the 2m high preload.
