Construction and Post-Construction Deformations of an MSE Wall using Terrestrial Laser Scanning

Devon Adamson, Marolo Alfaro, James Blatz
Department of Civil Engineering – University of Manitoba, Winnipeg, MB, Canada
Kent Bannister
TREK Geotechnical Inc., Winnipeg, MB, Canada

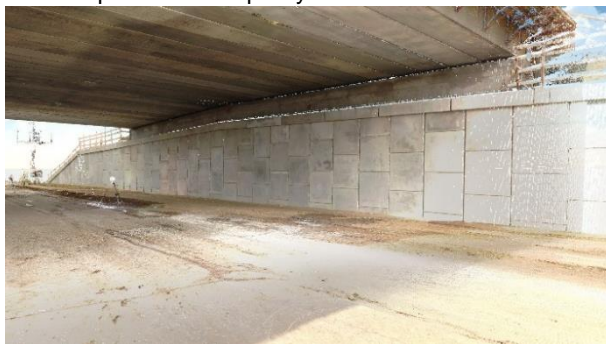
Figure 3 – Project Point Cloud of North Wall on August 28

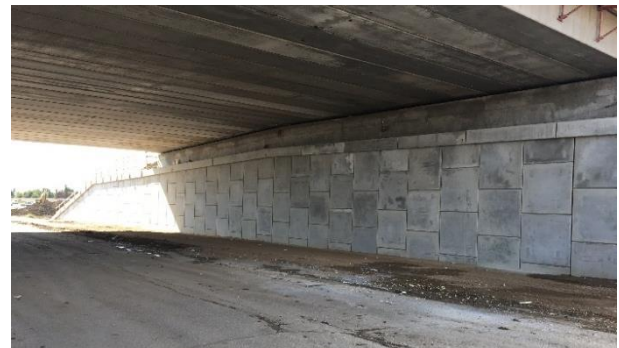
Figure 4 – Actual Photo of North Wall on August 28

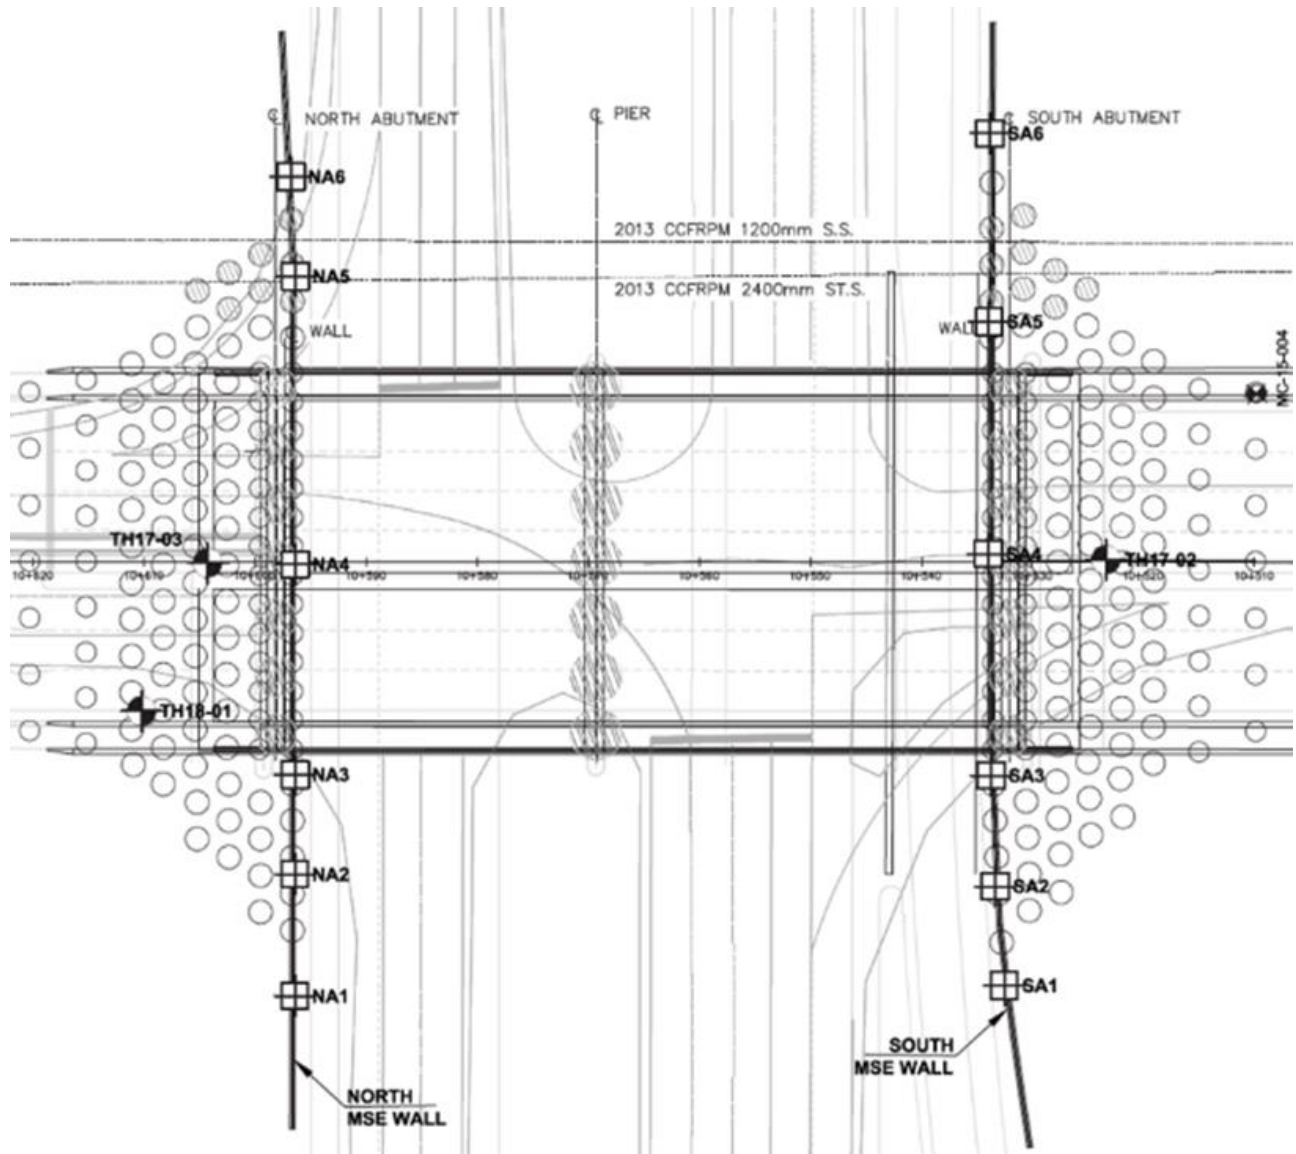
Figure 5 – Measurement Locations (provided by TREK Geotechnical Inc.)

The South Abutment settlement profile resembles the same 'W' pattern of displacements as shown in Figure 8 similar to that in the North Abutment. A potential explanation for this pattern is that the centre of the wall is supported on the stone columns while the edges of the wall are not (as shown in Figure 5). Less settlement is observed along the edges of the wall where fill heights are lower. The maximum settlement exhibited on the graph is 107mm on July 5th, 2018. This is a few millimeters over the August 28, 2018 scan which can be attributed to some registration error associated between these two dates. The differences between the July 5 and August 28 profile can likely be attributed to measurement error as it appears that settlements are largely complete. This is evidenced by upward movement between the two surveys at select locations which is considered highly unlikely to have actually occurred.

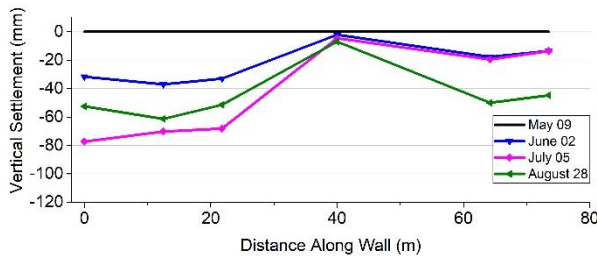
Figure 6 – North Abutment Terrestrial Laser Scanning Settlements

The North Abutment settlement profile resembles a 'W' pattern of displacements as shown in Figure 6 where the least settlement is in the centre and the most is at the outer sections. To note, the May 25th (16 days) settlement profile has been omitted as the data received from that comparison was out of error tolerance and did not exhibit the same behaviour as the rest of the scan dates. Looking at the overall profile, the maximum settlement was observed in the July scan with 77mm but looking at the rate plot, the wall is shown to move upwards from July to August on the left side of the graph (0 to 40m). This is due to registration error in the point clouds and more realistic this is an overestimation and the fact that the August 28 scan has a maximum settlement of 52mm gives reason to accept that the July settlement profile is likely an overestimation of the actual movement. The right side of the wall (Distance 40-80m along wall) shows that the July

scan is closer to June than August. This can be due to embankment buildup during construction between July and August and therefore there is the greater settlement in those time steps. A possibility behind this error is during registration of the targets, the wall may be tilted to best fit with its point cloud counterpart.

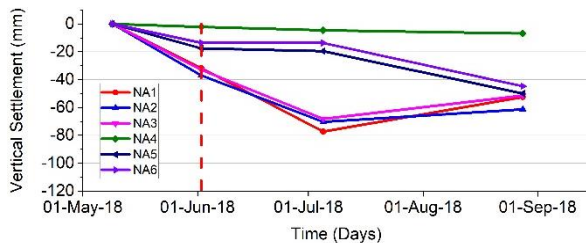
Figure 7 – North Abutment Terrestrial Laser Scanning Rate Plot

Looking at Figure 7, the rate and amount of settlement for both ends of the wall are similar to one another, which is good indication that differential settlement is not a concern as the criteria is set to a maximum of 1% along the wall.

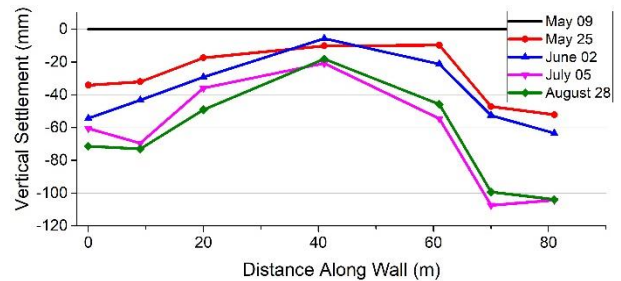
Figure 8 – South Abutment Terrestrial Laser Scanning Settlements

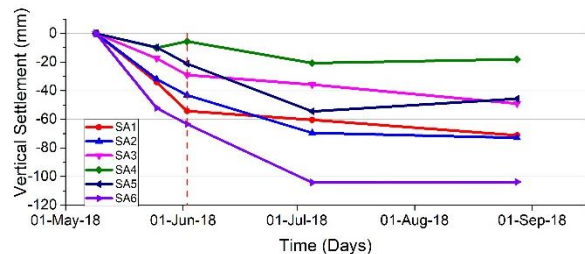
Figure 9 – South Abutment Terrestrial Laser Scanning Rate Plot

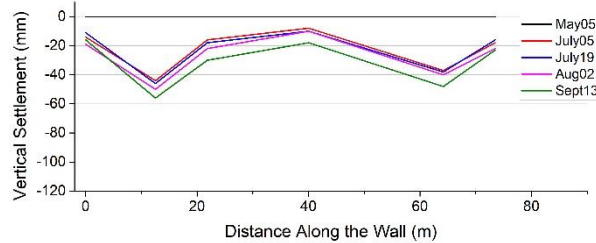
Figure 10 – North Abutment Total Station Measurements (provided by TREK)

The settlement profile for this abutment is defined in the 'W' pattern as exhibited with the TLS. The increments of settlement between each date are small with some deviations of negative settlement or upheaval, indicating some error in measurements. The magnitude of error is less than the TLS, the measurements are very similar to each other, and when referencing the long term settlement to January of 2019, the maximum settlement is 52mm. This confirms there has been small increments of settlement during construction and the measurement error is causing the small negative settlement.

to damage of the settlement plates that has occurred during construction and the amount of error in measurements, the settlement plate data are not being used and the total station measurements are relied upon instead. The total station data was made available by TREK Geotechnical Inc. in their instrumentation monitoring report summary (TREK Geotechnical Inc., 2019). The settlement profiles are shown in Figures 10 and 12. The rates of settlements are plotted in Figures 11 and 13.

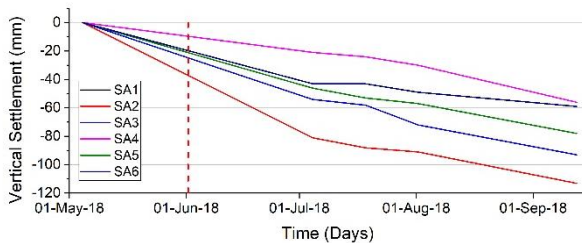
Figure 11 – North Abutment Total Station Rate Plot (provided by TREK)

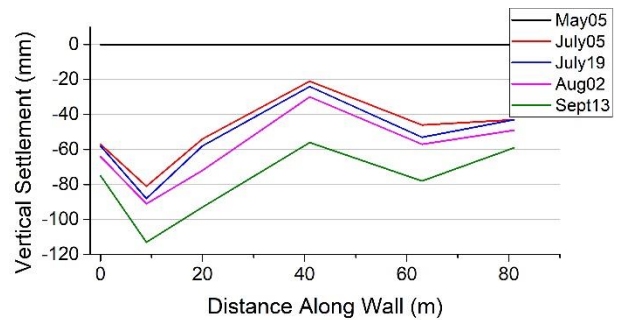
Figure 12 – South Abutment Total Station Measurements (provided by TREK)

The South Abutment shows a larger magnitude of settlement than the North Abutment and also shows increased settlement in the centre of the wall, between August 2 and September 13. This would indicate more overburden stress from the embankment. The maximum settlement measured by the total station is slightly higher than the predicted 55mm value.

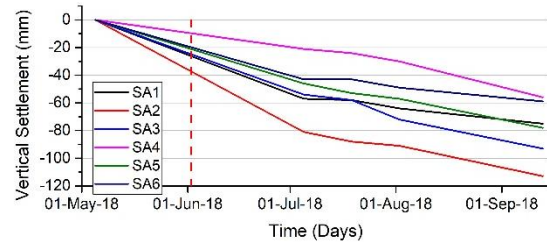
Figure 13 – South Abutment Total Station Rate Plot (provided by TREK)

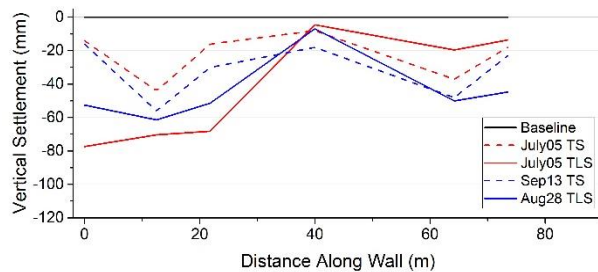
Figure 14 – North Abutment TLS vs Total Station

Looking at the table, the locations with the largest uncertainty were NA1, NA2 and NA3. This is understandable as the July scan at location NA1 and NA3 had maximum differences of -47mm and -36mm. The settlements in these locations can be discarded. The August scan does not fair as well, suggesting 35mm and 25mm more settlements for NA1 and NA2, respectively. The amounts of these settlements can be observed if there are large errors compounded from registering point clouds and RTK coordinates for benchmarks. Looking at the behaviour of pattern of movements for both methods, it is more reasonable to assume the total station is more accurate in relative settlement and that the TLS has overestimated the settlement, however the trend or behaviour of the settlement along the wall is similar and it is just the magnitude of the movement that is different. With differences of $\pm 20\text{mm}$ and less, it is fair to assume both methods are quite close to the actual settlement when referencing the range of errors listed in Section 6.

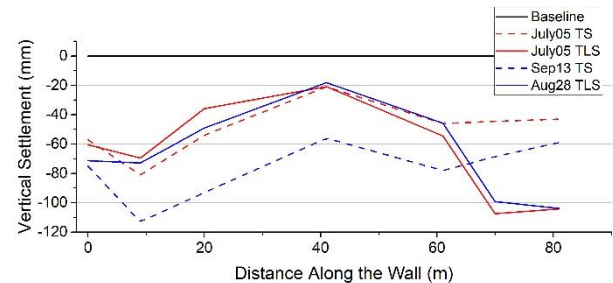
Figure 15 – South Abutment TLS vs Total Station

South Abutment has more of an even distribution of positive and negative differences, as evidenced by maximum values of -57mm and 35mm, respectively. The same problem outlined in Section 6.1, these values are too large to consider. The main concern is the August scan as they are mostly large positive values until location SA6 where it drops down to 50mm below the total station settlement readings. The location of SA6 and the August scan are all outside a reasonable acceptable threshold of 20mm, and should not be considered reliable. As stated with the North Abutment, the behaviour of settlement is similar while the magnitude of movement is different.

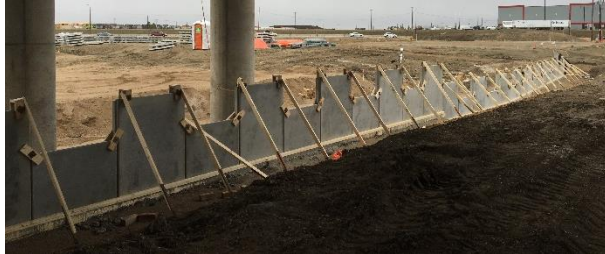
Upon reflection of if there was anything that could have been done to improve the measurements, more scans would have been set-up during the baseline reading (May 9) as the supports along the wall affected the line of sight for data points to collect on the panel face; as seen in Figure 16. Five scans were used for each abutment but this could be doubled to ten to improve the measurement.

Figure 16 – First Row of Panels Installed
