Case Study: Installation of a Soil-Cement-Bentonite Groundwater Cutoff Wall in Argentia, NL

Nathan Coughenour & Daniel Ruffing
Geo-Solutions, Inc. - New Kensington, PA 15068

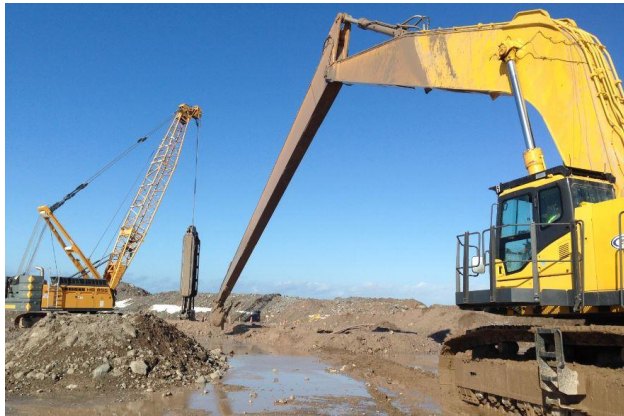
Figure 3. Initial procedure included a single excavator and a single clamshell

The proposed procedure for this project included two excavation headings. The cutoff wall was intended to be installed using a large excavator with a specialty stick/boom combination for excavation down to 26 m below grade and a clamshell excavator from 26 m to final depth of 32 m to 40 m (see Figure 3). Understanding that the

excavation conditions would be difficult and in order to reduce the chances of downtime, pre-drilling of the entire alignment down to 24 m below grade using a large caisson drill fitted with a 0.75 m auger/bit was planned. Although this drill would be expected to refuse on competent boulders and/or bedrock, it was still included to loosen cobble and gravel layers. In areas with rock layers or boulders, the plan was to move the alignment to avoid the troublesome area. In the event that the area could not be avoided, a drop chisel was planned for crushing boulders and for breaking other rock. In this case, the broken rock, boulders, etc. could then be removed using the excavator or clamshell. The drill used to pre-drill the alignment was also planned to be available to pre-drill locations deeper than 24 m, if necessary. Similar SCB slurry trench installation approaches to those proposed for use at this site had been used successfully used in difficult soil conditions and the pre-drilling/drop chisel contingencies were included to further increase the chances of success.

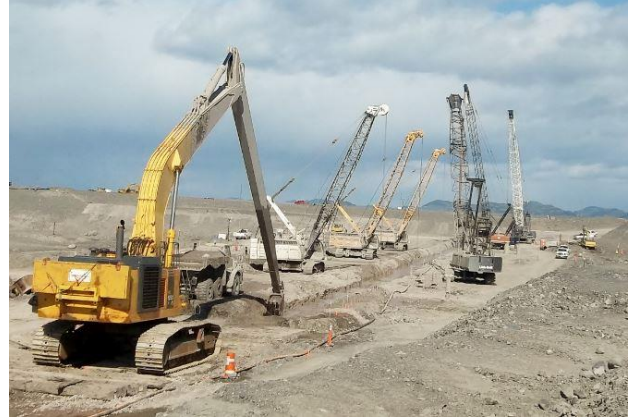
Figure 4. Modified procedure included three clamshells and two drill rigs

Second, the frequency, depth, and size of boulders encountered in the excavation exceeded expectations. Additional contingency measures, including an additional clamshell excavator and two crane mounted drills were mobilized to deal with these conditions (see Figure 4). The additional clamshell assisted with excavation as the clamshell work was the critical path activity. The crane mounted drills were used to drill through obstructions and pre-drill the clamshell excavation areas through the

excavated slurry filled slot (created from the excavation with the excavator).

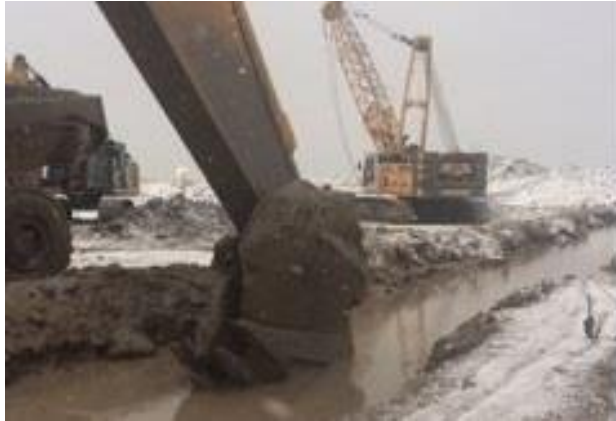
Figure 5. A boulder being removed from the trench with the long stick excavator

The frequency in which boulders were encountered during the installation of the SCB cutoff wall was not typical for a cutoff wall installation. Boulders were encountered over 91% of the excavation length and over an average of 22% of the depth in each excavation cut. Figures 5 and 6 display two of the boulders removed from the trench during the cutoff wall installation. Despite the frequency of boulders encountered, the cutoff wall was still able to be installed to full design depth along the entire alignment.

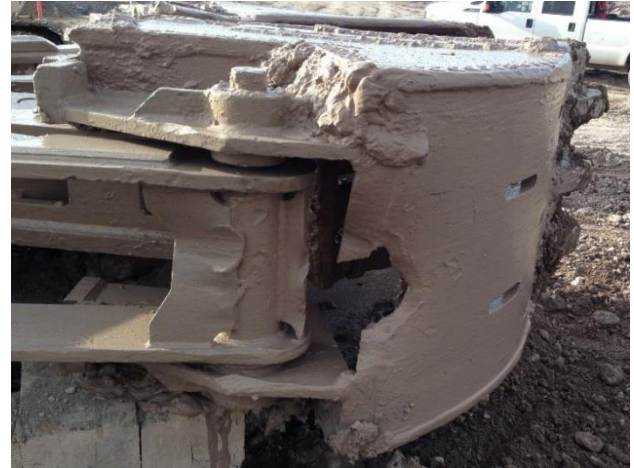
Figure 7. Damage to a clamshell bucket during excavation of boulders

The unusually high boulder frequency also caused damage to excavation equipment during boulder removal attempts. The excavators, clamshells, and drills used for the SCB wall installation incurred unusual damage both in terms of magnitude and frequency. Figure 7 shows a clamshell damaged during excavation operations while Figure 8 displays a broken bucket cylinder on the long-stick excavator. Through effective resource management and problem solving of the project team, the effects of these damages were able to be minimized as much as possible and allow for trench excavations to continue to full design depth.

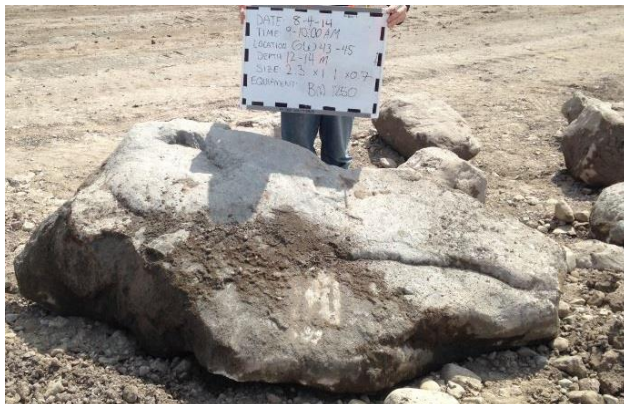
Figure 6. Boulder removed from trench measuring 2.3m x 1.1 m x 0.7m

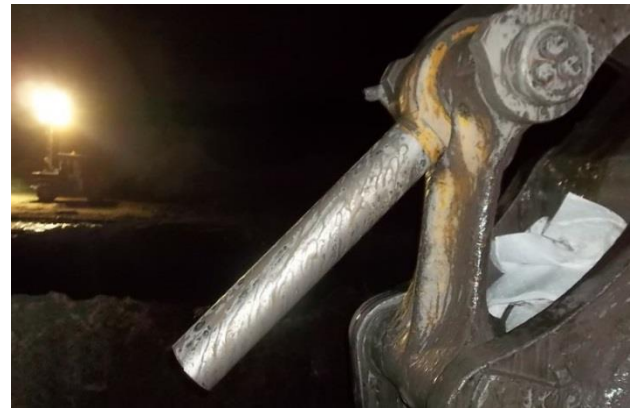
Figure 8. An attempt to remove a boulder from the trench resulted in a broken bucket cylinder on the PC-1250

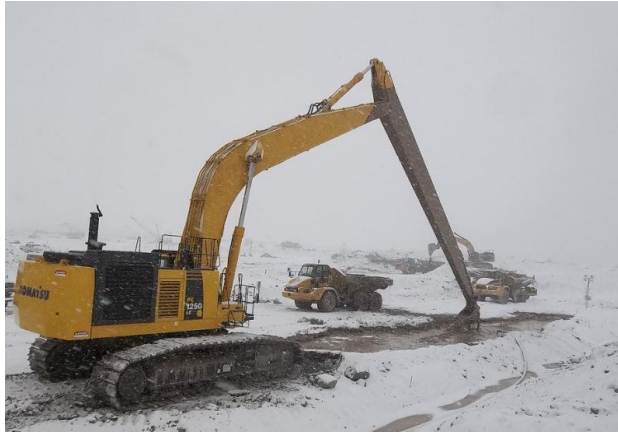
Figure 9. Snowy site conditions during winter work

The weather conditions were also challenging on this project. The winter of 2013/2014 in this area was more severe than normal. Figure 9 shows the cutoff wall being installed during the winter of 2013/2014. The cold winter temperatures slowed production and necessitated the construction of temperature-controlled tent structures for grout/slurry batching and repair facilities. The wind and fog also produced challenges to the project. Wind speeds averaged 20km/h to 30 km/h with gusts regularly surpassing 50 km/h. These high and frequent wind speeds provided challenges to the cutoff wall installation, especially for the crane-mounted clamshells, resulting in safety shutdowns.

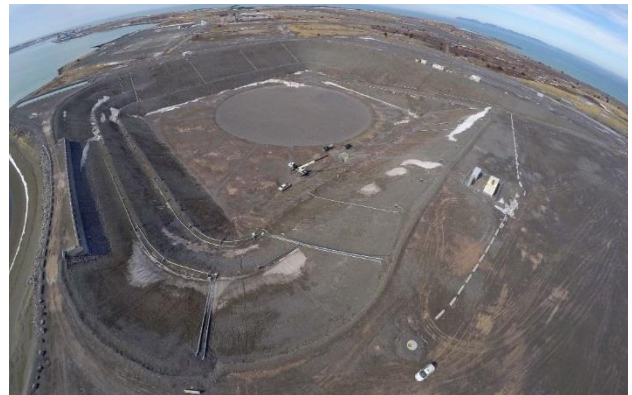
Figure 10. Aerial photo of the completed graving dock. (Dexter Construction Co, 2015).

The SCB cutoff wall was ultimately installed in accordance with the project objectives. Upon completion of the cutoff wall, the excavation and dewatering contractor for the graving dock noticed a substantial decrease in dewatering volume relative to the estimated volume indicating that the cutoff wall was working as well as or better than designed. Based on the geotechnical and groundwater flow studies conducted for the dewatering system design prior to construction, it was anticipated that 80 deep well pumps with a 10 L/sec capacity would be required to maintain water levels below the graving dock floor after installation of the cutoff wall. After installation of the cutoff wall only 24 of the 80 pumps were necessary to maintain water levels below the graving dock floor indicating that the cutoff wall not only met but far exceeded the design intent.
