Use of an Innovative Technology for Measuring Surface Roughness of Pavements

Prajwol Tamrakar, Mark H. Wayne, and Kris Broadhead
Tensar International Corporation,
2500 Northwinds Pkwy, Suite 500, Alpharetta, GA, USA

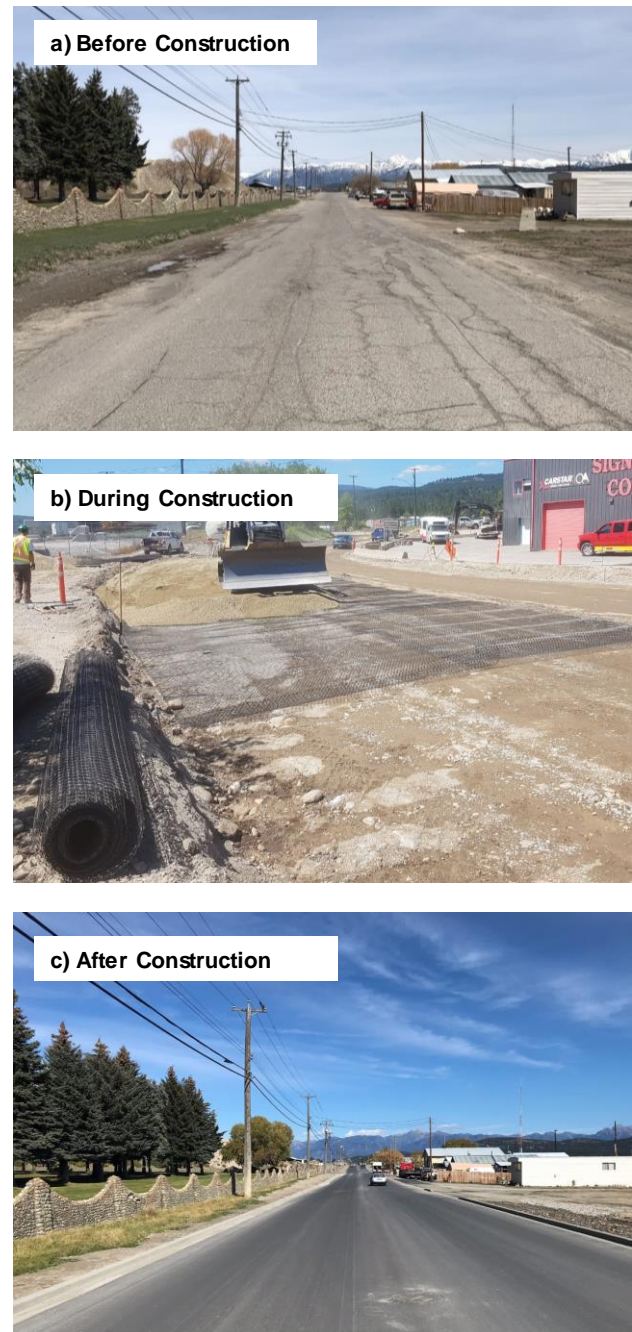
Figure 2. Before and After Rehabilitation of Cobham Ave West

Figure 2 shows the pavement condition of Cobham Ave W before and after rehabilitation. The ride quality of the pavement was significantly improved after rehabilitation. To quantify such improvements, pavement condition evaluation surveys were conducted over six different streets in the city of Cranbrook (as mentioned in Table 2). Surveys were conducted in both directions for measuring pavement IRI. Figure 3 provides the average IRI of pavement sections through the color-coded map as displayed in the web portal of TotalPave. The legend in the figure represents the IRI ranges. Most of the pavement sections have low IRI (<1.5 m/km) as represented by dark green color. Only a few pavements have sections where IRI is in the range 3.5-4 m/km.

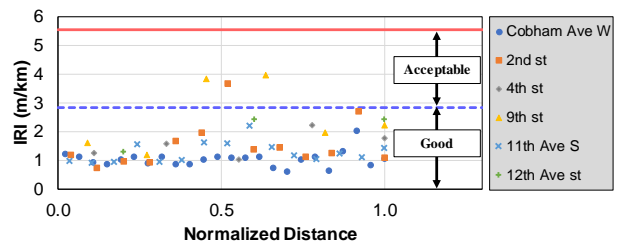
Figure 4. Pavement IRI based on the Normalized Distance

Figure 4 provides pavement IRI based on the normalized distance. As the total survey distance of different pavement sections is different, the IRI values are presented based on the normalized distance. The normalized distance was computed using the actual distance of IRI measurement divided by the total survey

distance. Figure 4 illustrates the distribution of pavement IRI along the longitudinal distance of the roadway. As indicated in the figure, almost all IRI measurements are in the good range as specified by Arhin et al. (2015).

To understand the overall condition of pavement, the IRI values shown in Figure 4 are averaged and presented in Figure 5. All pavements had IRI values in the good range. The pavement of Cobham Ave W had the lowest IRI

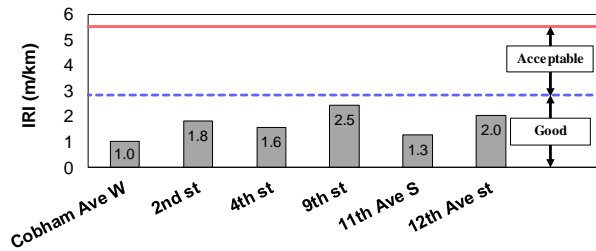
Figure 5. Representative Pavement IRI

and 9th St had the highest. Since the high IRI was reported for the pavement section (9th St) near the roadway intersection, the turning traffic might have contributed to increasing pavement roughness. Additionally, the roadway intersection was not rehabilitated. The other potential factors affecting IRI measurements are subgrade condition, braking of the vehicle, longitudinal pavement slope, underground utilities, freezing/thawing of unbound pavement layers and so on.

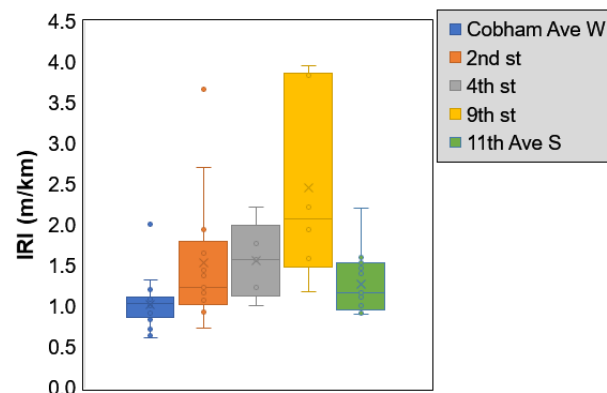
Figure 6. Box-and-Whisker Plots for IRI Data

Using the box-and-whisker plots, the statistical summary (a.k.a. a five-number summary) results for all test section are presented in Figure 6. The figure shows the minimum value, lower quartile (25%, Q1), median (50%, Q2), upper quartile (75%, Q3), and maximum value. The dots above each whisker are the potential outliers. Due to few datasets, the plot for 12th Ave st is not presented. As seen from the figure, the IRI measurements for Cobham Ave W, 4th st and 11th Ave S are consistent. And, the pavement sections of 2nd st and 9th st have a relatively high variation in IRI measurement which is also seen from Figure 4.
