Controlling Risk to Critical Infrastructure during Construction: Seine Riverbank Stabilization at the Branch 1 Aqueduct, Winnipeg, Manitoba

Kyle Hamilton, P.Eng., M.Eng., David Flynn, P.Eng., M.Sc., Bruno Pierre Arpin, P.Eng., Rob Kenyon, P.Eng., Ph.D., FEIC
KGS Group, Winnipeg, Manitoba, Canada
Linda McCusker, P.Eng., Jessica McCombe, P.Eng.
City of Winnipeg, Winnipeg, Manitoba, Canada

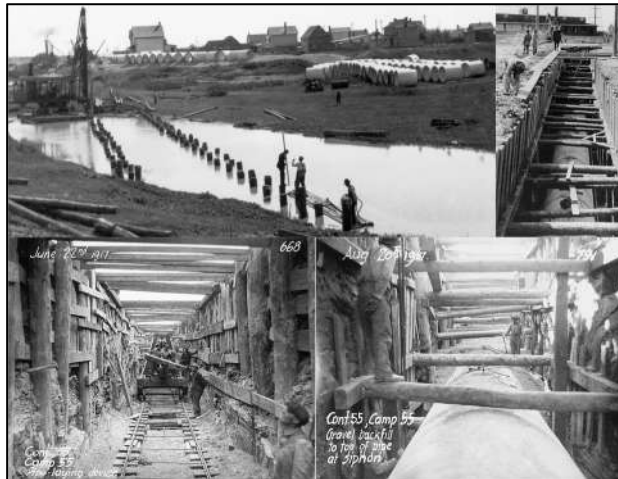
Figure 1: Original Construction of Branch 1 Aqueduct.

McPhillips Pumping Stations. This portion is a critical component of the City of Winnipeg's drinking water supply, delivering 173 million litres of water (approximately 40% of the City's treated water) every day to homes and businesses. Figure 1 shows the original construction of the Branch 1 Aqueduct (Aqueduct) at the Seine River crossing from the east bank near the corner of Rue Notre Dame and Rue Maisonneuve in St. Boniface to the west bank in Lagimodière-Gaboury Park. The Aqueduct consists of a 1.67 m diameter reinforced concrete pipe constructed of 2.4 m long precast segments that are supported by a cast-in-place concrete cradle. Construction consisted of an open trench excavation supported by timber shoring and tightly spaced planks with cross bracing, shown in Figure 1. The shoring was left in place after construction to provide additional protection and to act as a barrier between the trench backfill and the existing poor soil conditions. Remnants of the timber shoring can still be seen 100 years later on either side of the Seine River.

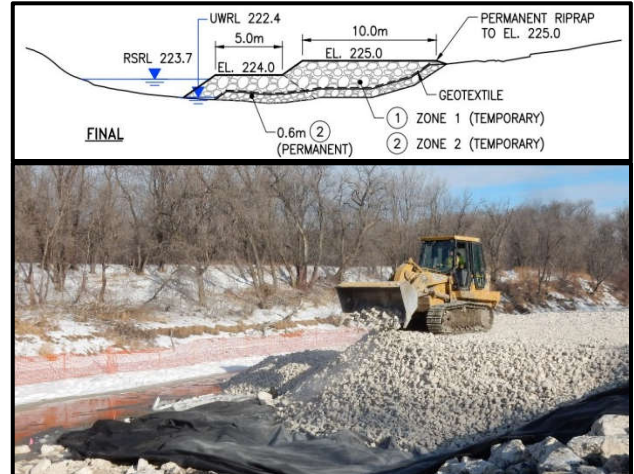
Figure 4: Permanent Riprap Blanket and Temporary Rockfill Berm.

Riprap placement and the temporary rockfill berm construction started on the north end (away from the active riverbank movements) and advanced south towards the Aqueduct (closer to the active riverbank movements). Consequently, the stability of the riverbank increased as the distance from the active construction area to the Aqueduct was reduced. The placement of the permanent riprap blanket and temporary rockfill berm are shown in the Figure 4.

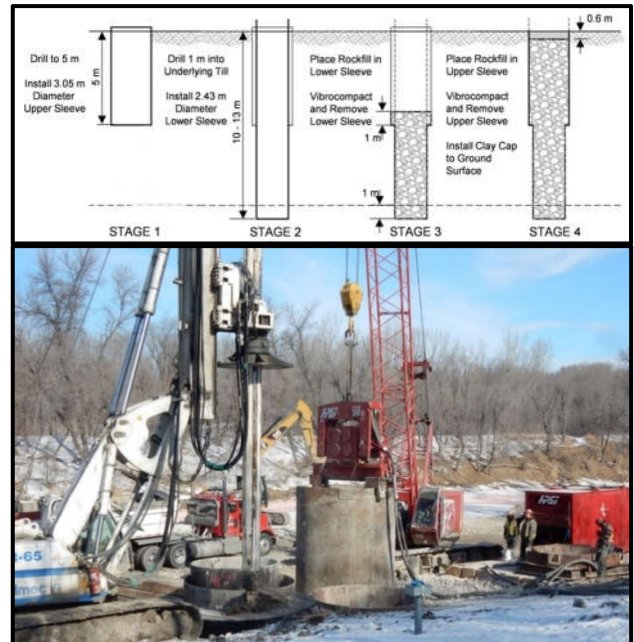
Figure 5: Rockfill Column Installation Method.

Rockfill columns were installed in four stages as shown Figure 5. Steel sleeve casings were installed in every column to minimize lateral movement. Casings were vibrocompacted and removed from the excavation using a vibratory hammer hoisted by a crane as shown in Figure 5. Excess clay remaining in the casings were removed prior to backfilling with the clean, crushed limestone. Installation of the 79 rockfill columns began in February 2018 and was completed in one and a half months' time in March 2018.

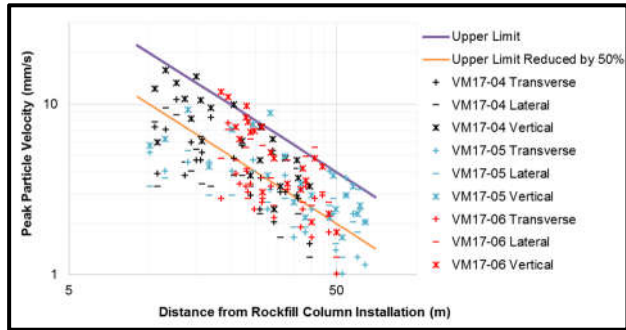
Figure 7: Radius of Influence of PPV at Distance during Vibrocompaction of Rockfill Columns.

The measurements from the seismographs were key in developing a safe radius of influence from the rockfill column being installed (vibration source) as shown in Figure 7. The benefit of vibrocompaction was weighed against the risk of damaging the Aqueduct from vibrations and resulting riverbank movement as the installation of the rockfill columns approached the Aqueduct. Based on the radius of influence, the Aqueduct would have likely experienced vibrations and riverbank movements in excess of tolerable limits if the rockfill columns closest to the alignment were vibrocompacted. Consequently, the rockfill column installation method was modified while working immediately adjacent to the 100-year old Aqueduct pipe. Construction induced vibrations were all kept below the specified threshold for maximum PPV, and in turn, preserved the integrity of both the Aqueduct and the nearby houses.

The attenuation of vibrations through soil is dependent on the frequency of the vibration source, as well as the soil parameters including: grain size, degree of consolidation, density, moisture content and temperature (Wiss, 1967 & Woods and Jedel, 1985). The attenuation of vibrations for the simplified upper limit measured during initial start-up, shown in Figure 7, was calculated according to the method developed by Wiss (1981):

An attenuation rate of $n = 1.0$ was found to provide a strong fit to the measured results. This attenuation rate was lower than anticipated, as the findings from Woods and Jedele (1985) generally suggest attenuation rates of $n = 1.5$ and 1.1 for clay and glacial till, respectively. The lower attenuation rate observed during construction can be partially attributed to frozen soils which attenuate vibrations less than thawed soil (Barkan, 1962).

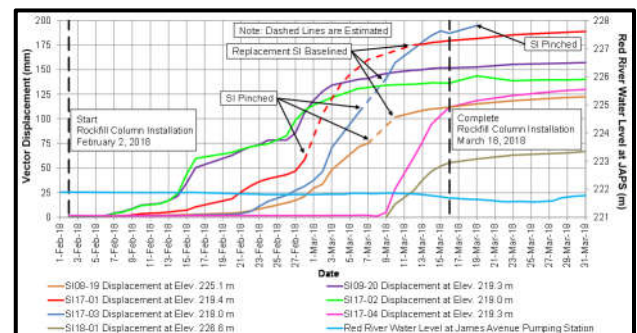
Figure 9: Maximum Vector Displacement

Slope inclinometers (SIs) on the mid-bank generally measured the highest magnitude of movement at Elev. 218 m and 219.4 m above the clay/till interface. An example of key full depth slope inclinometer readings from SI09-20 on the mid-bank is presented in Figure 8, depicting movement along the clay/till interface during construction. Maximum vector displacements from select slope inclinometers are presented in Figure 9.

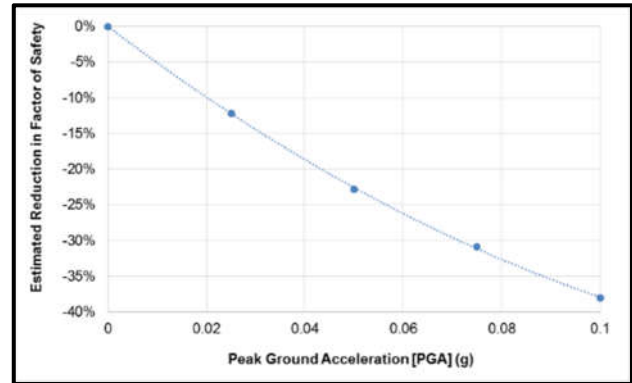
Figure 10: Sensitivity Analysis Reduction in Factor of Safety versus PGA during Construction

Based on the vibration monitoring, a peak ground acceleration ranging from 50% to 60% of the measured maximum value was applied to the riverbank in the pseudo-static slope stability analysis. The applied peak ground acceleration was estimated to be 0.06 g at a distance of 11 m and 0.02 g at 24 m. A sensitivity analysis was completed for peak ground accelerations ranging from 0 g to 0.1 g, as shown in Figure 10. The reduction in the FS along the critical section was estimated to be approximately 25% at a distance of 11 m and 10% at a distance of 24 m.

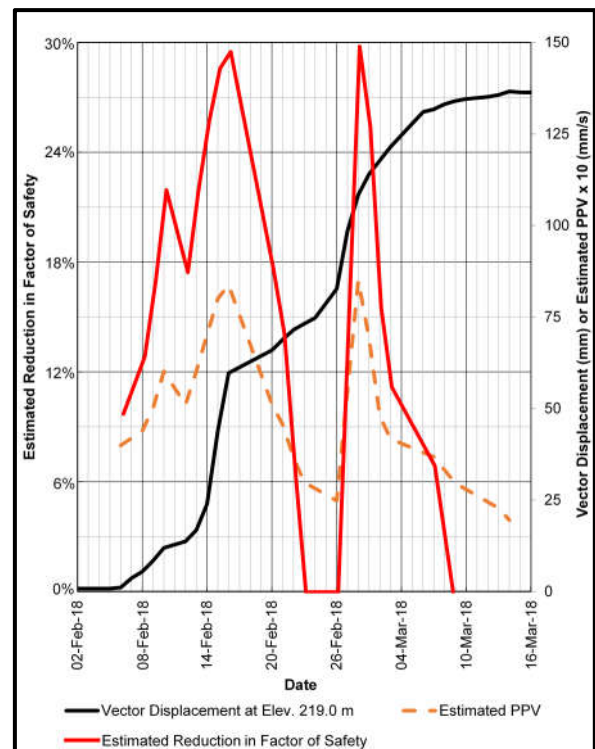
Figure 11: Estimated Reduction in Factor of Safety at SI17-02 during Construction of Rockfill Columns

The estimated reduction in the FS at the location of SI17-02 during the construction of the rockfill columns is shown in Figure 11. The estimated vibrations and reduction in FS was the highest (24-30%) when installation of the rockfill columns occurred immediately downslope. This timeframe corresponded directly with measured large riverbank movements at the location. The reduction to riverbank stability was limited in scale and continuous monitoring results did not indicate any threat to the integrity of the Aqueduct.
