Some Geotechnical Aspects of Land-to-Sea Transition Zones

Matich, M.A.J. (Fred)
MAJM Corporation Ltd., Toronto, ON, Canada

Jim Scott
AECOM, Greenwood Village, CO, U.S.A.

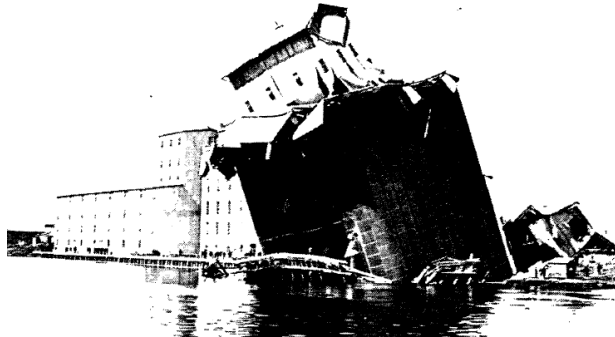
The Ogilvie Grain Elevator described variously by Theimer (1969); Vervoort (1990) and The Thunder Bay Museum; was built on the Kaministikwia River in 1904. It was a 26 bin structure, 90 feet (27m) high, of steel construction carried on a pile-supported concrete mat. On May 26, 1906, it suddenly started to move towards the river. As noted in an article in the Thunder Bay Museum, within 24 hours it had moved about 50 ft. (15m) and had come to rest in the river at a 15 degree angle. The wharf was wrecked. The Elevator was damaged. However it did not break up. Much of its contents of 380,000 bushels of wheat were lost. The cause was attributed to deepening of the river at the Wharf by dredging which was aggravated by scour during flooding. The Elevator was replaced with one twice its size, but built further from the river. The replacement performed well from a foundations

standpoint, during a long service life. A photo of the Elevator in its failed position is given in Figure 5.

Figure 5. Ogilvie Elevator in its Failed Position
(Courtesy: The Thunder Bay Museum)

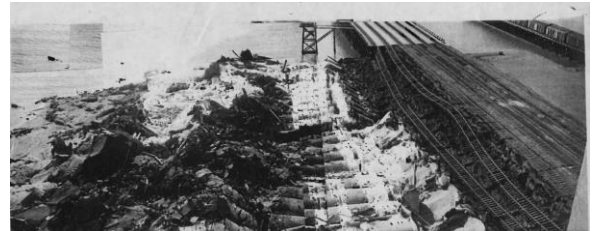
The United Grain Growers Terminal was built on the Current River in 1927-28. A major component (Storage Annex No. 2) collapsed suddenly into the harbour on September 23rd, 1959 spilling 2.5 million bushels of grain into the adjacent slip. It also created a wave 16 feet (5m) high which wreaked havoc in the harbour. The Elevator Terminal is composed of two Storage Annexes (Nos. 1 and 2) together with a number of associated structures arranged in line along a dock. The dock area was reclaimed using Wakefield timber sheet piling for containment, and silt dredged from the adjacent Lake bottom. Each Storage Annex is 375ft. (115m) long, 100ft (30m) wide, and 124ft. (38m) high. The base of the Elevator Structure rests on a concrete mattress-type raft 3.3ft. (1m) thick supported on timber piles driven through the hydraulic fill and natural lake-bottom clay to refusal in glacial till. Each Annex was composed of 56 circular concrete compartments arranged in four rows of 14 and supported on 5052 vertical piles. The Wakefield sheet piling was anchored at the top by a series of tie rods which were anchored at their inshore ends to timber A-frames each consisting of vertical and batter piles the heads of which were embedded firmly in the concrete mat foundation. A 6 track 60ft (24m) wide, 30 ft (8m) high railway timber trestle was located on the land side of Terminal. It was buried in granular fill in the late 1930's and the tracks transferred to the fill.

In 1958, some loss of reclamation of fill occurred through a damaged section of Wakefield sheet piling. This was repaired. In the month before the failure, the Wharf was hit on two occasions by a ship coming in to the Elevator. Lateral movements of the Elevator prior to the failure were only about 1 inch (25mm). this contrasted sharply with known larger lateral movements of other grain Elevators in the Harbour area which were also carried on timber piles but without batter piles. Movements in the other cases occurred without distress and were stopped by

application of restraining measures. A description of this failure and discussion of the most likely causes is included in Peck et Al. (in preparation). It is believed that there were a number of contributory factors among which were the failure of the inclined piles of the A-frames acting as batter piles to the Elevator. A photo of Annex No. 2 taken after the collapse is given as Figure 6.

Figure 6. The United Grain Growers Limited Current River Terminal After Failure. (Courtesy: Viterra Inc.)

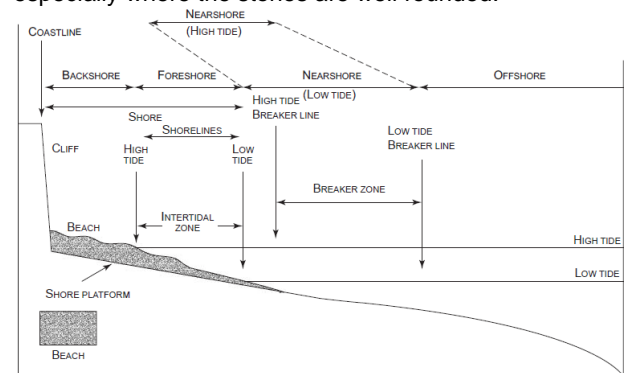
Figure 8 from Bird (2007) illustrates the various zones along coasts. The shore is the zone between the water's edge at low tide and the upper limit of effective wave action, usually extending to the cliff base. It includes the foreshore, exposed at low tide and submerged at high tide, and the backshore, extending landward from the normal high tide limit, but inundated by exceptionally high tides or by large waves during storms. The shoreline is strictly the water's edge, migrating to and fro as the tide rises and falls.

A beach is an accumulation of loose sediment, such as sand, gravel or boulders, sometimes confined to the backshore but often extending across the foreshore as well. Some beaches extend down to, and below, low tide level. Shingle is beach gravel, especially where the stones are well rounded.

Figure 8. Coastal terminology (After Bird, 2007)
