## GROUND IMPROVEMENT, CONSTRUCTION AND MONITORING OF CHALLENGING UNDERGROUND EXCAVATIONS BENEATH THE SENSITIVE HERITAGE LIBRARY OF PARLIAMENT BUILDING, OTTAWA

T. G. Carter, P.J. H. de Graaf, M. J. Telesnicki, Golder Associates, Ltd. Mississauga, Ontario, Canada  
G. S. Webb, D.W. Miller, Golder Associates, Ltd. Ottawa, Ontario, Canada  
L. Poulter, Ogilvie and Hogg Architects Ltd., Ottawa, Ontario, Canada, and  
P. Frame, Public Works and Government Services Canada, Ottawa, Ontario, Canada

The engineering and construction of an almost 10 metre deep, 20 metre diameter basement excavation, along with ancillary underpinning, tunnels, shafts, and raises to provide new underground space in the limestone bedrock forming the foundations of the Library of Parliament in Ottawa, Canada, without damage to the existing heritage building or disruption to the proceedings of Parliament has required innovative application of novel excavation techniques, detailed design of complex excavation geometries and implementation of stringent control procedures to ensure that the required quality of excavations is achieved. Excavation design, ground improvement and heavy pre-reinforcement as well as exte

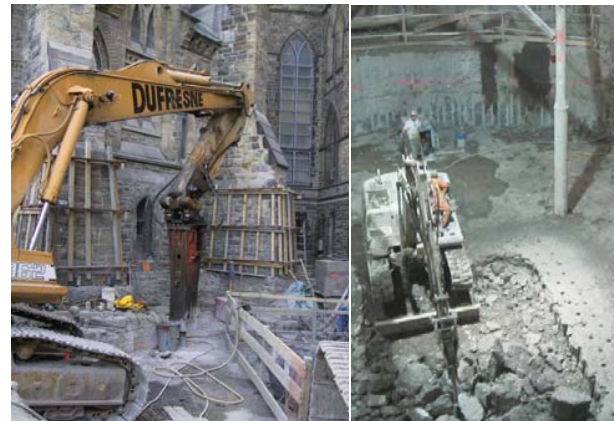
Figure 5: 66 kW Hoe Ram as used to excavate the upper portion of the Access Shaft (left). 25 kW Hoe Ram working in the Mechanical Room (right).

Hoe-rams ranging up to 66 kW power output (as shown in Figure 5) were used in combination with other rock fragmentation methods. The upper zone of weathered rock to 6 m depth (the max reach of the excavator) of the Access Shaft was excavated using this equipment. However because of access difficulties and necessity of maintaining vibration limitations, most of the breaking within the mechanical room and tunnels, once the rock had been split, was also undertaken using hoe-ramming, but using smaller machines.

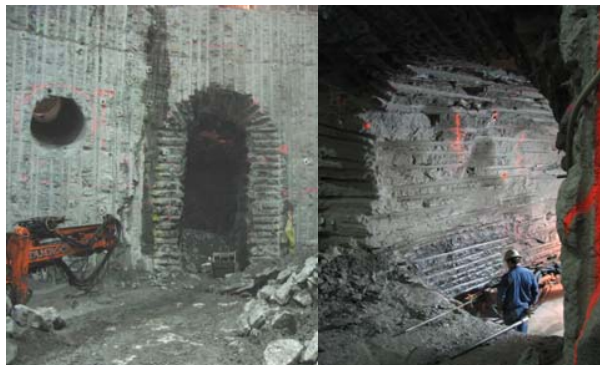
Figure 8: Final excavation profiles showing tight line drilling and good wall control for the Mechanical Room wall, Stair 'B' Tunnel (left) and LOP Tunnel (right).

To mitigate overbreak and rock mass damage beyond the design lines, the Contractor predrilled (or saw cut) all final excavation surfaces. This was usually achieved by drilling 89 mm (3 1/2") diameter holes leaving 75 mm (3") wide intervening webs. In some instances where difficult access or poor ground conditions dictated, either interlocking cored holes were drilled or rock saw cuts were made in lieu of percussion-drilled perimeter holes.

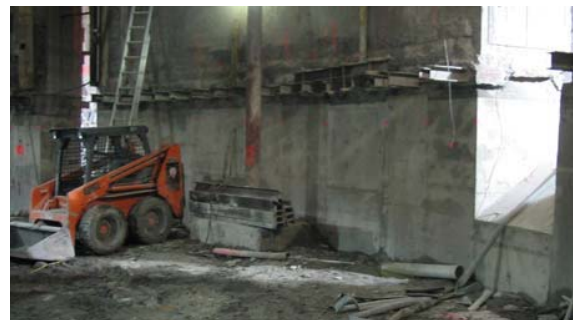
Figure 11: Completed inner ring wall underpinning.

The underpinning was completed without any significant effects being observed by the instrumentation. This was achieved through adequate rib pillar pre-support using fibreglass reinforcement elements, careful excavation, attention to line drilling, optimization of excavation sequence and timely dry packing of cured concrete underpinning blocks. Only localised, relatively small responses of the order of 2-4mm were noted.
