STABILITY OF FROZEN AND THAWING SLOPES IN THE MACKENZIE VALLEY, NORTHWEST TERRITORIES

Larry Dyke, Geological Survey of Canada, Ottawa, Canada

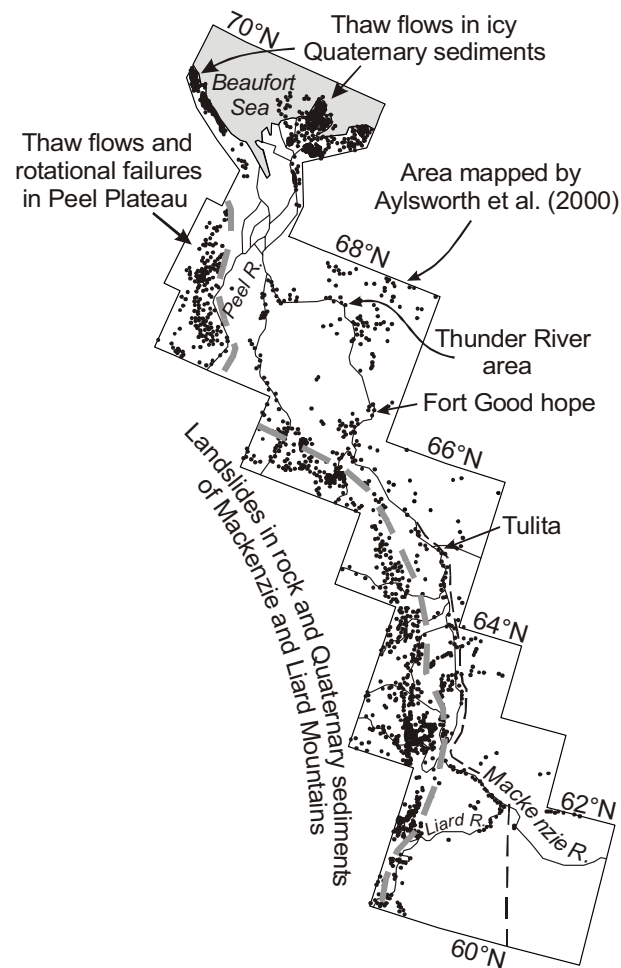
Figure 1. Locations of landslides of all types in the Mackenzie valley as mapped by Aylsworth et al. (2000). Each dot may represent more than one landslide. Dashed black line is the Norman Wells pipeline. Grey dashed lines show approximate boundary between lowland and mountainous areas.

No slopes in the Mackenzie valley have received more engineering attention than those crossed by the Norman Wells pipeline (route shown on Figure 1). This 300 mm diameter buried oil pipeline traverses the discontinuous permafrost zone between Norman Wells, Northwest Territories and Zama, Alberta and has been operating since 1985. As part of the pipeline design, about 165 slopes to be traversed by the pipeline were identified as requiring modification to reduce the likelihood of failure or disturbance due to erosion or thaw (Hanna and McRoberts 1988). Most of these slopes are approaches to

The Thunder River area (see Figure 1) serves as a convincing example of the effectiveness of fire as a landslide trigger (Figure 3). Thirteen hundred square kilometers of forest adjacent to the Mackenzie River burned in 1986 and within one year extensive active layer slides had developed (Harry and MacInnes, 1988). Several of these slides have evolved into retrogressive thaw flows. These features are primarily in silt-rich tills with head scarps that have visible ice contents of up to 50%. The primary effect of the fire is to reduce or eliminate the insulative quality of ground surface

As a general observation, only banks rising at least 50 m above river level appear to be prone to extensive, repeated failure. Banks exposing glaciolacustrine sediments and tills downstream of The Ramparts (Figure 7) are generally lower than this and show little activity of a rotational nature. The most impressive area of rotational landslides is in the vicinity of Old Fort Point (Figure 7), beginning on the right bank of the main channel about 50 km upstream of Tulita and continuing for about 40 km. Figure 7 shows where banks in glacial sediments immediately adjacent to the Mackenzie River exceed a height of 50 m. Also shown are the segments of these high bank intervals which show recent deep rotational failures. Failures become more evident with distance to the south, suggesting that a decreasing thickness of ice-bonded sediments may be responsible for decreasing bank stability.

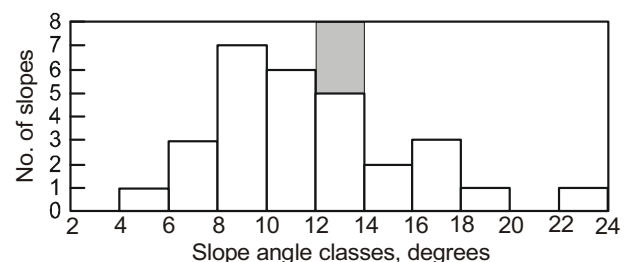
Figure 2. Range of average angles for 29 slopes considered most susceptible to failure along the Norman Wells pipeline. Grey bar indicates the approximate minimum angle of slope that failed as active layer slides after the Thunder River fire.

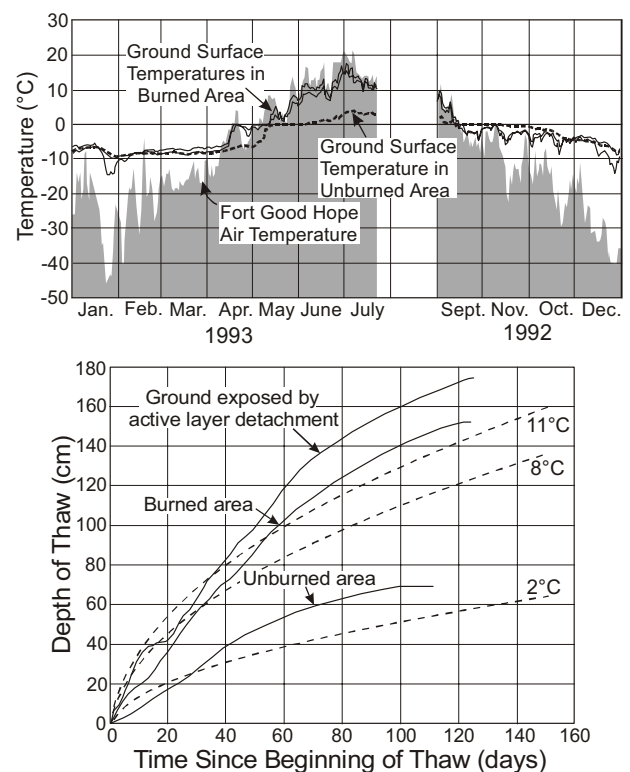
Figure 4. Influence of forest fire on ground surface temperatures and rate of thaw. Solid lines on lower graph show predicted thaw for measured ground surface temperatures shown in upper graph. Dashed lines show predicted thaw for an instantaneous application of the mean thawing temperature.

The extreme environmental change that is associated with the triggering of active layer slides by forest fire can be compared with the impact of right-of-way preparation on slopes along the Norman Wells pipeline. The fire at Thunder River essentially doubled the rate of thaw (Figure 4). Thawing has been accelerated on some slopes along the pipeline right-of-way but not to the degree caused by a fire. Although thawing contributes to destabilization according to existing thaw-consolidation theory, the possibility of slope drainage due to lateral high hydraulic conductivity and the sensitivity of slope failure to cohesion suggests that fire-related slides happen when the frost table can reach an ice-rich and hence minimally cohesive horizon. Although the restraining effect of the typical trough-shaped thaw surface beneath the pipeline right-of way has been recognized, additional stability may be conferred by better than expected pore pressure drainage.

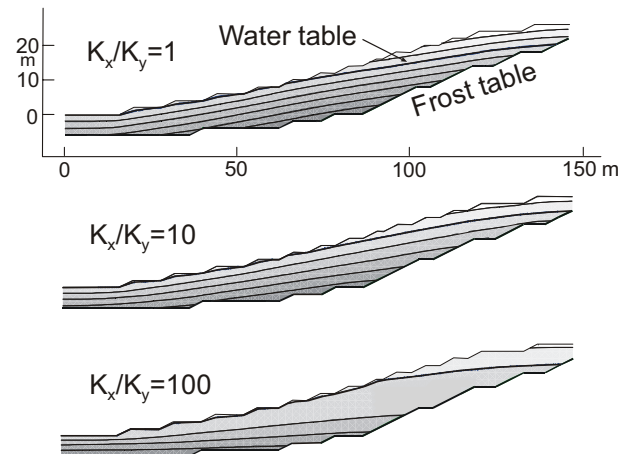
Figure 5. Pore pressure distribution in slopes with the horizontal hydraulic conductivity, K_x , varying by factors of 1, 10, and 100 times the vertical hydraulic conductivity, K_y . A water flux of 3 cm/mo from the frost table simulates thaw. Pore pressure contour interval = 2 m of pressure head, positive pressure head below water table.

depending on the degree of anisotropy. Pressure head distributions for a hypothetical thawing slope under increasing hydraulic conductivity parallel to a slope are shown in Figure 5. No consolidation is taking place but the pressures shown are falling from an initial slightly excess pore pressure along the frost table. The modelling results in Figure 5 suggest that these anisotropic hydraulic conditions act to prevent excess pore pressures from developing over much of a thawing slope.

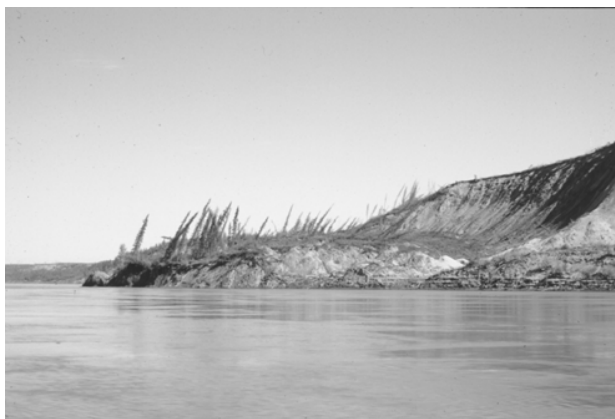
Figure 6. Rotational landslide in the Old Fort Point area along the Mackenzie River. The slide occurred in Spring, 1999, the year photographed. The bank is approximately 60 m high. This slide required re-routing of navigation to the opposite side of the river.

tributaries (e.g. Figure 6). These slides occur where these streams have cut into glaciolacustrine sediments laid down in a series of glacial lakes that existed in concert with the retreat of the Laurentide ice sheet (Smith 1992; Duk-Rodkin and Lemmen 2000). Typically, sands and gravels overlie the silts and clays. These slides usually involve the entire height of the bank (as much as 80 m above river level) and can be up to one kilometer in length. These slides may remove as much as 200 m of the bank crest in a single failure, although less than 50 m is typical. In their work near the confluence of Mountain River and Mackenzie River, McRoberts and Morgenstern (1974) demonstrated that these slides involve failure of ice-bonded sediments.

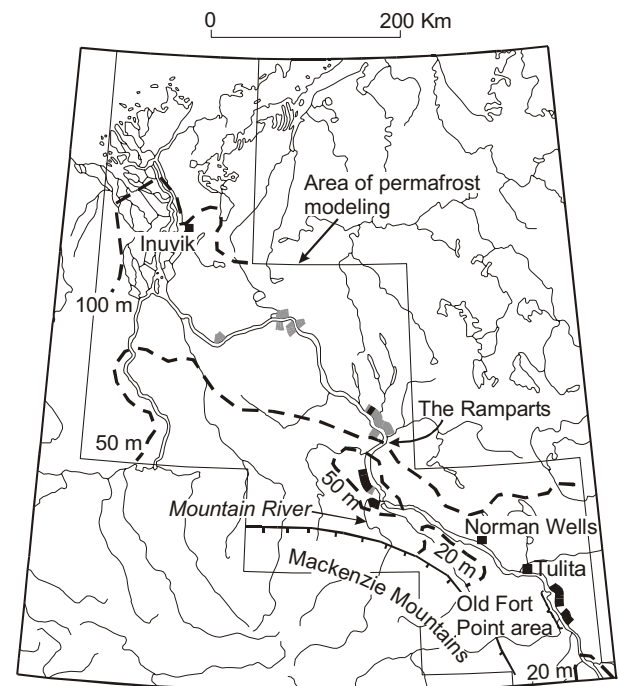
Figure 7. Lower Mackenzie valley showing reaches of the Mackenzie River having banks composed of glacial sediments in excess of 50 m high (grey segments) and portions of these segments which show active slope failure (black segments). Permafrost thickness, generalized from the modelling of Wright et al. (2001), is shown by dashed contours.

Permafrost thicknesses predicted by the regional modelling of Wright et al. (2001) are included in Figure 7. Thus along the northern reaches of the Mackenzie River, permafrost is likely to be thicker than the bank height, resulting in slopes which are completely stable against deep-seated failures. At the mouth of Mountain River the modeling indicates permafrost to be approximately 50 m

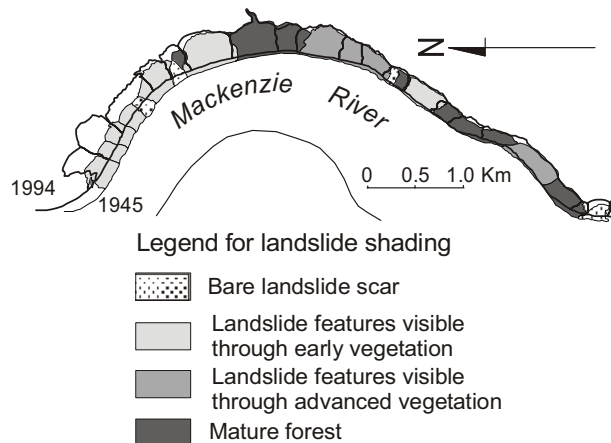
Figure 8. Rotational failures mapped along an actively eroding reach of the Mackenzie River in the Old Fort Point area. Slides appearing on airphoto coverage in 1945 and 1994 are categorized according to stage of re-vegetation.

An analysis of slides in the Old Fort Point area demonstrates an association between slide size and toe erosion rate. River bank position for two reaches in the Old Fort Point area are compared in Figure 8 using air photos from 1945 and 1994. Individual slides have been outlined and qualitatively ranked according to freshness of the slide scar. Along these segments, river shorelines have retreated as much as 120 m in the 49 years between

the air photos and slide crests have in a few cases retreated even further. There is an obvious association of more recent slides, based on a bare slide surface, with the most rapidly eroding sections of each reach. Furthermore, slides with the longest run-outs and greatest increment of bank retreat tend to coincide with the most rapidly retreating shores.

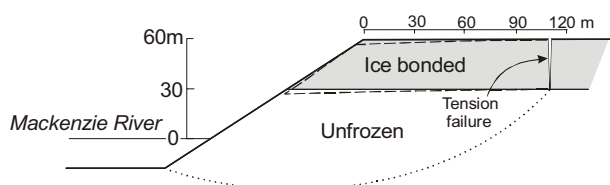
Figure 9. Hypothetical cross-section of an eroding river bank. Bending of ice bonded layer (dashed lines-exaggerated) takes place in response to toe erosion and deformation of the underlying unfrozen material. Eventual

tensile failure may trigger rotational failure of the entire bank (dotted line).

A limiting equilibrium analysis may not be appropriate for predicting the stability of eroding permafrost slopes in the Mackenzie valley because the stiffness of the ice-bonded portion of the slope may influence the mechanism of failure. Rapid toe erosion and slope loading may result in loss of support for the ice-bonded permafrost horizon as small amounts of deformation in the underlying unfrozen sediments places a bending moment on the permafrost layer. Tensile failure of the permafrost layer will be favoured but at a minimum set back from the bank crest to achieve the required bending moment (see Figure 9). Given a probable tensile strength of frozen sand on the same order as measurements of shear strength (a few 100 kPa), the tensile stress required for failure would not occur closer than at least 100 m from the bank crest for ice-bonded permafrost 30 m thick. Tensile failure in the permafrost would remove a major element of slope strength, perhaps triggering failure of the entire bank.
