Challenges with terrain stability mapping in northern British Columbia – the special case of large complex landslides

Marten Geertsema, B.C. Ministry of Forests, Prince George, BC Canada
James W. Schwab, B.C. Ministry of Forests, Smithers BC Canada

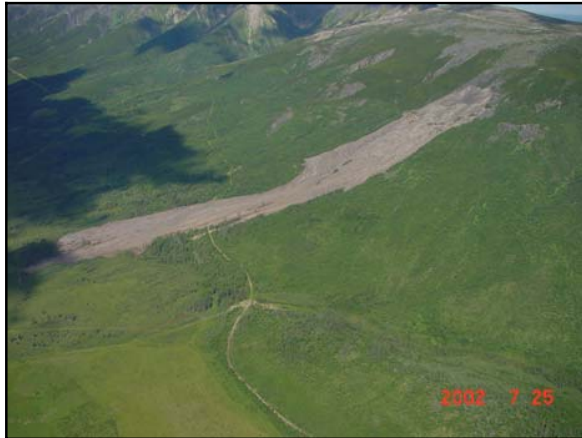
Figure 4. The Pink mountain landslide – a 2 km long rock slide – debris avalanche that achieved remarkable spreading and thinning through the undrained loading of entrained rock slide debris.

A large landslide at Pink Mountain (Figure 4) with a 2 km travel distance occurred in June 2002 (Geertsema et al. (2003). Pre-slide deformation of the slopes above the landslide has been significant. The scarps of at least two earlier landslides, and evidence of slow deformation are visible above the 2002 landslide and the zone of detachment underwent previous movement.

The rock slide entrained underlying fine textured till and colluvium resulting in a rock slide - debris avalanche (Geertsema et al. 2003). Hungr and Evans (In press) argue that an initial rock slide on to soil can cause rapid undrained loading of the soil, elevating pore water pressures, and causing liquefaction, drastically reducing soil friction. The travel distance of the Pink mountain landslide, the degree of spreading and thinning, and the low *fahrböschung* (11.6°) were likely enhanced by partial liquefaction of this lower material as a result of rapid undrained loading.

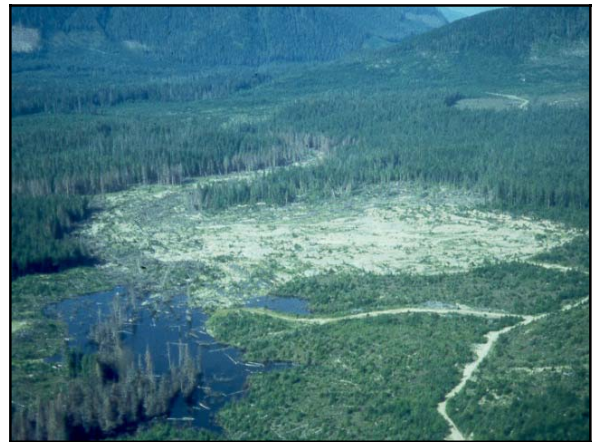
Figure 5. The Mink Creek earth flow-spread involved quick clays and occurred in glaciomarine sediments near Terrace, BC.

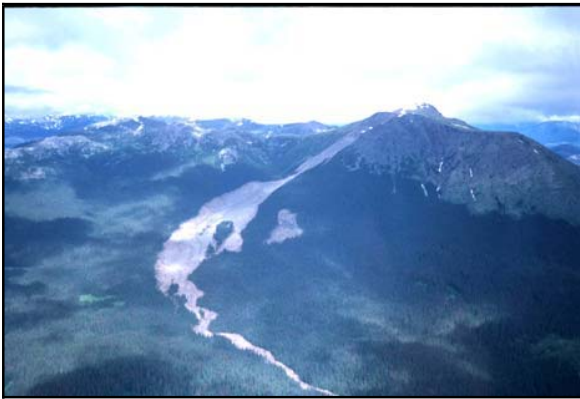
Figure 6. The Harold Price rock slide - debris flow (June 28, 2002) involved permafrost at its head. The smaller landslide to the right is a catastrophic earth spread that occurred in 1999.

The Harold Price landslide (Figure 6; Schwab et al. 2003) originated at the lip of a southwest-facing cirque occupied by a rock glacier. Interstitial ice was observed in the main scarp after the landslide. After travelling 1.3 km, the rock slide transformed into a debris flow, which became channelized at 2.2 km. The total travel length of the landslide was 4 km, but a hyperconcentrated flow carried sediments and logs an additional 3.5 km down Harold Price Creek. The volume of the landslide is about 1.6 M m^3 and its fahrböschung is 9.9° . This slide was related to melting permafrost, but also became much larger by undrained loading of till resulting from entrainment of the displaced rock rubble – a mechanism explained by (Hungr and Evans, In press).

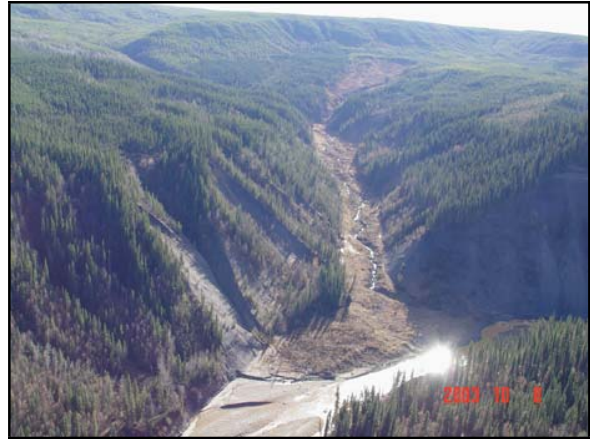
Figure 7. The Buckinghorse area of northeastern BC has reported sporadic permafrost and large rapid earth flows, such as this one which is 1.75 km long on a gradient as low as 3° .

A significant cluster of retrogressive earth flows occurs in the Buckinghorse area of northeastern BC (Figure 1; Table 3). They occur on extremely low gradients (3°) with travel distances up to 1.75 km. Although there is not yet a confirmed link, these landslides occur in an area where sporadic permafrost is encountered. In addition, they also occupy preglacial buried valleys. Thus unknown, hidden elements may include permafrost as well as subsurface bedrock topography.

Excellent examples of large landslides in diamicton-filled preglacial valleys include the Muskwa (Figure 2) and the Buckinghorse (Figure 7) landslides.
