## APPLICATION OF A REAL TIME MONITORING SYSTEM TO A LANDSLIDE ON THE SASKATCHEWAN HIGHWAY NETWORK

P. Jorge Antunes, Saskatchewan Highways and Transportation

Allen J. Kelly, Clifton Associates Ltd.

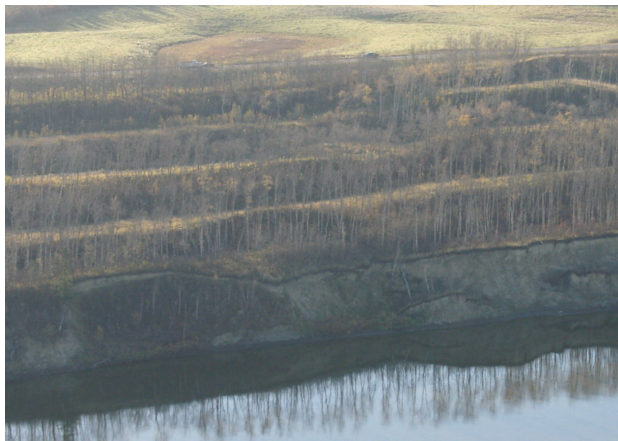
Figure 2. Aerial oblique showing multiple landslide blocks.

(Kelly et al. 2005b). Figure 1 shows the location of the landslide site where Provincial Highway No. 302-02 approaches within 250 m of the river. The surface geometry of the slide mass shows a number of individual slide blocks, indicative of a multiple retrogressive mechanism, Figure 2. The landslide appears to be triggered by severe river bank erosion and high pore water pressures from poor drainage. A risk assessment assigned the landslide to the urgent risk category as there were threats to public safety and a significant impact on infrastructure. Figures 3, 4 and 5 show the landslide impacts on the highway.

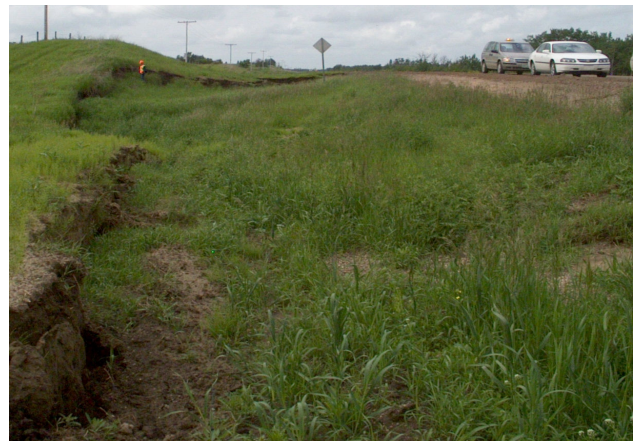
Figure 3. Landslide headscarp in south ditch looking west.

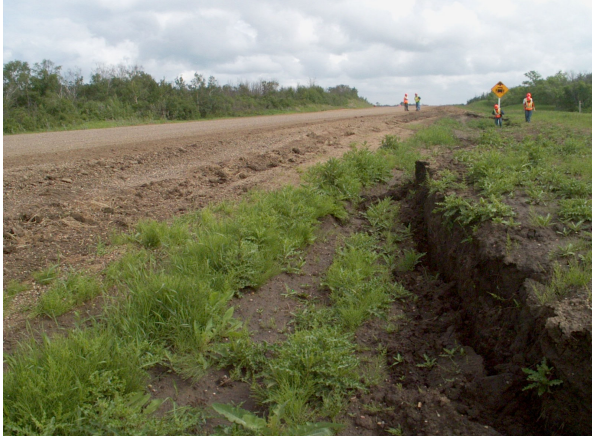
Figure 4. Landslide headscarp in south ditch disrupting ditch drainage with a ditch level higher than the road.

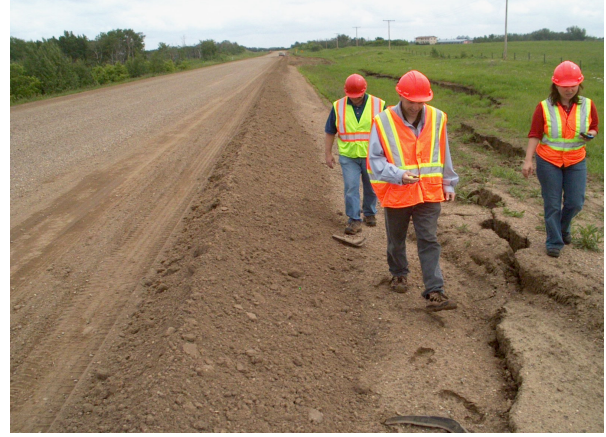
Figure 5. Cracking of the highway shoulder near the west limit of failure.

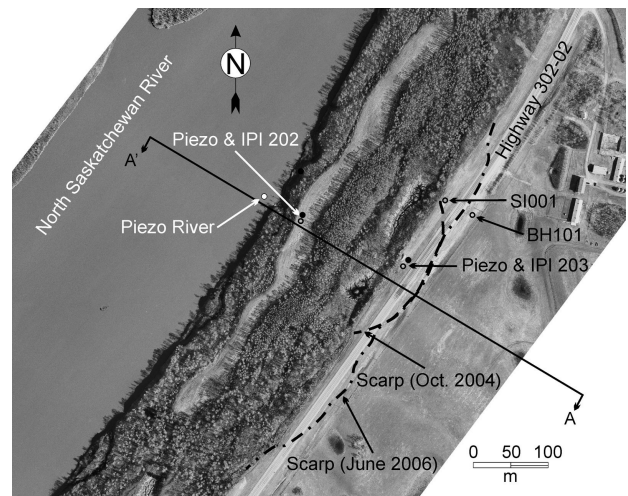
Figure 6. Location of inclinometers, piezometers, cross section A-A', and landslide features.

Between October 2002 and May 2004 four boreholes were drilled and electric-logged to determine site stratigraphy, locate the failure plane, monitor the rate of slope movement and define the site pore water pressures. Two of the bore holes, SI001 and SI002, were completed with slope inclinometers adjacent the road and the river bank and a third bore hole near the river bank was completed with a piezometer nest. Both slope inclinometers indicated a well defined shear plane with high rates of movement. Location of the boreholes and instrumentation are shown in Figures 6 and 7.

consists of in-place inclinometers (IPI), vibrating wire (VW) piezometers, barometer and temperature sensors. The instrumentation was installed in two locations, one located on the river bank and the other adjacent to the highway (Figures 6 and 7). At the highway location the original IPI (BH103) was destroyed on 15 March 2006 by on going movement; therefore, a second IPI (BH203) was installed on 26 May 2006. Table 1 presents a summary of the instruments installed at both locations. All real time monitoring equipment was purchased from Durham Geo Slope Indicator.

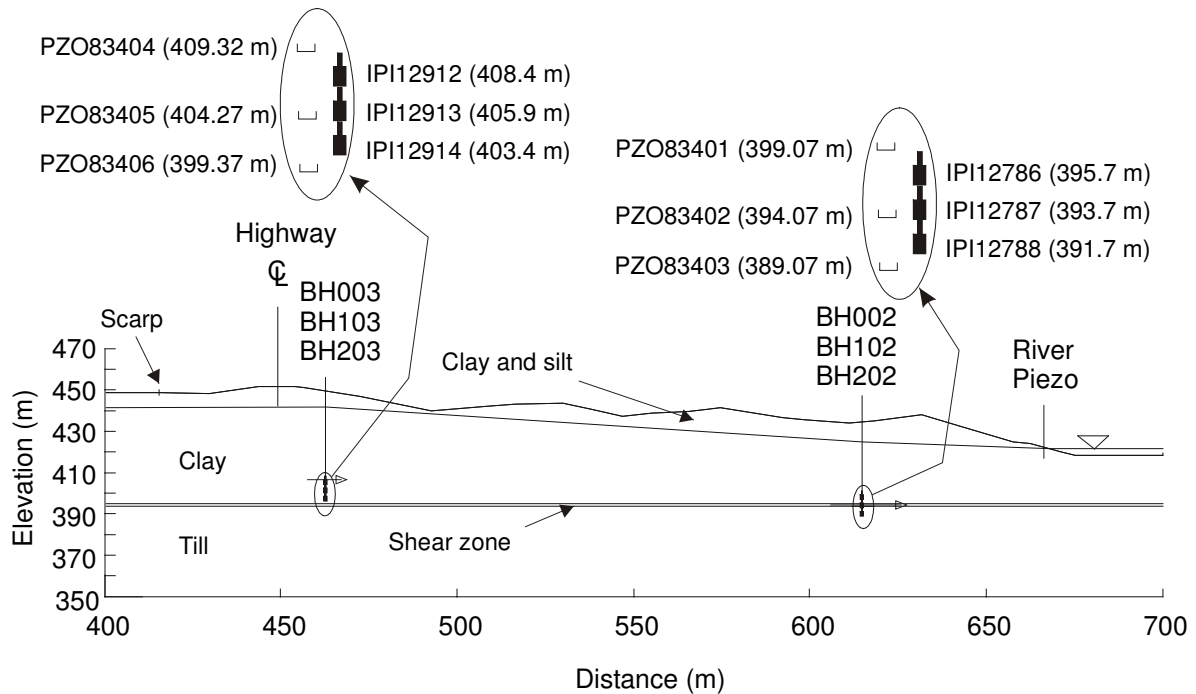
Figure 7. Cross section A-A' showing stratigraphy and instrumentation locations.

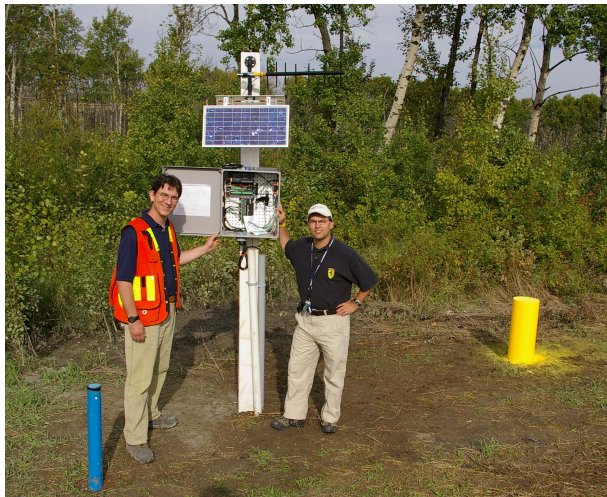
Figure 8. Instrumentation and data logger near the highway.

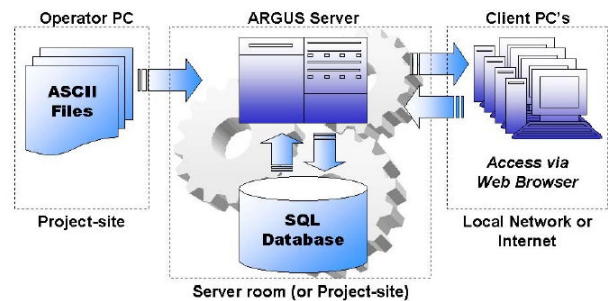
Figure 9. Schematic of ARGUS monitoring software

ARGUS handles all data processing requirements, starting with storage of data into a MySQL database, performing the required calculations on the data, presenting the results in graphical and numerical format; generating alarm messages and creating automated PDF reports. Since ARGUS works on the internet, distribution of the processed data is immediate. Users anywhere can log on to view data and graphs with only their web browsers (Boart Longyear Interfels 2005). A schematic of the ARGUS monitoring software is indicated in Figure 9.

ARGUS processes the readings collected from sensors at the project site, making the resulting data available on the internet. Users access the data and graphs via their web browsers. Data files from the project site are forwarded to ARGUS. ARGUS scans the files for alarm conditions and then stores the data in a project database. The data is available immediately to anyone who has an internet connection.

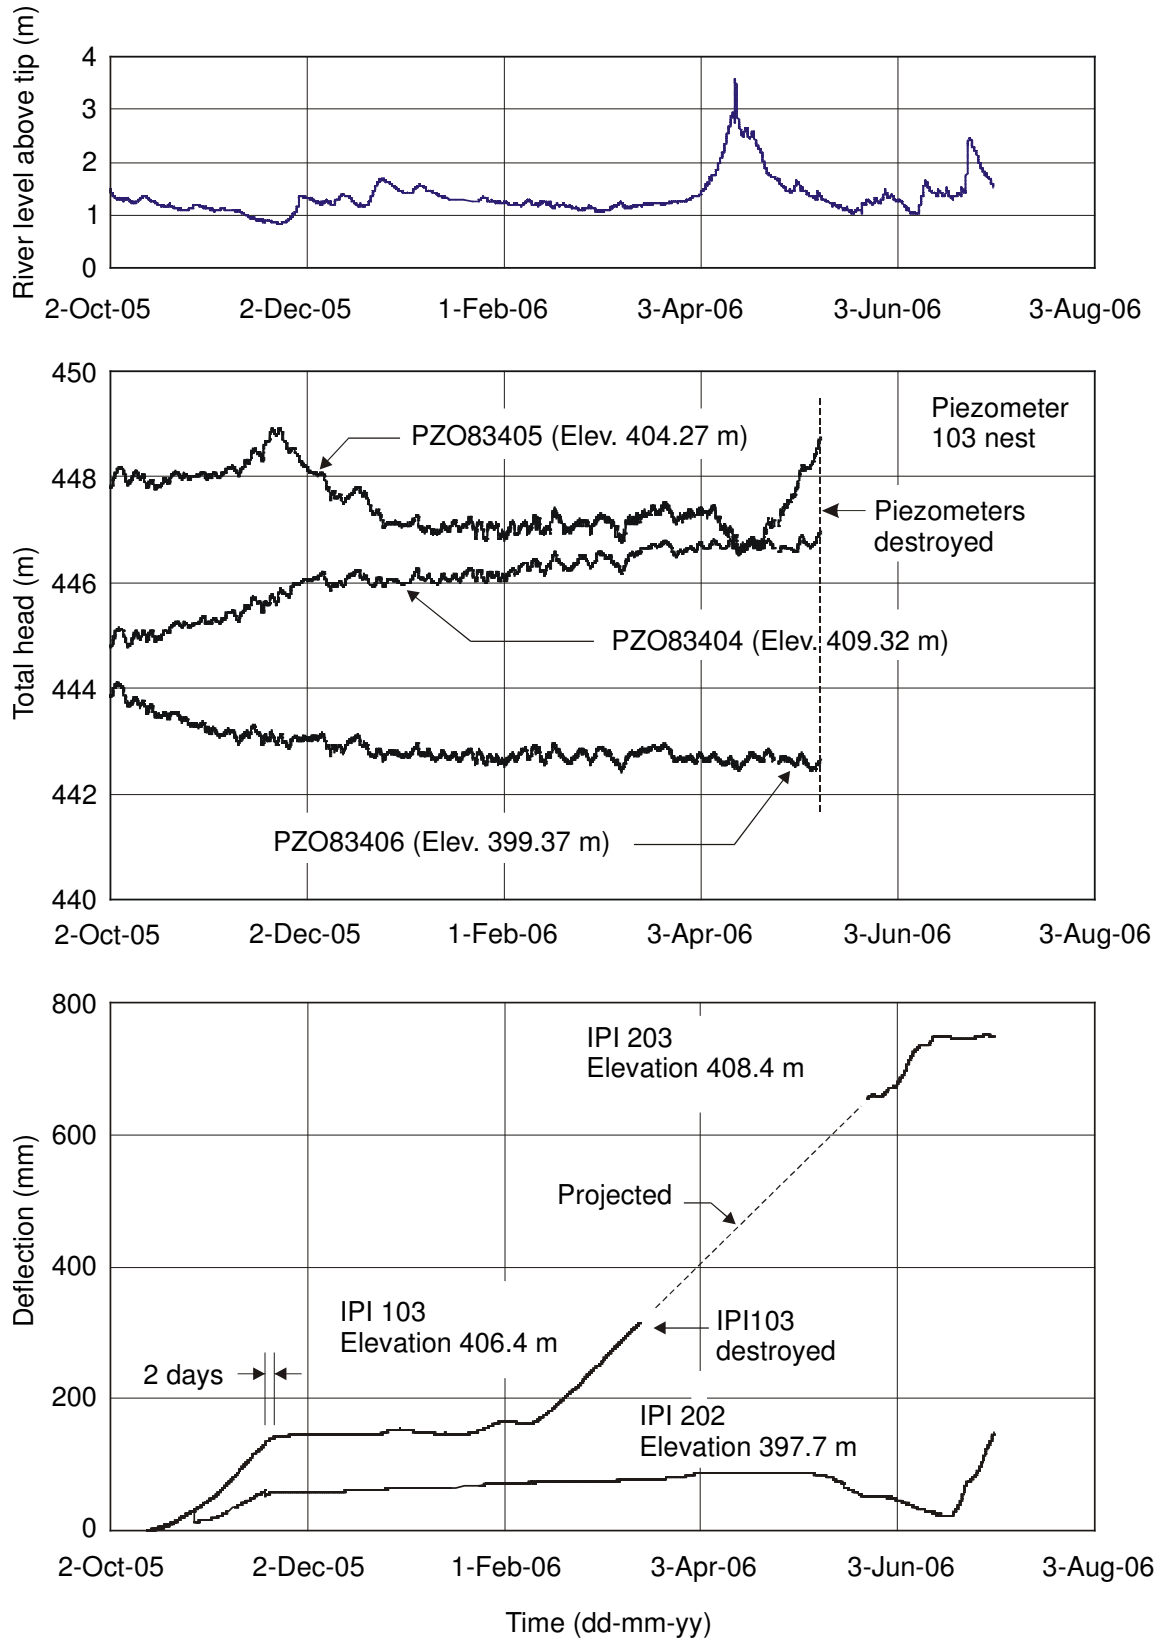
Figure 12. River level, piezometer head and IPI deflection versus time plots.

Trend plots including time plots, profile plots, and correlation plots, can be printed or included in reports. Example of the trend plots are shown in Figure 12.

This site provides continuous data from multiple sites which can be compared across a long term timeline. Figure 12 displays plots of river level, piezometer head and IPI deflection versus time.

A time lag of 2 days between movement at the river bank IPI202 and the highway IPI203 was observed between 21 November and 23 November 2005. After 23 November the deflection in both IPIs remained relatively constant until early February 2006. IPI103/203 showed a rapid rate of movement in the order of 5 mm per day for the period of February to June, 2006. The movement was constant and resulted in the destruction of IPI103. IPI103 was replaced by IPI203 on 26 May 2006. During this period of rapid movement, VW piezometer PZO83405 at the shear zone of Piezometer nest 103 showed a rapid increase in pore water pressure by approximately 2 m of head before the piezometer sheared off. The piezometers 5 m above and below the shear zone did not show the same increase in pore water pressure; therefore, the increase in pore water pressure may be related to shear induced pore water pressures.

It can be seen from these plots, that following the flood cycle in May 2006, IPI202 at the river bank began movement of approximately 1 mm per day. This is likely due to the rapid drawdown effects of the river following the flood cycle. This rapid drawdown destabilized the lower landslide block and allowed the movement shown in IPI202.

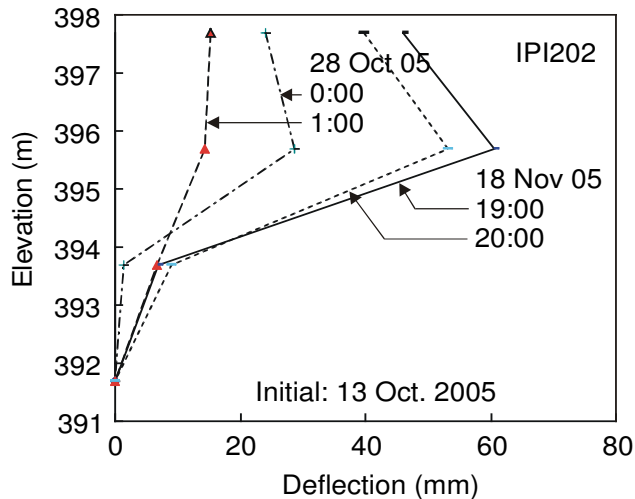
Figure 13. Rapid deflection in IPI202 over a period of one hour on 28 October and 18 November 2005.

Previous measurements of the landslide movement with periodic monitoring of the slope inclinometers did not provide information on the variability of the landslide rate of movement. However, real time monitoring of the instrumentation recorded the details of the landslide movement over time. It was assumed that the landslide moved along at a constant rate. However, the real time data indicated that the landslide movement occurred in short periods of time of less than an hour followed by days of relatively inactivity where strain built up for the next movement event. The plots of IPI202 deflection for 28 October and 18 November 2005 show the large jump in deflection between hourly readings.
