# SEEPAGE IN THE WEATHERED FOUNDATION OF ABSHINEH DAM (IRAN), PART I: THE EFFICIENCY OF ONE LINE GROUTING

## ABSTRACT

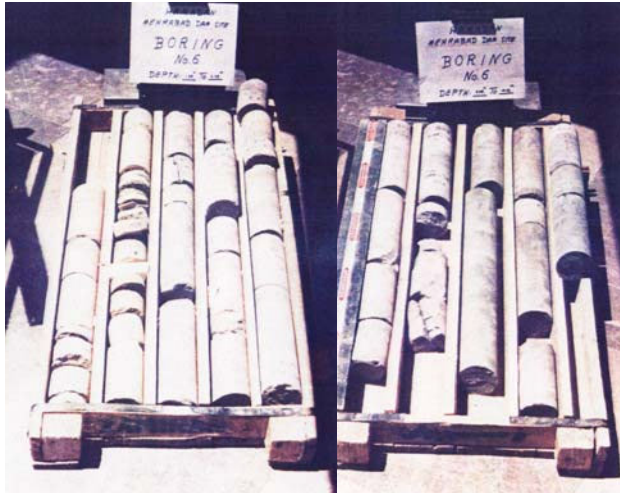
Figure 4. The cores of the borehole which are bored at the dam axis, from left to right (Mahab Ghodss, 1996)

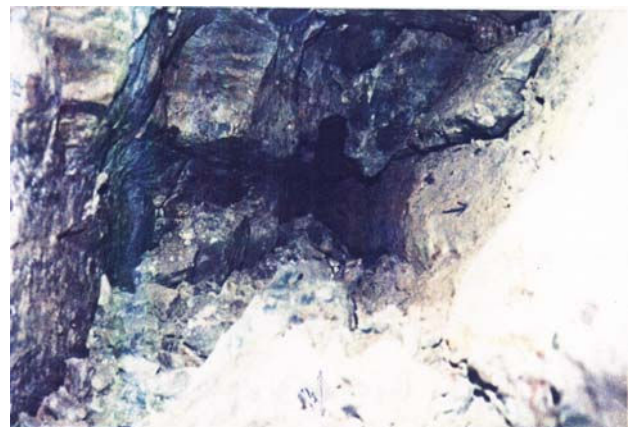
Figure 5. Boring a vertical shaft over the crest, C1 crossed the fault through the foundation

In this time, even grouting more than 7.5 tons cement in C1, a borehole at the right abutment of dam, could not fill it up; so was a shaft with diameter of 70 cm bored from the crest, and the excavation exposed a fault under the foundation. Figure 5 shows a picture taken from inside of the fault. Therefore, to make this fault sealed, a masonry-wall in one-meter thickness was created, and then it was grouted with a mixture of the cement and bentonite. As far as, there is a serious doubt about the efficiency of this approach, the seepage has been separately analyzed, and the consequences of this wall on the surrounding are evaluated.
