Monitoring cyclic strain below a railway embankment overlying a peaty foundation using novel instrumentation

Michael Hendry

Canadian National Railway, Edmonton, Alberta, Canada

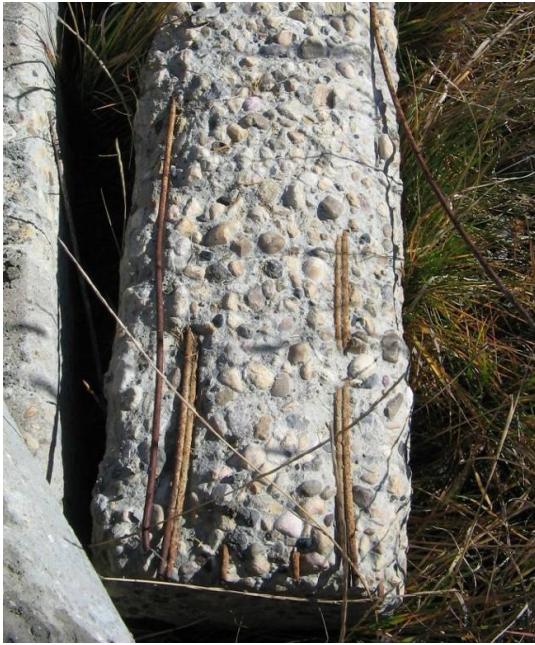
Figure 3. Picture of the worn underside of concrete-tie. This tie is a typical example of the ties removed from between mile 101.4 and 102.1 in October 2007.

The rail and concrete-tie structure as well as the embankment require increased maintenance to ensure serviceability. Large movements of the rail-track structure have caused the concrete ties undergo increased wear as they are pushed and rolled through the ballast. The ties often become skewed, broken, or wear out prematurely. The result of this wear is a rounding the underside of the concrete ties eventually exposing steel reinforcement (Figure 3), and rail seat abrasion (the sawing of the rail through the tie).

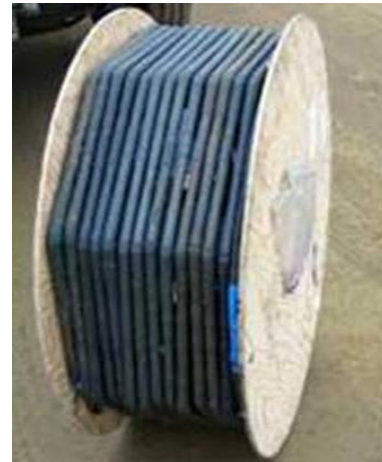
Figure 5. SAA on spool (104 m array shown) (Abdoun and Bennett 2008).

The motion capture system consisted of a research-grade ShapeAccelArray (SAA). The SAA was a MEMS-based deformation monitoring system manufactured by Measurand Inc. The SAA consisted of 30 cm (1 foot) rigid segments connected by a two degree of freedom joint which allows the joint to bend but not twist (Figure 5). The resulting data was a 3D shape of a borehole at 30 cm intervals (Abdoun and Bennett 2008). The research-grade SAA is capable of reading at a rate of up to 120 Hz, though an internal analog low-pass filter on the individual MEMS had an upper frequency of only 20 Hz.

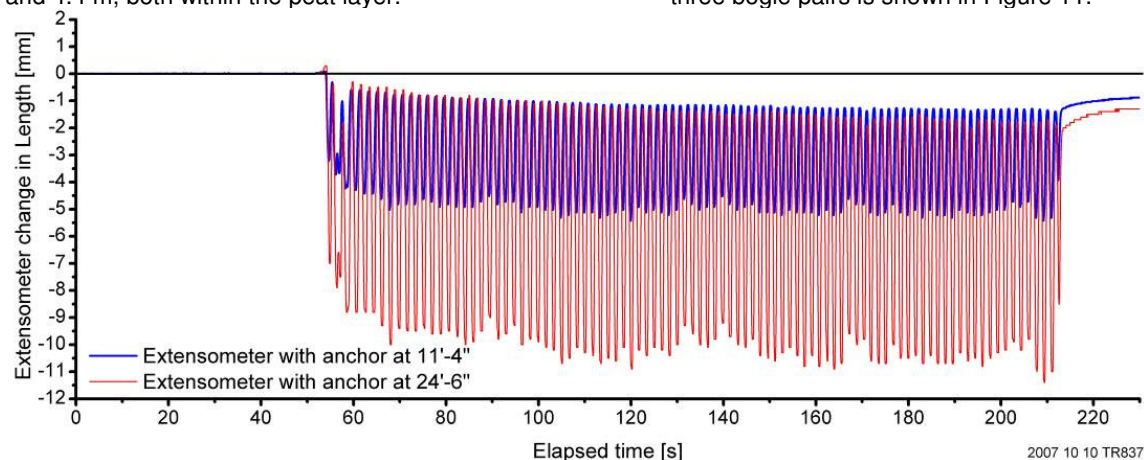
Figure 8. Extensometer measurements at mile 102.0 during the passage of a grain train.

The extensometer data is presented in Figure 9. Only the deepest (7.46 m) and the shallowest (3.46 m) extensometers were working that day. The overall deflection of the embankment reached 10.5 mm. Of this deflection, 7.5 mm was cyclical in nature and occurred during the passage of each pair of bogies (front and back of cars). Up to 3 mm of the overall deflection was residual deflection which remained between the application of cyclic bogie loads and after the passage of the train. The residual deflection immediately reduced to 1.2 mm after the train passed and decreased to 0.5 mm prior to the arrival of the next train 13 minutes later.

Almost half of the cyclical deflection and most of the residual deflection occurred within the embankment and the upper 0.6 m of peat.

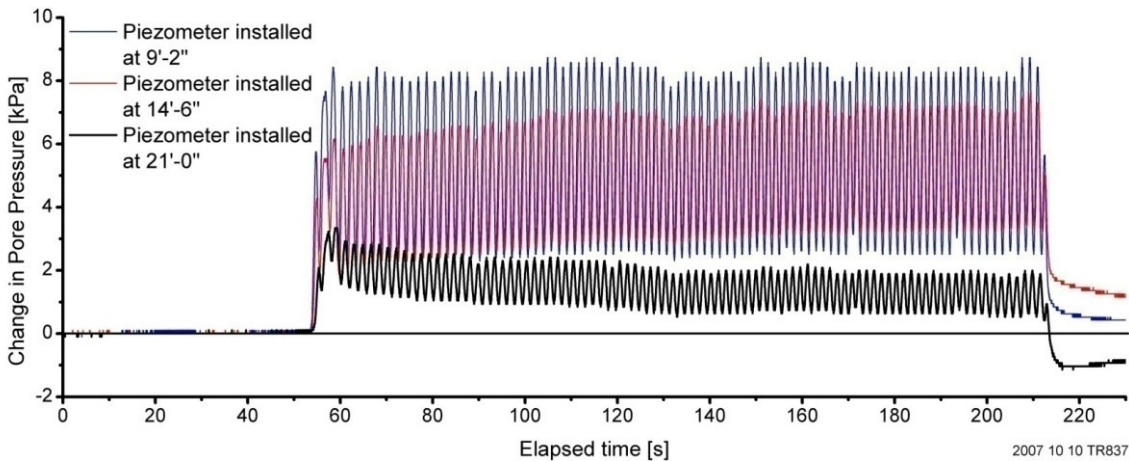
Figure 9. Strain-gauge piezometers measurements at mile 102.0 during the passage of a grain train.

The strain-gauge piezometers installed at mile 102.0 showed a significant increase in the pore-water pressure due to the train loading. The excess pore-water pressure, from the two piezometers in the peat, reached maximum values after only the passage of the locomotives and a few cars. The excess pore-water pressure in the peat then fell towards zero shortly after the passage of the train. The excess pore-water pressure in the silty-clay reached a maximum shortly after the passage of the locomotives and steadily declined during the passage of the train. After the passage of the train the excess pore-water pressure dropped to a negative value before recovering to zero.

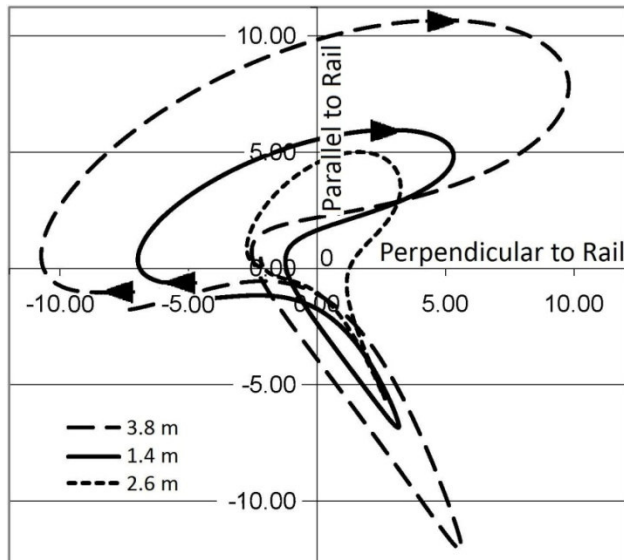
Figure 12. Resulting path of three SAA joints in the horizontal plane due to the passage of a pair of bogies (time 101.5 to 103.3).

The deflection of three SAA joints are the horizontal plane is plotted in Figure 12. This motion clearly shows a difference between the response of the structure to the lead bogie versus the trailing bogie, and the three-dimensional nature of this response.

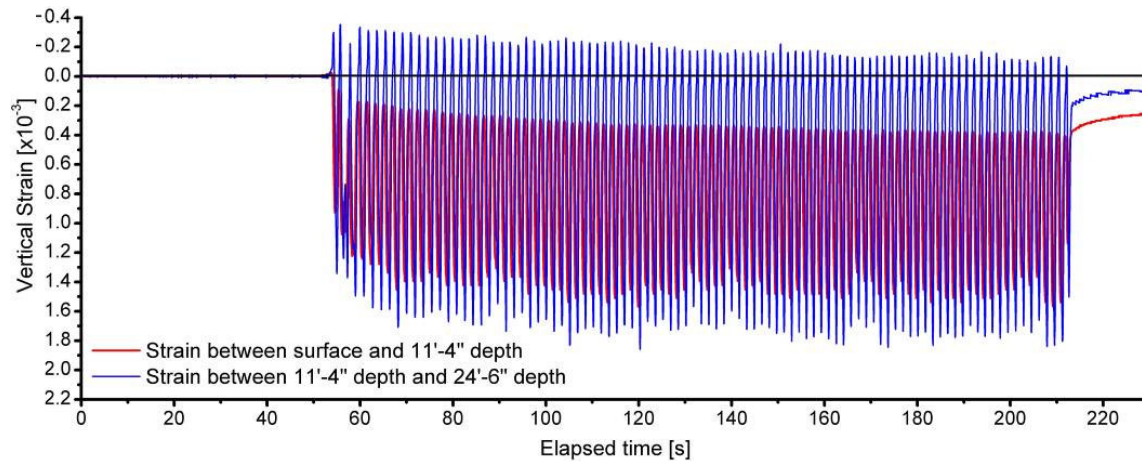
Figure 13. Strain over length of shallowest extensometer and between the anchors of the shallowest and deepest extensometers from measurements at mile 102.0 during the passage of train.

To determine the distribution of strain within the structure the vertical strains were calculated over the length of the shallowest extensometer, and between the anchors of the shallowest and deepest extensometers. The results are presented in Figure 13. From this it is evident that both the embankment and underlying materials have residual strain which is somewhat greater extent in the embankment. The deeper strains are negative (expansive) between cyclic loads. The speed at which the train is travelling does suggest these are due to dynamic excitation (Hendry 2007).
