Combined GPS and EDM monitoring on Turtle Mountain, Alberta

Glen Bjorgan

Corey R. Froese

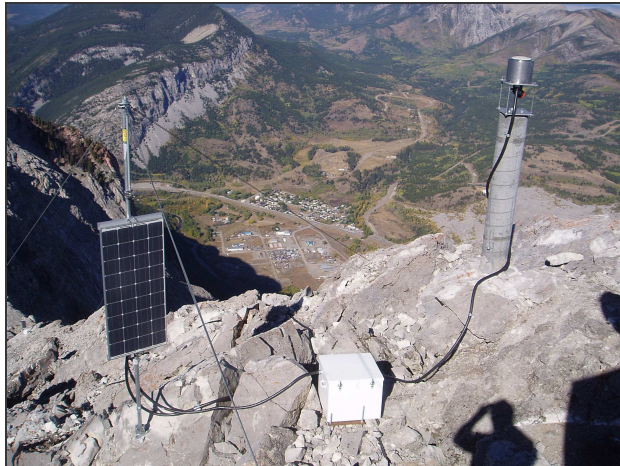
Figure 2. Typical Turtle Mountain GPS Station showing the antenna (right), battery (centre) and solar panel (left)

The harsh environment found on Turtle Mountain made the design of the GPS system quite challenging. The GPS receivers could expect to encounter severe weather (including frequent electrical storms), vandalism, power shortages, and even rock falls that threatened to undermine the stations. As such, it was decided to custom design a robust GPS receiver that used solar power, wireless communications, and whose cost was low enough to be considered potentially disposable.

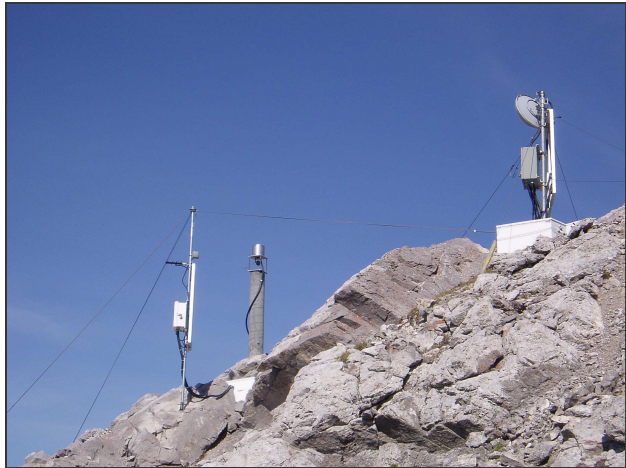
Figure 4. South Peak GPS Station

The first set of three graphs (Figures 5, 6 and 7) shows the results from the South Peak station. As its name infers this GPS station is set on the South Peak of Turtle Mountain. This is a significant installation as South Peak is the primary area of the mountain which is under study and considered potentially unstable.

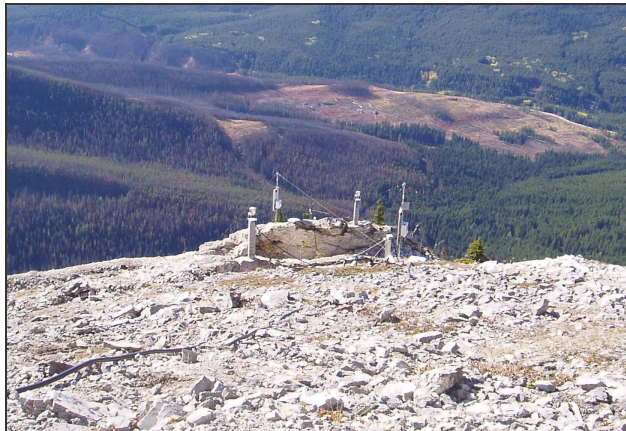
Figure 8. Upper West GPS Station (Lower West Behind)

The Upper West GPS station is on the West side of the South Peak adjacent to one of the deep fractures that encircles the peak (Figure 8). Upper West and Lower West have been installed on opposing sides of a large crack which is also being monitored with surface extensometers (Moreno and Froese, 2006).

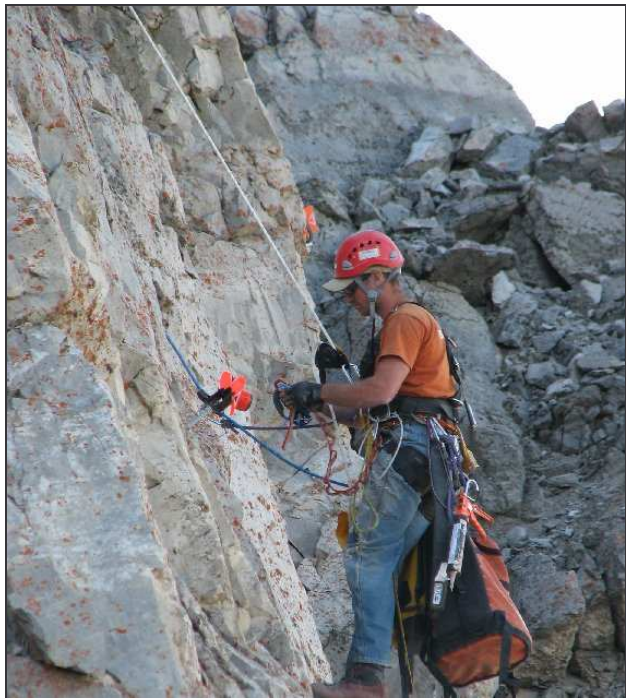
Figure 12. Vertical Systems International Installing Prisms below South Peak

There are several areas on Turtle Mountain where the installation of GPS receivers or other active sensors would be impractical or even impossible due to the steep and unstable nature of the eastern face of the mountain. In order to realize some useful monitoring data for these areas corner cube reflectors (prisms) were installed. At present there are 20 prisms installed on the mountain that allow for the measurement of distances from a total station installation in the valley at the base of the mountain (total distances ranging between 2150m and 2965m). These prisms are primarily mounted on the rock face left by the original 1903 slide, but some prisms have also been placed on undisturbed portions of the mountain for reference.

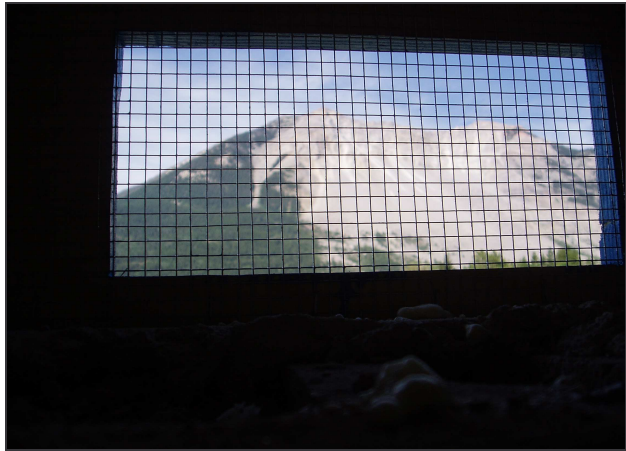
Figure 14. View of Turtle Mountain from the Total Station Enclosure

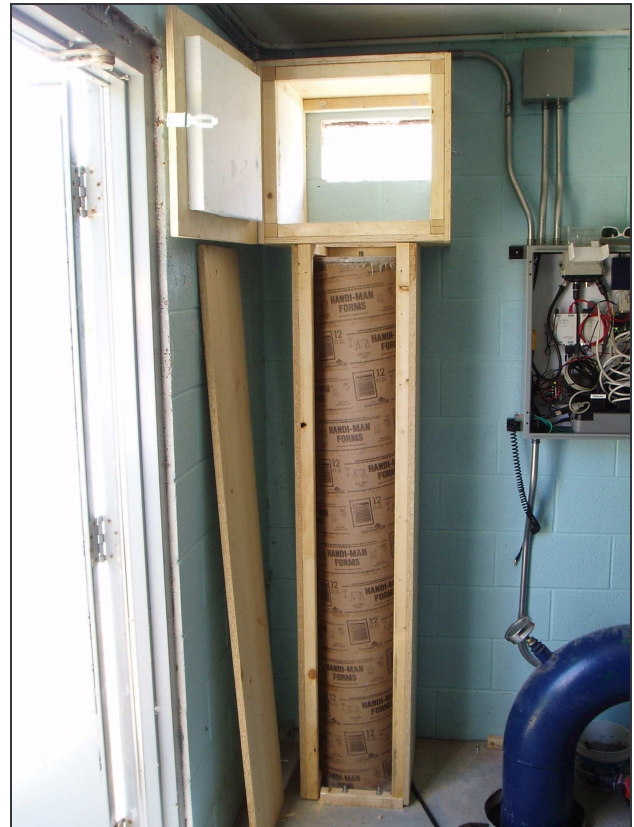
Figure 17. Total Station Enclosure Showing Concrete Support Column
