Monitoring results from a full-scale field test of rockfill columns

Kendall Thiessen, Marolo Alfaro & James Blatz
Civil Engineering – University of Manitoba, Winnipeg, Manitoba, Canada

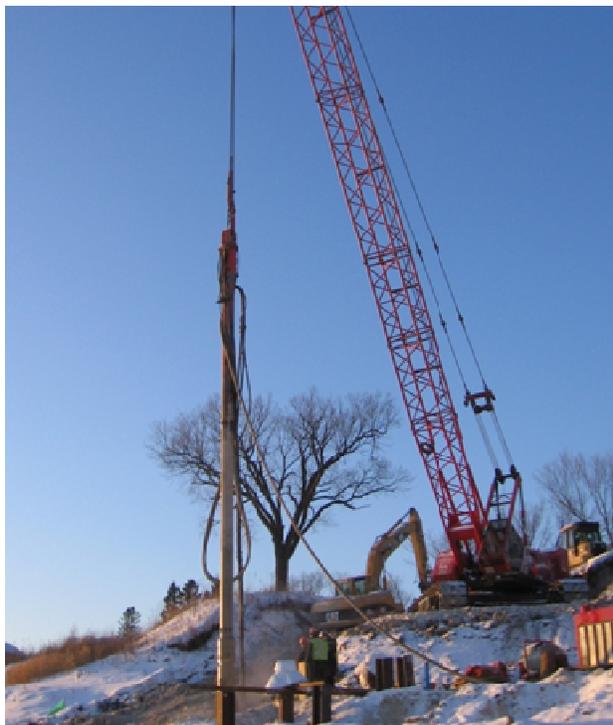
Figure 3. Compacting columns with vibrolance

The columns were pre-bored using a pile drilling rig. The open shaft was immediately backfilled to the surface with 150mm down crushed limestone rockfill. The rockfill was compacted with the hydraulic vibrolance seen in Figure 3. The columns were charged with water to help the lance penetrate the rockfill, and also to increase the density achieved by the compaction effort. To advance the lance through the rockfill, air was jetted through the tip, while vibrating its way down.

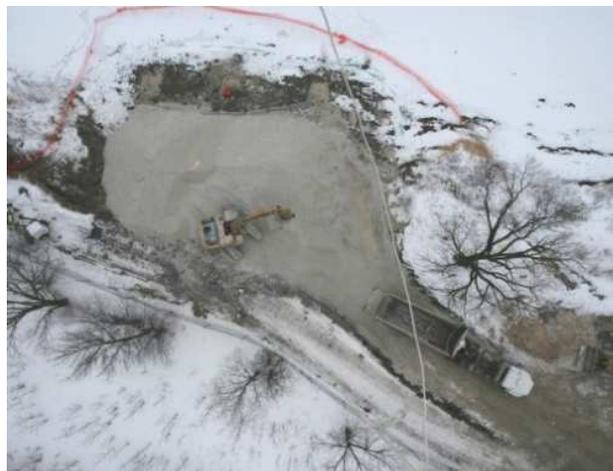
Figure 4. Aerial view of rockfill column research site during test loading with photo taken from tethered aerostat

The photos in Figures 4 and 5 were taken on day 7 and day 8 respectively

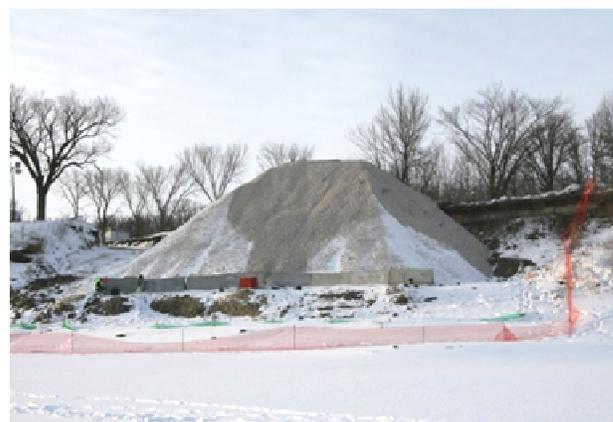
Figure 5. Rockfill Column research site during test loading
