Sealing a Complex Flowing Well in the Manitoba Interlake: A Case Study of the Silver Flowing Well

J.J. Bell, B.Sc.(G.E.), P.Eng

R.N. Betcher, M.Sc., P.Geo.

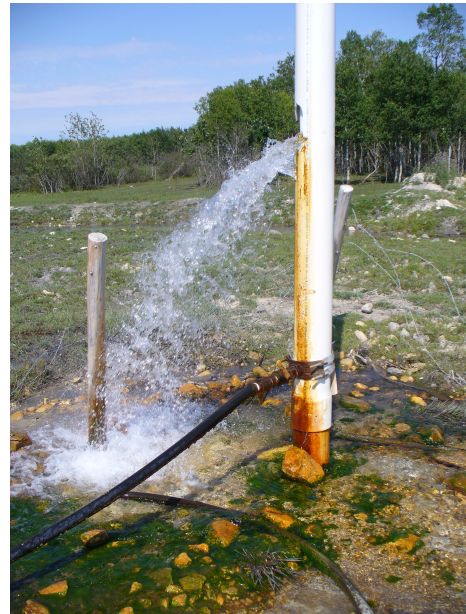
Figure 2 – Silver flowing well (source – MWS, 2007)

Sometime following the abandonment of the borehole, the land owner connected a small saddle and valve to the well to allow for continuous watering of his nearby animal trough. A small trench was dug to the ditch on the north side of the property, to allow the water to flow to the

provincial drain system, and ultimately to the Icelandic River. The well as it was left is shown below as Figure 2.

The Province of Manitoba and the RM of Armstrong expressed a desire to have the well properly capped and sealed. The province visited the site and measured the flow in the channel to be approximately 37 L/s. The province developed a request for proposal to seal the well.

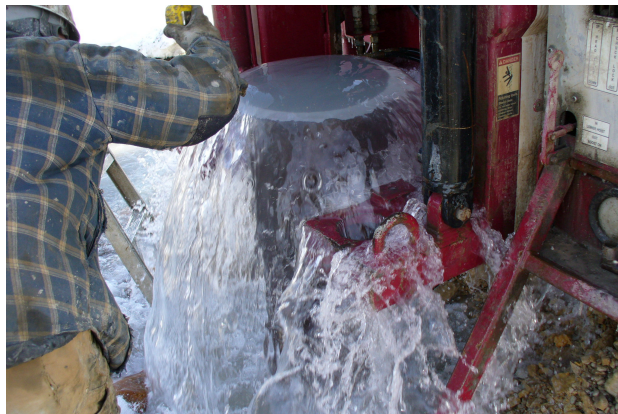
Figure 3 – 16 inch diameter casing installation (source – MWS, 2007)

Following the rig set up and levelling, the casing advancement method was used to advance 6.4 m of 406 mm casing overtop of the existing PVC casing. It should be noted that the 406 mm diameter casing was equipped with a 406 mm diameter casing drilling shoe, equipped with carbide cutting buttons. A 381 mm diameter tricone roller bit was used to drill out the casing/cement/gravel

The casing was set to a level of approximately 5.5 m below grade, with approximately 1 m of stick up. A photo showing the casing installation is shown below as Figure 3. With the service air blowing the well, the head was noticed to drop, which showed a good seal between the 406 mm diameter surface casing and the upper clays/tills. With the service air shut down and the drill rod/bits removed, water flowed overtop of the 406 mm casing to a level of approximately 76.2 mm above the top of the pipe. Using equation #1 for 406 mm pipe revealed a flow rate of approximately 145 L/s (Anderson, 1971, pg.155).

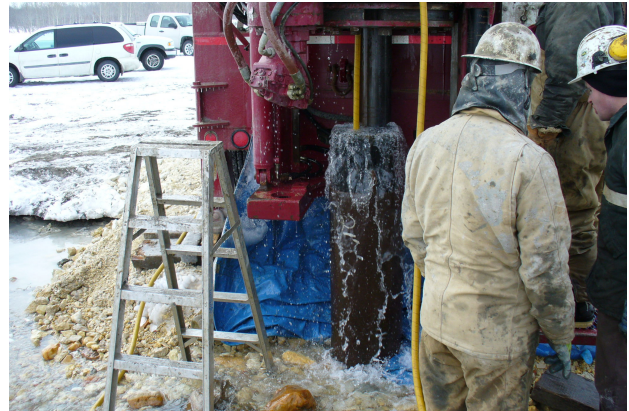
Figure 4 – Final pumping arrangement (source – MWS, 2007)

Once the 305 mm casing was fully installed, 152 mm diameter threaded and coupled pipe was installed to a depth of 11 m. The pipe was equipped with an air line fitting at the bottom to allow for air line pumping with the

service compressor of the rig. Using his method, water was able to be pumped from the well at a rate of approximately 160 L/s. At this flow rate, water was just flowing over the top of the 406 mm casing. Several 50 mm diameter suction hoses were then installed in the 305 mm well to allow for water to be siphoned off and discharged on the ground nearby. These two methods were able to maintain the head below the top of the 406 mm diameter steel casing.

The final pumping arrangement is shown below in the following photograph as Figure 4.

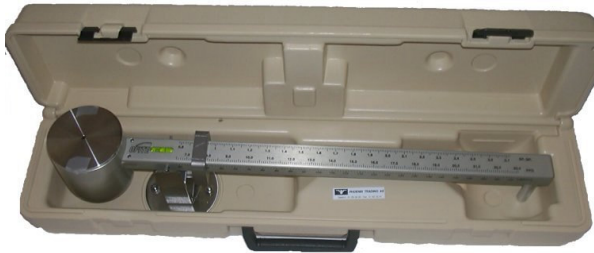
Figure 5 – Mud balance (source – author)

Prior to arriving at the site, a cement grout mixture was determined from Anderson, 1971. The design mix for the cement called for approximately 17 L of water per 40 kg sack of cement. This mix was determined to have an approximate weight of 1440 kg/m³ prior to setting, and 2000 kg/m³ once fully cured after 28 days. The weight of this mix was determined to have enough mass to overcome the approximate 6-7.5 m head in the borehole. Prior to ordering the cement mixture, unit weights were calculated ahead of time using a sample mix design on a

mud balance, which is shown below as Figure 5. The balance was used to determine if the mix design would be acceptable for the weighting material.

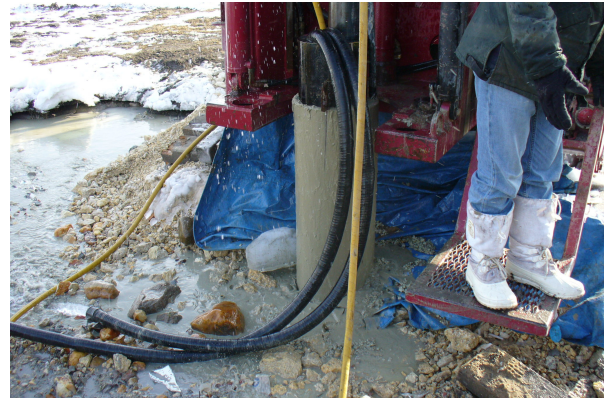
Figure 6 – Cementing process (source – MWS, 2007)

The cement was pumped into the well using a high pressure pneumatic grout through a 25 mm diameter grout line placed between the 305 mm and 406 mm diameter casings. The grout line was extended to a depth of approximately 10.6 m below grade. During the cementing the air line pumping system and siphoning lines were operated to maintain the lowered head conditions in the well. Cement was noted to rise on the outside of the 406 mm diameter casing. During the grouting procedure, cement was noted to discharge from the 305 mm well during the air lift pumping, although the discharge did indeed clean up immediately afterwards. After approximately 75 bags of cement were pumped into the well before water discharge was noted in the space between the 305 mm and 406 mm diameter steel casings. In total, approximately 100 bags of cement were utilized in the grouting procedure on the well.

Due to the sensitivity of the installation of the 406 mm diameter steel casing, it was decided that leaving the casing in place after the grouting operation would offer the most protection for the newly placed grout seal. Since a substantial amount of the cement came out at surface on the outer side of the 406 mm diameter casing, it can be assumed that the casing is firmly cemented in place to the surrounding geology. Figure 6, shown below details the cementing process.
