Application of Air Launched Soil Nails to a Soft Soil Landslide

The Saskatchewan Ministry of Highways and Infrastructure (SMHI) engaged MDH Engineered Solutions Corp. (MDH) to assist in the investigation of a shallow landslide in an environmentally sensitive area on Provincial Highway No. 56 north of the town Lebre, Saskatchewan. Part of this work involved the development of repair options to stabilize the roadway embankment. The landslide was on a heavily vegetated and steep embankment with a water course at the toe of the embankment. Traditional repair techniques such as slope flattening or a toe berm would be difficult to construct and would have significant local environmental impacts. In order to address these concerns, air launched soil nails (soil nails) were chosen as the best method to stabilize the slope. The soil nails could be installed from the road surface which would mitigate any environmental impacts and safety concerns. The design and installation procedures are primarily based on empirical parameters. This paper describes the landslide and air launched soil nails.

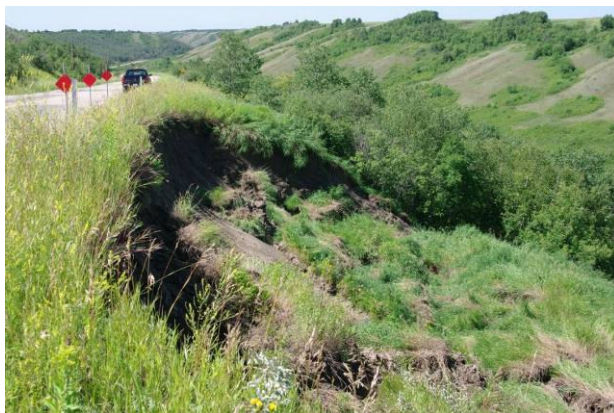
Figure 2: Looking southeast – 30 m scarp and 12 m drop

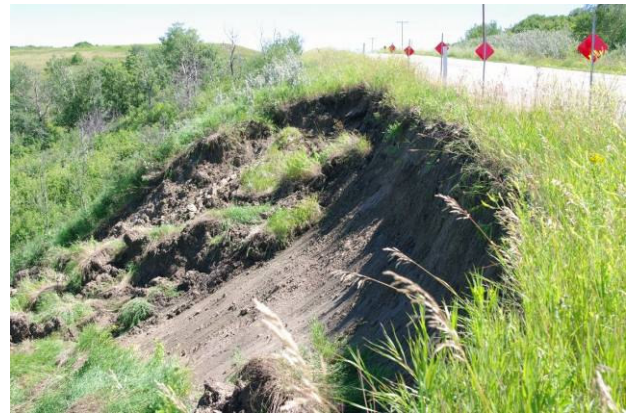
Figure 3: Looking northwest – Landslide head scarp adjacent to highway

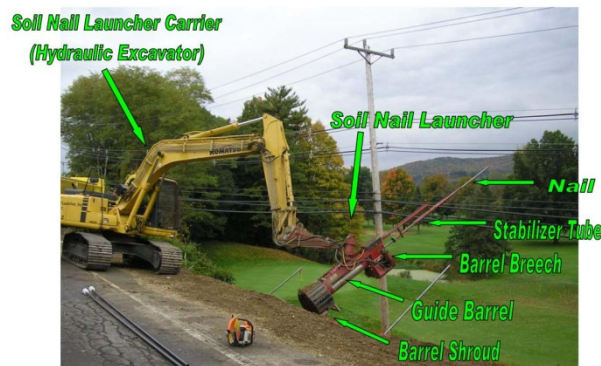
Figure 4: Soil nail launcher schematic

Air launched soil nailing is a relatively new technology that has achieved increased acceptance as a technique to stabilize shallow landslides. Morsky Industrial Services (Morsky), the exclusive supplier of this technology in Canada, was contracted to perform the required soil nailing. This technology uses pressurized air to launch 6.1 m long perforated or imperforated nails into the ground (Figure 4). All penetrating force from the air pressure is located at the tip of the nail (Figure 6). The shear strength of the soil nails helps to stabilize the soil mass and resists movement along the shear plane. This reinforces the soil and forces potential slip circles back beyond the depth of penetration of the soil nails.

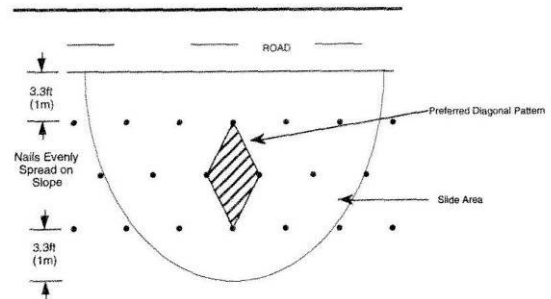
The soil nail design pattern consisted of a diagonal offset pattern of 1.0 m (Figure 5). A minimum distance of 1.0 m was required from the highway. The soil nails were extended to edges of the landslide area.

Figure 5: Soil nail design pattern

The current soil nail design parameters are primarily empirical. Soil nail spacing is designed based on a simplified wedge analysis (New York State Department of Transportation, 2008 and United States Department of Agriculture, 2004). This design methodology is still in the developmental phase, therefore the minimum soil nail spacing was used for this landslide.

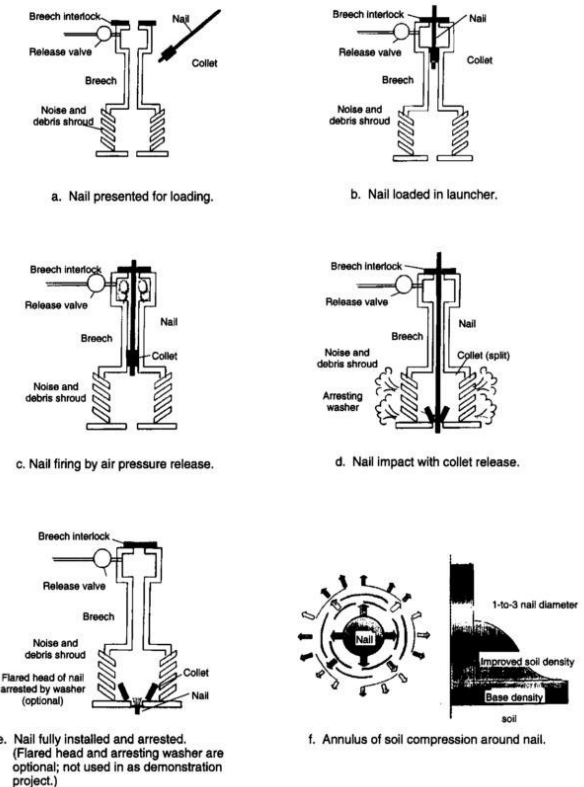
Figure 6: Soil nail launcher schematic of operation

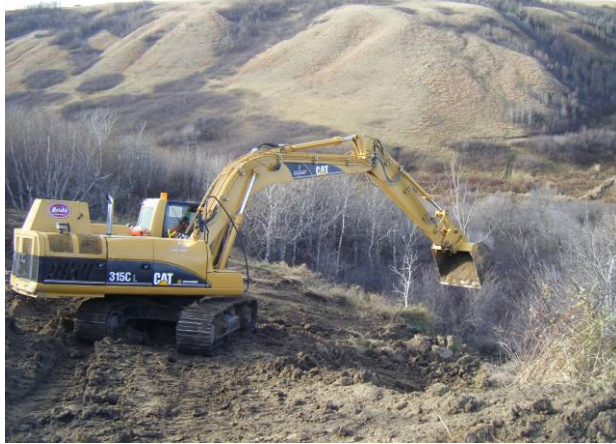
Figure 7: Removal of excess disturbed soil

Site preparation began on October 20th, 2008. This process involved removing all excess disturbed soil from the slide and closing any cracks in the disturbed slope (Figure 7). Additional preparation for the TRF involved digging a small trench at the crest of the highway embankment to secure the TRF (Figure 8). This is required to anchor the TRF and ensure surface water stays on top of the TRF.

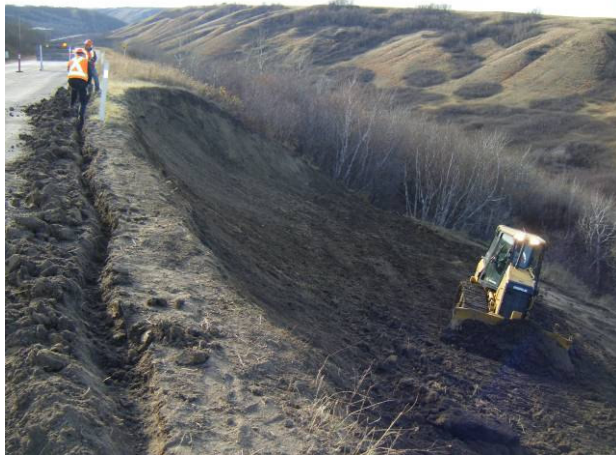
Figure 8: TRF trench at crest of embankment

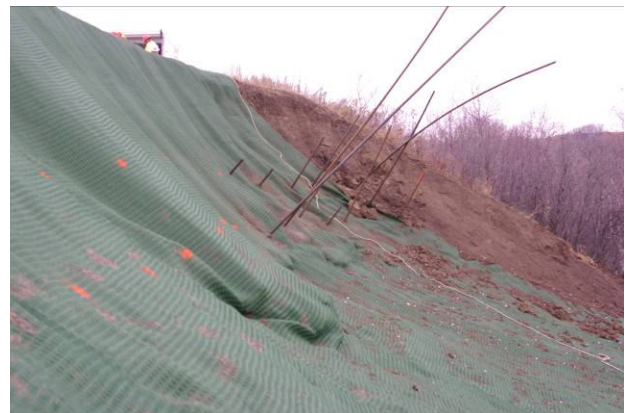
Soil nailing started on October 21, 2008. Initially, soil nail penetration into the soft soil was variable using the air pressure typically used for soil nail launching. Some nails penetrated to the target 6.1 m depth while others did not (Figure 9). Examination of the soil nails' penetration locations after nailing showed that the launched soil nails had not penetrated into the embankment, but they created small cavities and voids from the impact (Figure 10). Typical air pressures used to launch soil nails ranges from

Figure 9: Unsuccessful soil nail penetration

To solve the penetration issues, the air pressure was increased to launch the soil nails. Increased air pressures proved to be ineffective, therefore construction was stopped to evaluate if mechanical issues were preventing proper soil nailing penetration.

MDH then recommended that Morsky decrease the air pressure used for launching the soil nails. Air pressure was decreased below levels normally used for launching soil nails. The air pressure was decreased to approximately 5515 kPa (800 psi). The soil nails were then able to penetrate the soil to the expected depth into the highway embankment. Minor air pressure adjustments were required for the remaining soil nails that were installed in order to achieve the required penetration depth.

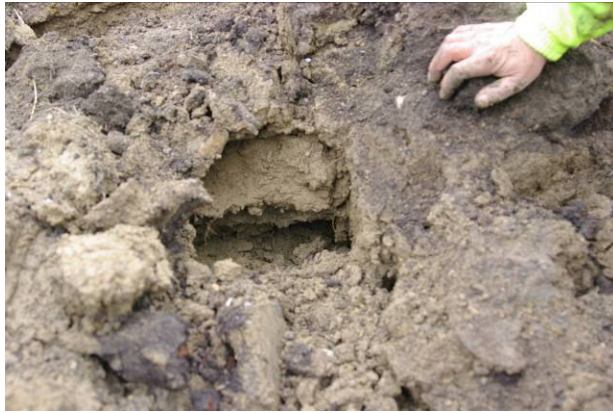
Figure 10: Small void created in ground post soil nail launch

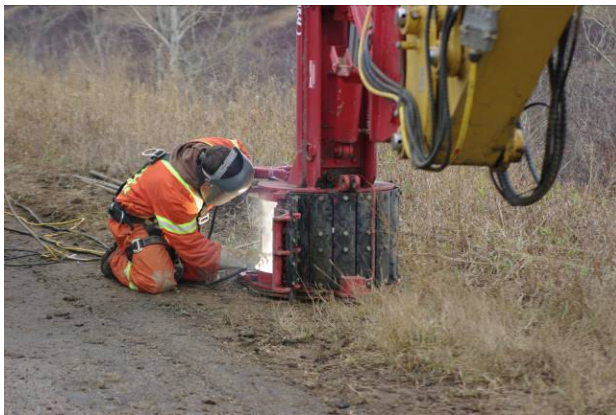
The problem was initially attributed to an equipment malfunction or faulty soil nail collars. After inspecting and completing maintenance on the launching mechanism and the soil nail alignment mechanism (Figure 11) and using different soil nail collars, soil nailing was attempted again. Further attempts to launch soil nails proved to be ineffective after these changes were made.

Figure 11: Inspection and maintenance on soil nail launcher

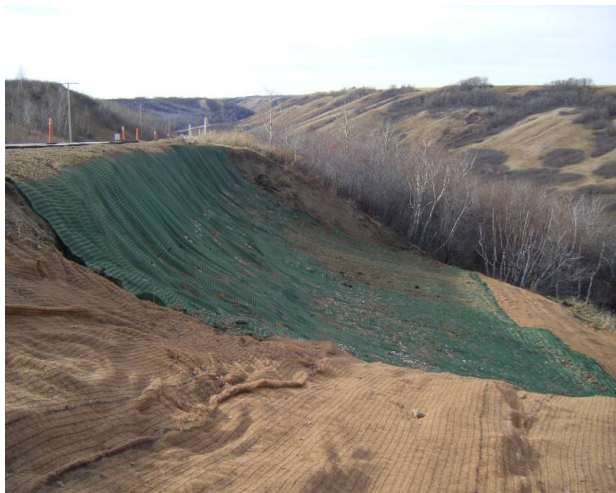
Figure 12: Completed soil nailing and TRF installation

Concluding the installation of all the soil nails, the exposed ends of the soil nails were cut and plates were welded on the soil nails to secure the TRF.

The soil nailing was successfully completed on October 24, 2008 (Figure 12). SMHI installed asphalt curbing along the 30 m section of highway above the landslide scarp (Figure 13). The curbing will direct highway surface runoff away from the landslide area to half culverts to direct drainage safely down the slope (Figure 14).

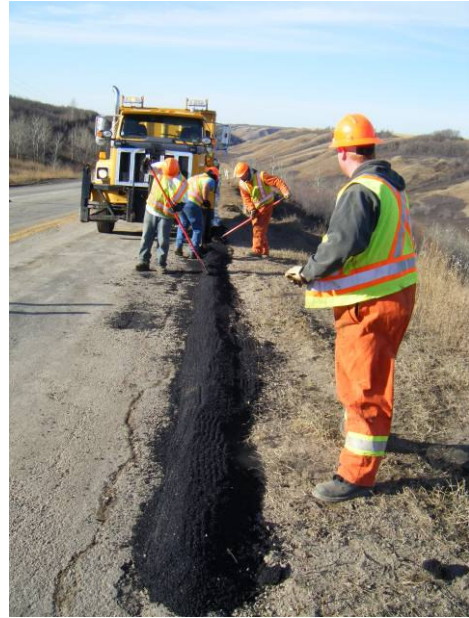
Figure 13: Asphalt curbing installation

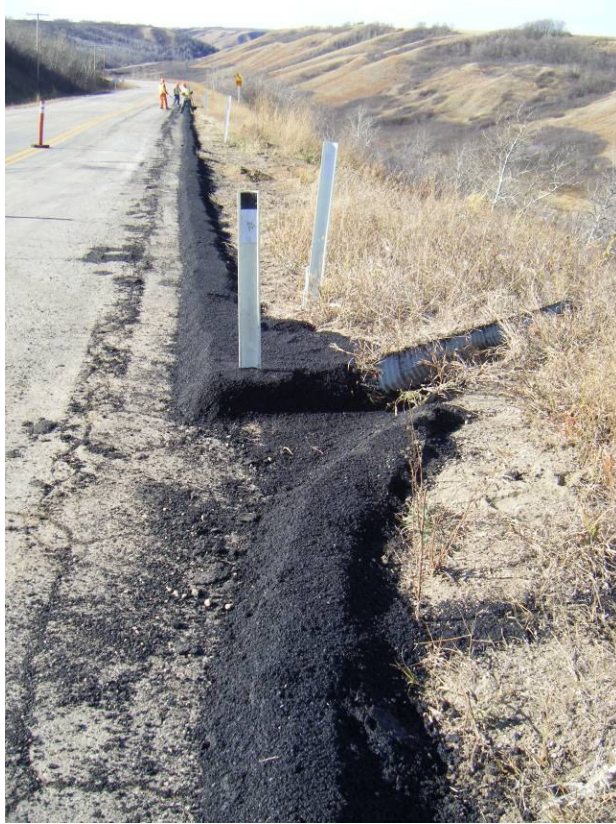
Figure 14: Asphalt curbing for installed half culvert
