# The Flexible Use of Ground Support for the Inner Northern Busway Project, Brisbane

Tim Cartledge, Chris Bridges, Trevor Smith & Garth Powell  
*Coffey Geotechnics Pty Ltd, Brisbane, Queensland, Australia*

Major excavations within city centres present enormous challenges to the design and construction teams charged with carrying out the work. Effective ground support systems need to be employed in order to reduce the risks of all parties concerned and can reassure stakeholders. This paper presents details of the design of the various ground support types installed for a project in the Brisbane CBD.

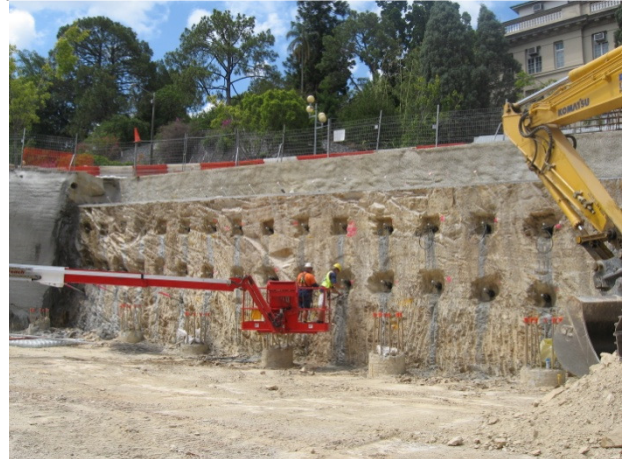
Figure 10. Installing dowels below Albert Street

Adjacent to the waterfall the footpath of Albert Street was removed as part of the excavation. The reinstatement solution was a cantilever walkway out over the busway excavation, placing large moments on the rock. Two rows of 7m long dowels were installed below the walkway (see Figures 10 & 11). These dowels were 50mm diameter

bars, installed at 20° below the horizontal as a preventative measure.
