# PTA-InSAR rock slope monitoring at the Gascons site, Gaspé Peninsula, Quebec

R. Couture, F. Charbonneau, K. Murnaghan & V. Singhroy  
*Natural Resources Canada, Earth Sciences Sector, Ottawa, Ontario, Canada*

## ABSTRACT

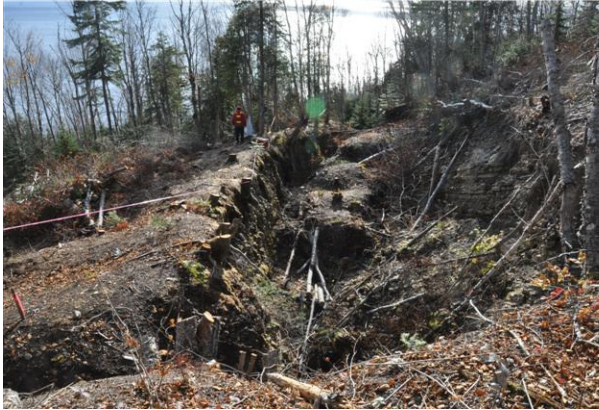
Figure 3. Photo illustrating a large open fissure in the forested sector (Sector II in Figure 2) above the railway corridor.

As introduced in Section 2.2, the forested sector is characterized by the presence numerous large, open fissures mainly oriented NNE-SSW and ESE-WNW coinciding with the main discontinuity sets found in the underlying bedrock. Fissure openings vary from tens of centimetres to tens of meters (Figure 3), indicating significant slope movement and instability processes at the site. These processes generate high levels of maintenance along this stretch of the railway line as some fissures extend beneath the railway. Movement mechanisms are not fully known but they potentially involve sliding along a deep seated plan of weakness, as well as toppling in the rock cliff (Sector I). The paper by Cloutier et al. in these conference proceedings gives an insight on the possible instability mechanisms.

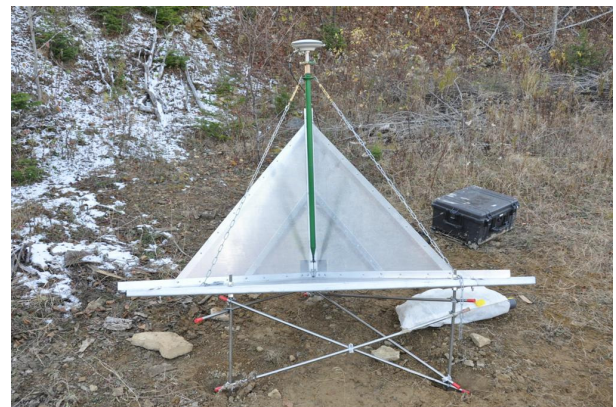
Figure 4. Photo of a corner reflector (CR1) installed at the Gascons site. A D-GPS antenna is temporarily

installed on the corner reflector to measure its exact location.

Trihedral corner reflectors (Figure 4), although they have been used for over 50 years for radiometric and position referencing, are now being used as point target for interferometry. These corner reflectors are phase coherent pass to pass and thus can be used to measure the position changes of the underlying scene (e.g. active slopes). These aluminum trihedral corner reflectors offer four advantages: i) they are simple devices to manufacture; ii) they have large radar cross sections for their physical size; iii) they have wide angular acceptance angles; and iv) they are reasonably easy to deploy (C-CORE 2006).

When bedrock was outcropping or <1 m below the surface, the anchoring system chosen involved 5/8-11" threaded stainless steel rods anchored into the bedrock by drilling 1"-diameter and 12"-deep holes and cementing the rods in place using fast drying glue. Holes were drilled with a portable generator-powered hammer drill. Drilling direction and inclination were dictated by the position and orientation of the corner reflectors. Fine particles from drilling were blown out of the holes before inserting the glue and rods. Three to five holes are usually required: two for the front legs and one to three for the back of the corner reflector. Figure 4 shows a

typical installation for a corner reflector anchored in bedrock (CR1).

The corner reflectors were surveyed with Novatel dual frequency GPS with site occupations between 3 and 22 hours in length (Figure 4). A local survey monument was used for differential corrections. The survey marker position was determined using NRCan PPP (Precise Point Positioning) with an absolute accuracy of 1 cm. The 3D sigma relative accuracy of the reflector positions was better than 1 cm for all reflectors. Three old benchmarks were surveyed with similar accuracy except one with 2 cm accuracy due to overhead obstructions.

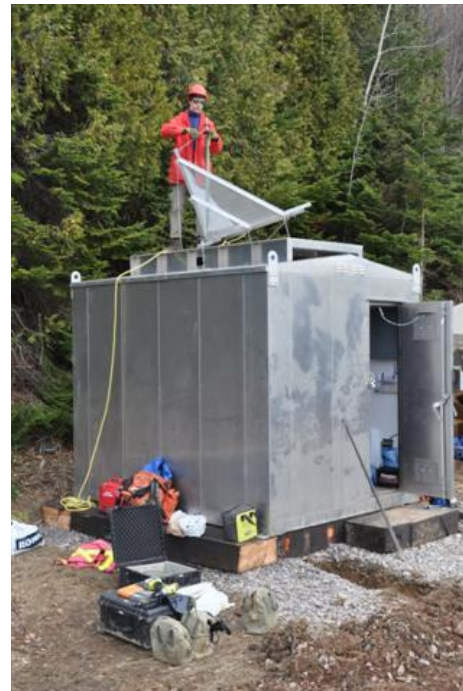
Figure 6. Photo of corner reflector CR2 installed on the roof of a utility bunker at the Gascons site.

The installation of CR2 was facilitated by a stainless steel plate mounted on the roof of the utility bunker. 5/8-11" threaded stainless steel rods bolted into that plate were used as front and back legs for CR2 (Figure 6). In this case no additional reinforcement rods were required to ensure stiffness and stability of CR2.

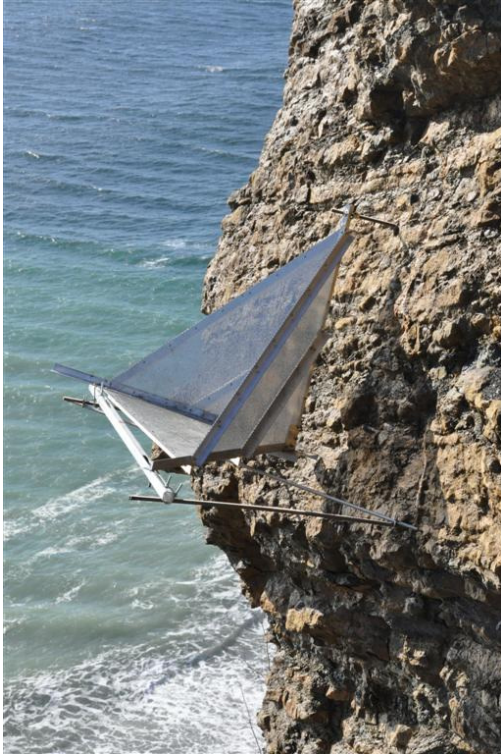
Figure 7. Corner reflector CR3 anchored on a southeast facing rock face of the Petit-massif at the Gascons site.

Corner reflector CR3 belongs to both alignments and is installed on the southeast facing rock face of the Petit-massif (Figure 7). This is considered the most unstable block among the entire unstable zone.

The anchoring of corner reflector CR3 at the Petit-massif was somewhat challenging as it was installed on a rock face (Figure 7). The installation required the professional services of rock climbers.

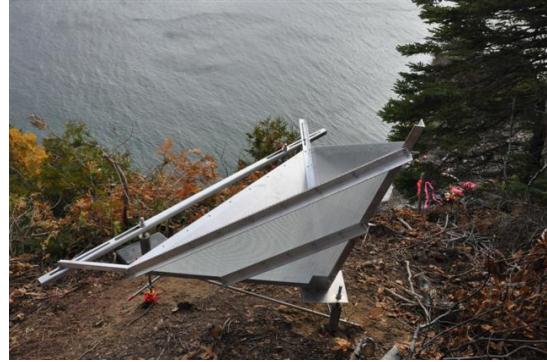
Figure 8. Photo of CR4 located on top of the railway cut.

Corner reflector CR4 is located immediately adjacent to the railway track on top of a 10 m-high railway cut (Figure 8). CR4 is installed upslope of an open fissure that extends beneath the railway bed and towards the Petit-massif.

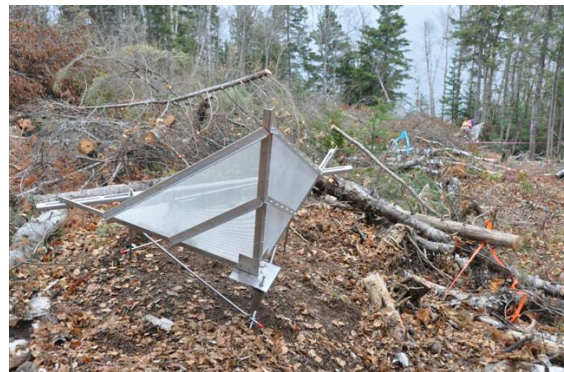
Figure 9. Photo of corner reflector CR5 located on the north side of fissure No.G.

Two corner reflectors (CR5 and CR6, Figures 9 and 10 respectively) were installed on both sides of a large open fissure (identified as Fissure No. G in Lord et al. 2010 in these conference proceedings) that extends over 55 m from the railway track to the northern tip of the unstable area (Figure 5). It defines the north and northwestern limits of the unstable area. This fissure is about 9 m wide at its maximum and exhibits a graben-like shape with collapsed rock blocks.

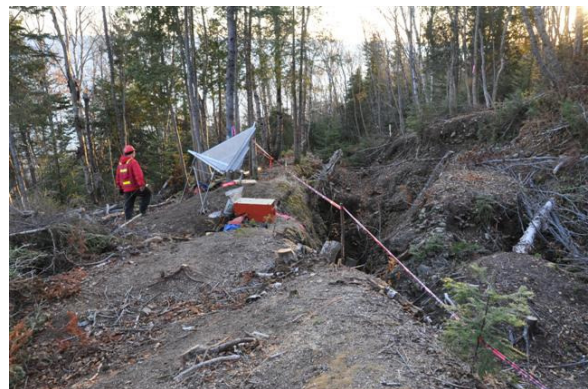
Figure 10. Photo of CR6 located on the downslope side of fissure No. G.

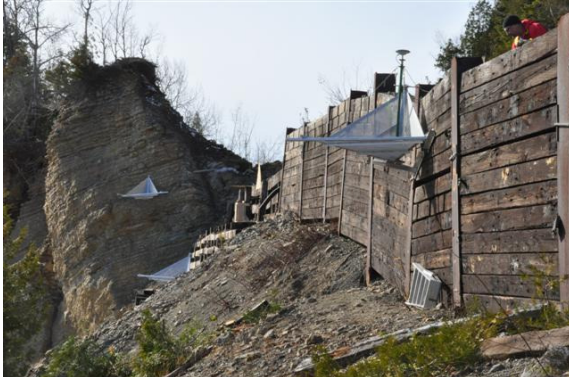
Figure 11. Photo illustrating corner reflector CR7 (foreground) with a D-GPS unit mounted on it. Corner reflector CR8 installed on the retaining wall (left-hand side of the photo) and CR3 anchored on a southeast face of the Petit-massif (background).

Finally, two other corner reflectors (CR7 and CR8) were anchored on two sections of the retaining wall extending 15 m and 35 m east of the Petit-massif. CR7 was installed on one of the vertical iron H-beams at the eastern end of the retaining wall (Figure 11). This section of the retaining wall shows indication of past displacement as shown in Figure 11.

CR8 was anchored to the wooden structure of the western section of the retaining wall (Figure 11). This section of the retaining wall was re-built after the July 23<sup>rd</sup>, 1998, failure of the rock slope. Protective structures at CR7 and CR8 prevent potential damage caused by plowed snow or falling and bouncing rocks.

The same technique was used to anchor CR8 on a wooden platform mounted at the base of the westernmost section of the retaining wall (Figure 11).

Finally, corner reflector CR7 required a unique anchoring design as the back of the corner reflector was attached to a vertical steel H-beam, whereas one side was anchored into horizontal 6x6" wooden creosoted beams (Figure 11). Rigidity was found sufficient with only three anchoring points; the external side of the base of the corner reflector did not require any anchoring.
