# Geosynthetics as eco-friendly defence against erosion in arctic regions

The partners of the European EUREKA project Σ1 3702 GISSAC (Geosynthetics for Innovative Sustainable Solutions in Arctic Climate) aimed to develop an environmentally friendly embankment solution in arctic conditions, with geosynthetic bags and tubes filled with local soil. It started in 2006, and is funded by grants from Foundation Franco-Norvégienne, the French Agence Nationale pour la Recherche (ANR), Statoil and the partners of the project: Main challenges for such a

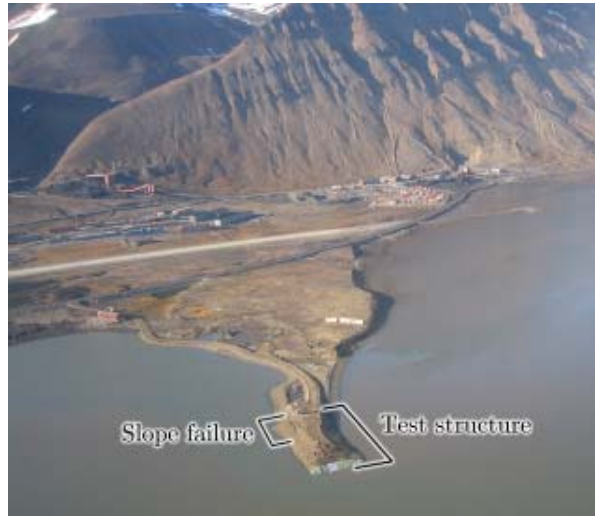
Figure 3. Aerial view of the breakwater.

A 50 meter long breakwater was built during the summer of 2006. The inclination of the embankment is 1:3.5 (Figures 3 and 4). Its top is 3.2 above datum and 5 m wide. The masses were extracted from the mountainsides surrounding Svea.

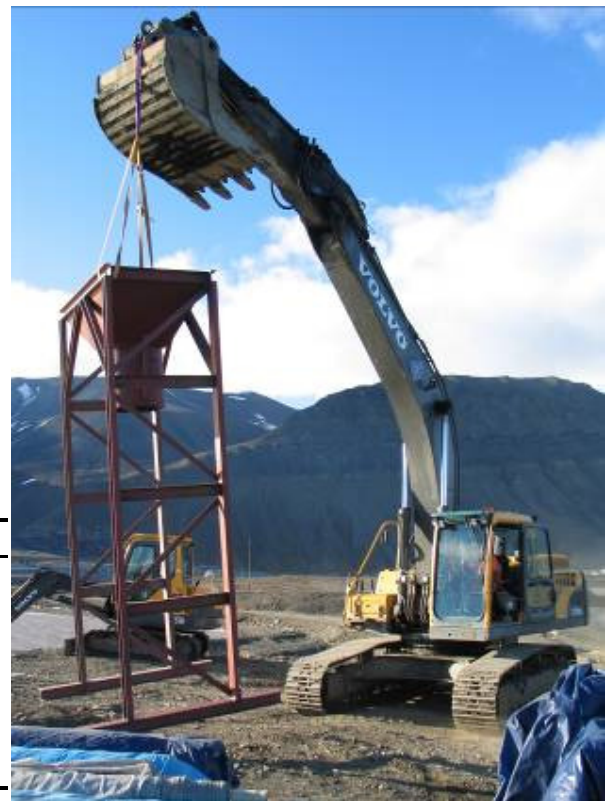
Figure 6. Elevated funnel used to fill the bags on site.

Filling equipment was designed for the project, consisting of a funnel and a box, which was attached to the arm of an excavator (Figure 6). The bags were filled with local masses. 70% of the masses had a diameter smaller than 19 mm. The construction took place in August 2006. The filling and installation of a bag took approximately 10 minutes and required two excavator operators and two bag operators. 150 bags were constructed in total (Figure 7).

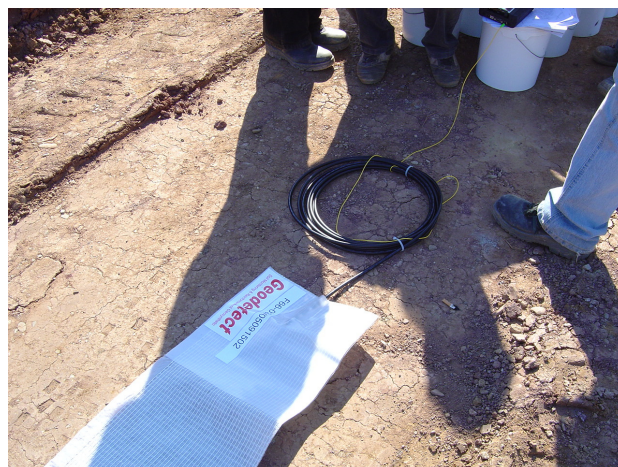
Figure 11. The TenCate GeoDetect® textile fiber optics sensor

The TenCate GeoDetect® S-FBG solution embodies a strip of geocomposite fabric, fiber optics, software and instrumentation to provide an innovative solution for the multi-functional requirements of a geotechnical application (Figure 11). It uses Fiber Bragg Gratings (FBG) technology to measure strain in soil structures as low as 0.02% with a spatial resolution of 1 m.

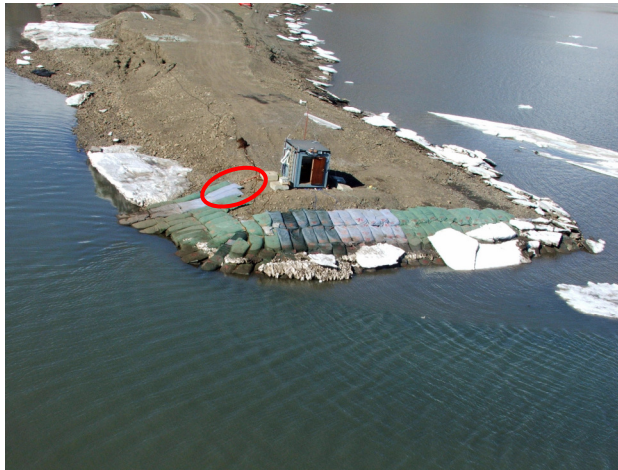
Figure 12. Location of the textile fiber optics sensor (red shape).

The strip was laid below the bags of the West corner (Figure 12). The strain measured between the installation in September 2006 and spring 2007 ranged between 0 to 0.1%, concluding to no significant movement of the bags, nor settlement of the slope. The connection cable (Figure

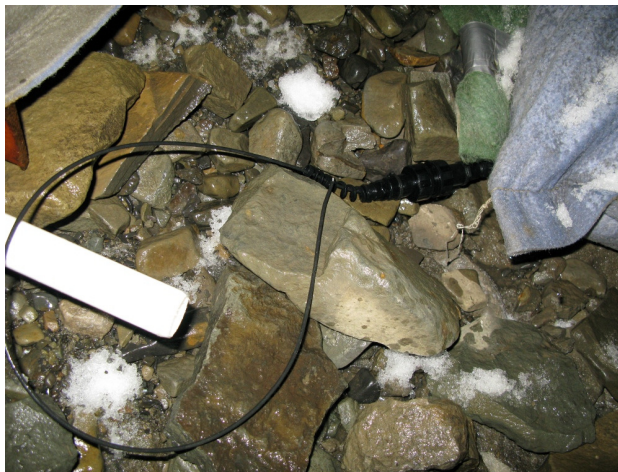
Figure 13. The connection cable from the textile fiber optic sensing strip below the geobags.

13) was cut by an engine. It is planned to repair it and run new measurements in summer 2010.

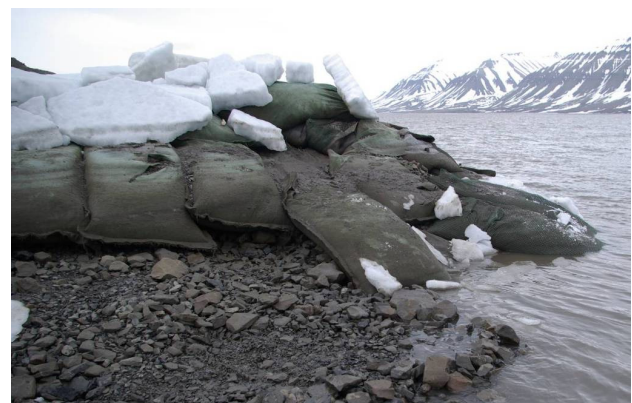
- 1 bag has been lost as it was without side-bags which were sampled the year before and gives more side impact from the ice blocks pushed over the bags from the East (or less probably from the West) (Figure 15);
- 5 bags have been severely damaged (large holes); they are all situated in the side areas (East & West) and

Figure 15. Visual inspection in 2009. Contact of the ice on the west corner One hole on bag 26, second on the left.

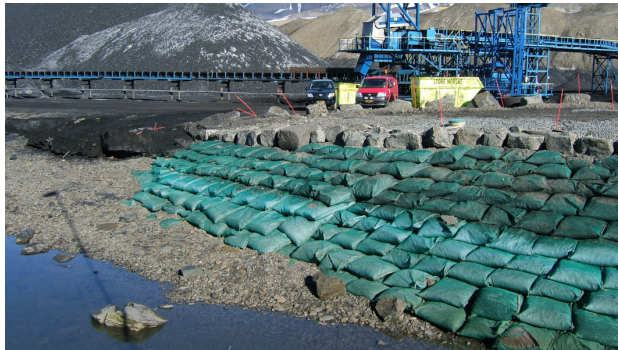
Figure 17. The Kapp Amsterdam quay wall stabilised with the geobags

The geobags solution is a real economical alternative to traditional rocks. For example, geobags were used to reinforce an existing quay previously protected with large rocks against scour erosion at the Kapp Amsterdam harbor in Svea, a few kilometers from the Barryneset experimental site (Figure 1). It consists in a slope stabilization built with 10 levels of geobags (Figure 17). Two years after installation, the results are very promising and will be published in other papers.
