# Development of Accelerated Dewatering Technology for Managing Oil Sands Fine Fluid Tailings

Rick Lahaie  
*Synchrude Canada Ltd., Fort McMurray, Alberta, Canada*  
Jack T.C. Seto  
*BGC Engineering Inc., Edmonton, Alberta, Canada*  
Denise Chapman  
*O'Kane Consultants Inc., Saskatoon, Saskatchewan, Canada*  
W. David Carrier, III  
*Argila Enterprises Inc., Lakeland, Florida, U.S.A.*

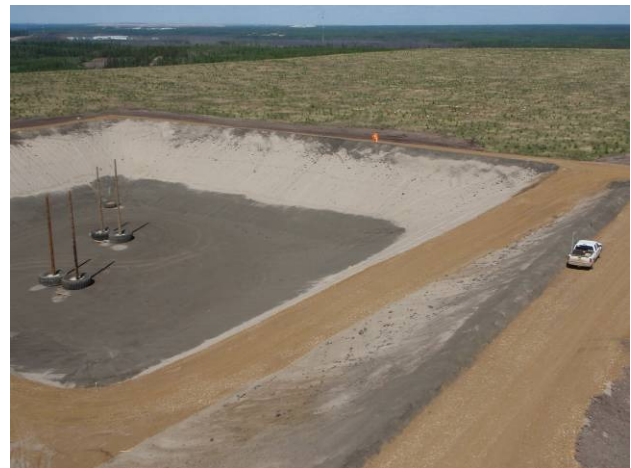
The dewatering pit was constructed between April and June 2009. Figure 1 shows a view of the dewatering pit prior to pit filling.

Figure 1. View of containment pit prior to filling.

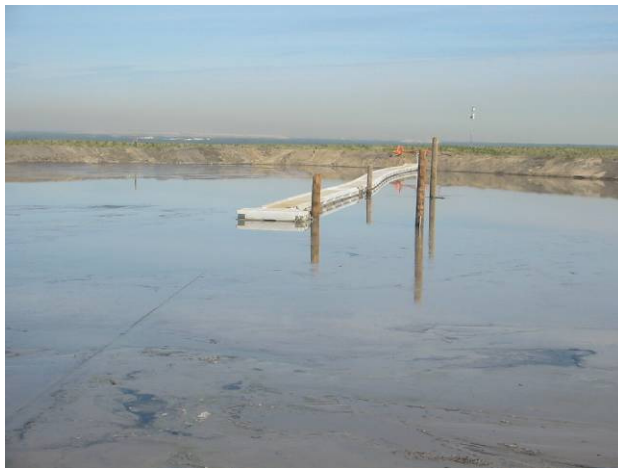
Because of the initial fluid state of the MFT (i.e., untrafficable to foot traffic), plastic modular docks were assembled together to form a walkway and working platform off which instrumentation could be installed, and for sampling and in situ testing of the deposit. Figure 2 shows a view of the floating walkway.

Figure 2. View of floating walkway and instrumentation power poles (August 28, 2009, one week after pit filling).

At the completion of pit filling, the pond was observed to be covered by a layer of fluid, as shown in Figure 2. By September 11<sup>th</sup>, about three weeks after the pit was filled, a noticeable crust with some cracking had begun to develop around the perimeter of the deposit as shown in Figure 4.

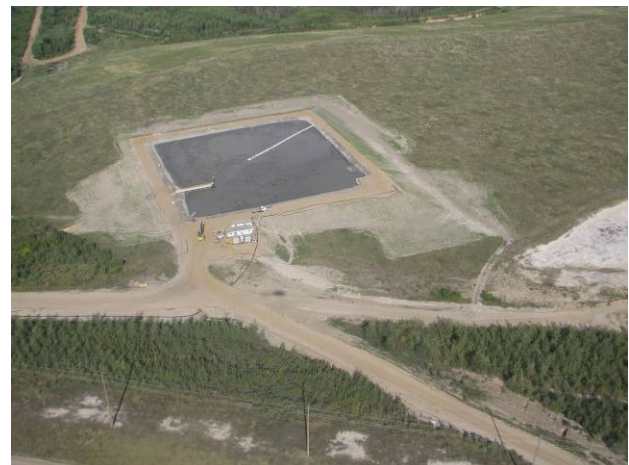
Figure 3 shows an aerial view of the test deposit shortly after the pit was filled.

Figure 3. Aerial view of dewatering pit shortly after pit filled.

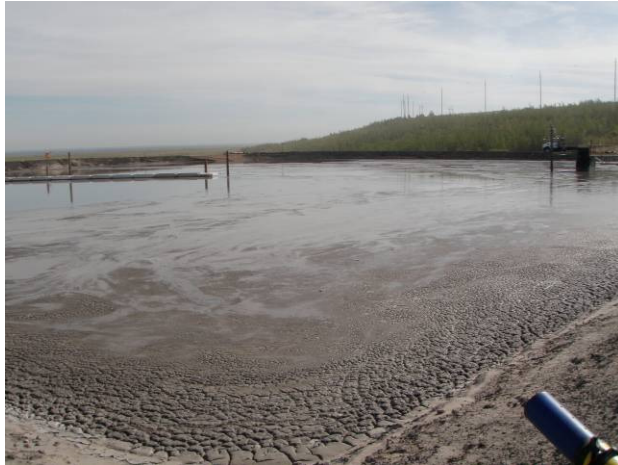
Figure 4. View of MFT deposit surface on September 11, 2009 (three weeks after pit filling).

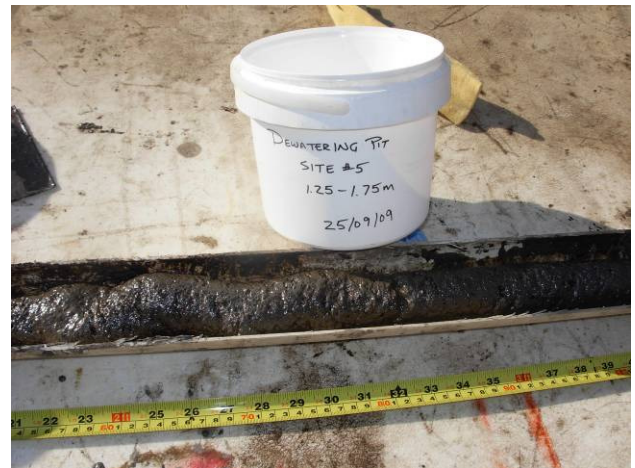
In late-September, 2009, in situ samples were collected from three locations, two alongside the floating walkway and another next to the spill box. Continuous samples over the full depth of the MFT deposit were collected at approximately 50 cm depth intervals using a piston tube sampler. Figure 7 shows a typical sample.

Figure 7. Typical MFT sample.

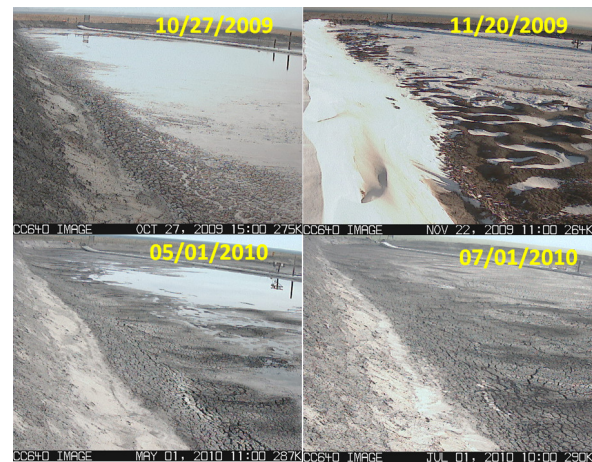
The automated cameras have worked well. Figure 9 shows how the surface at northern edge of the deposit changed over a four-week period between October 27 and July 1, 2010 (two to ten months after pit filling).

Figure 9. Surface changes along northern edge of deposit between late-October 2009 and early-July 2010.

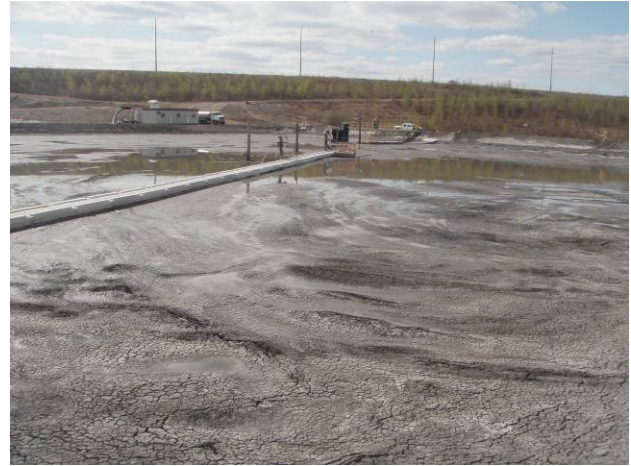
In April 2010, a fairly large, shallow pond was present at the deposit surface (see Figure 10). By mid-June 2010, the pond disappeared. Figure 11 shows a view of the surface in July 2010. Figure 12 shows a closer view of crack formation around instrumented pole PP-3 in July 2010.

Figure 10. View of MFT deposit surface on April 26, 2010 (eight months after pit filling).

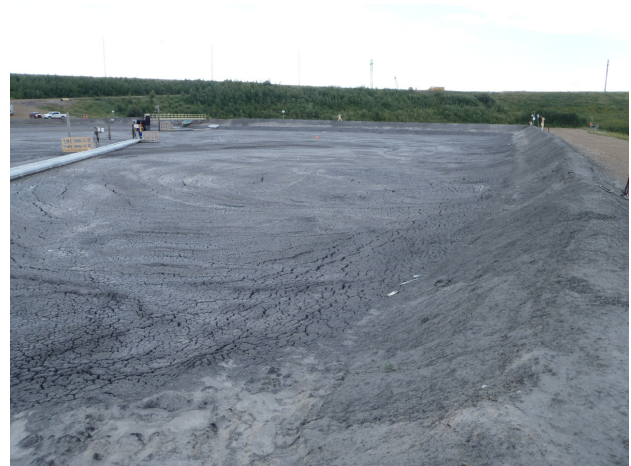
Figure 11. View of MFT deposit surface on July 6, 2010 (ten months after pit filling).

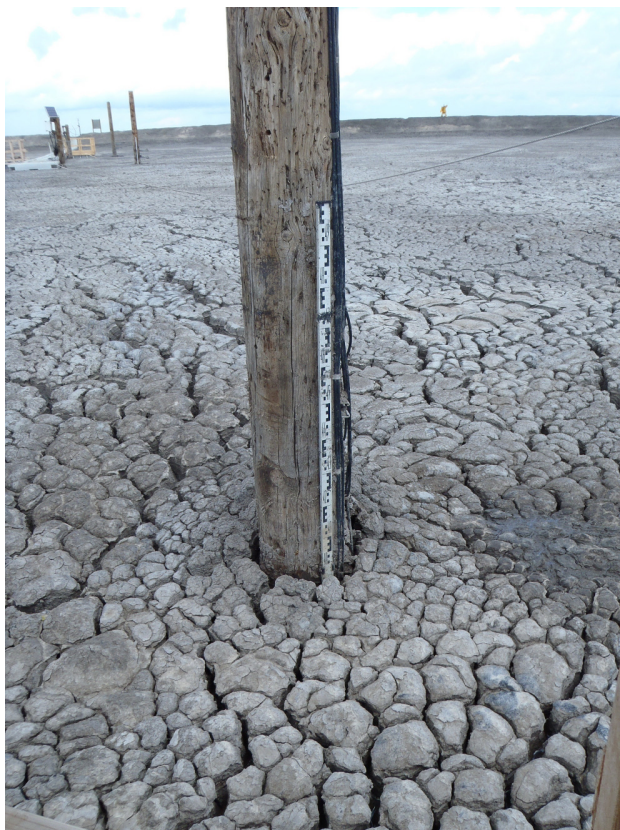
Figure 12. View of MFT surface around instrumented pole PP-3, July 6, 2010 (ten months after pit filling).
