Risk management of large rock slopes – state of practice

Renato Macciotta, C. Derek Martin & Norbert R. Morgenstern
 Department of Civil and Environmental Engineering – University of Alberta, Edmonton, Alberta, Canada

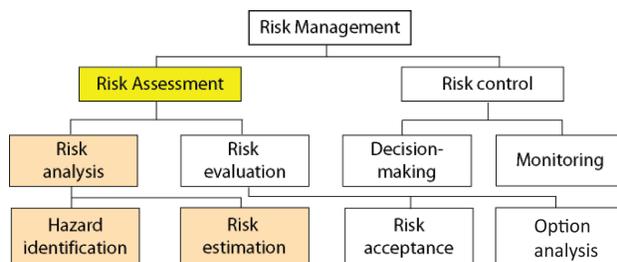
Figure 1: A framework for risk management (CSA, 1991).

Geotechnical engineering is fundamentally about managing risk. Morgenstern (1995) summarized risk assessment concepts using the framework for risk management adopted by the Canadian Standards Association (Figure 1).

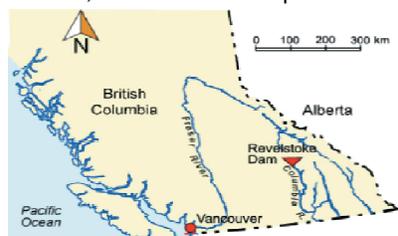
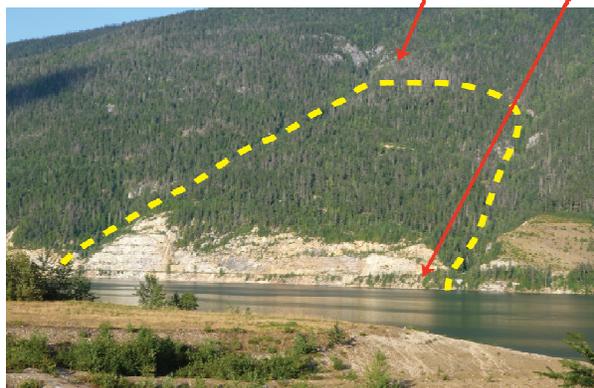
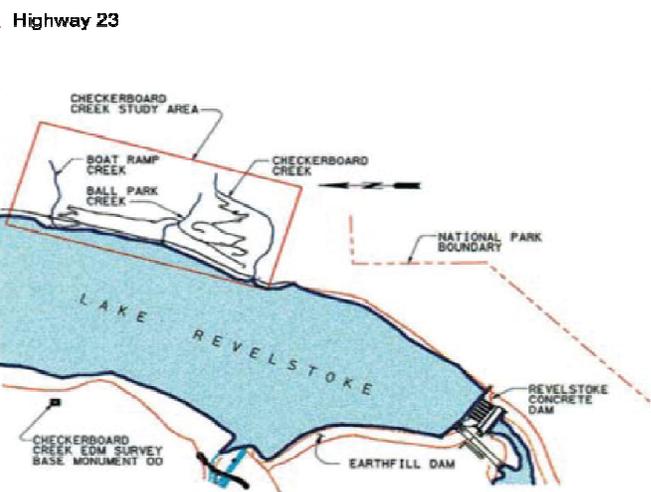
Approximate Checkerboard Creek Rock Slope Boundaries

Figure 2 Location and approximate boundaries of the Checkerboard Creek rock slope.

The importance of the Checkerboard Creek rock slope stability conditions is related to its location within the Revelstoke Dam reservoir, and to a lesser extent the existence of a secondary highway along its toe (Highway 23 - see Figure 2). The consequences of a potential slope failure and subsequent wave generation within the reservoir would compromise the earth and concrete dam structure, as well as the power house, and potentially

The extent of the deforming rock mass has been interpreted from geological studies and deformation monitoring. The upper boundary is well defined by the alignment of the uppermost exposed tension cracks. The lateral boundaries, as well as the toe boundary are not as clear and have been interpreted from the site geology, slope topography and deformation patterns. The active zone has an average slope angle of approximately 45 degrees, being steeper at the toe (road cut) with a slope angle of 50 – 60 degrees. Deformations have been detected up to 50 - 60 m deep. This active zone has a total volume estimated to range between 2 to 3 Million m³ (Watson et al. 2004). Figure 2 shows the location and approximate boundaries of the Checkerboard Creek rock slope.

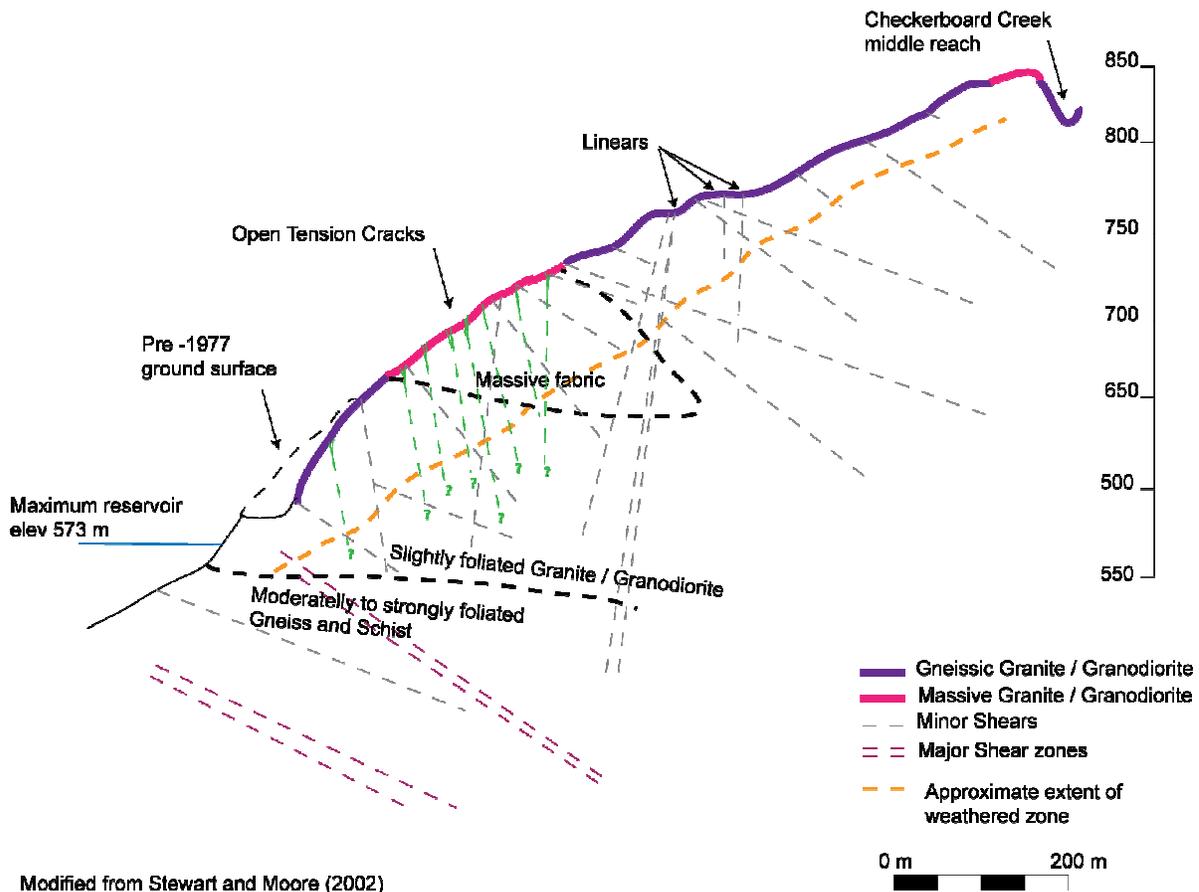
Figure 3 Simplified sketch of the Checkerboard Creek rock slope geology

undisturbed and blocky rock; to highly weathered and altered, weak and disturbed rock. Sheared and crushed zones are commonly found. The poor quality rock mass is typically found within 60 m from the slope surface, where the active deformations have been observed. Rock mass beneath this area is generally fair to good in quality, with localized zones of poor quality rock along shear zones and sub-vertical joints (Stewart and Moore 2002). Figure 3 illustrates the Checkerboard Creek rock slope geology.
