Recent UK experiences in investigation, design, assessment and management of hard rock slopes

D. M. Tonks, I. M. Nettleton, R. M. Denney, G. M. Hurworth
Coffey Geotechnics Ltd, Manchester, United Kingdom

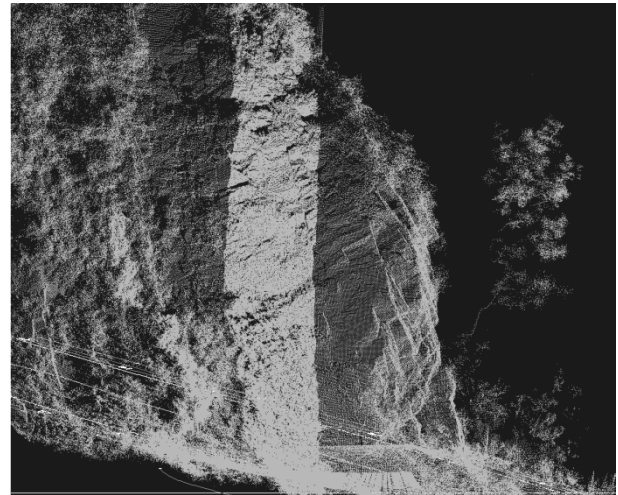
Figure 3. Laser survey raw data showing view in Figure 2.

Investigations involved rope access inspections and a laser scanning survey of the rock mass. The information gathered was used to model more accurately the size and likely failure planes. The laser survey was found to accurately highlight the different planes and their angles. Intersections of the different planes could then be extrapolated, thus enabling 3D modelling of the rock mass as a whole. Figure 3 shows an extract of the raw laser survey data, generated from 'point cloud data'.

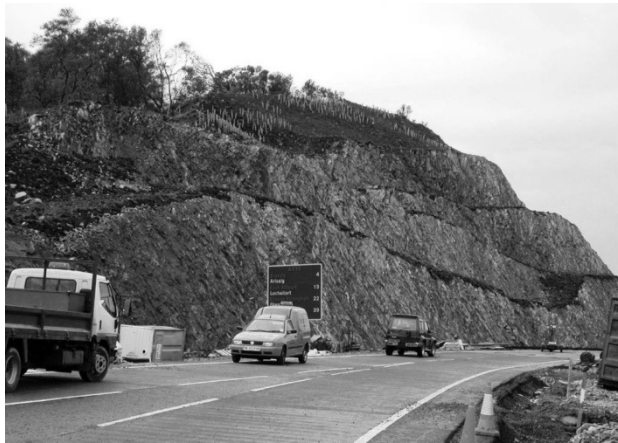
Figure 5. Curved benches to reduce visual impact.

The final section of the upgrade was from Loch Nan Uamh to Arisaig, approximately 7.5km. The proposed route included 25 rock cuttings, many of which are substantial, some in excess of 35m high. It was paramount that the final design for the whole upgrade scheme was landscaped and environmentally acceptable (Figure 5) being in an area of outstanding natural beauty and through a Special Area of Conservation (SAC).

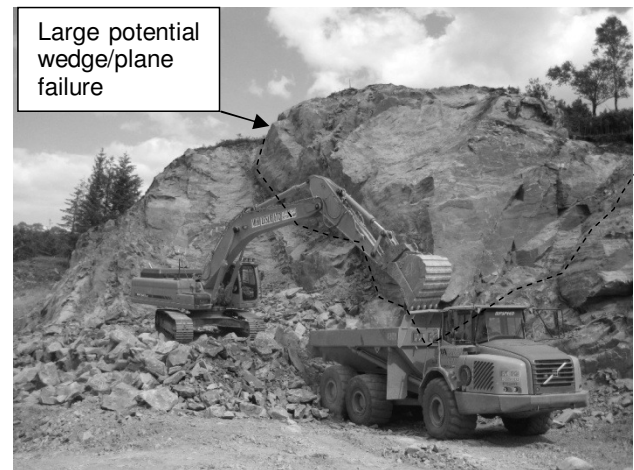
Figure 6. Slope with large potential wedge/plane failure identified during excavation.

An example of this is presented in Figures 6 and 7. A large potential plane/wedge failure was identified during the excavation of a cutting (Figure 6). The potential

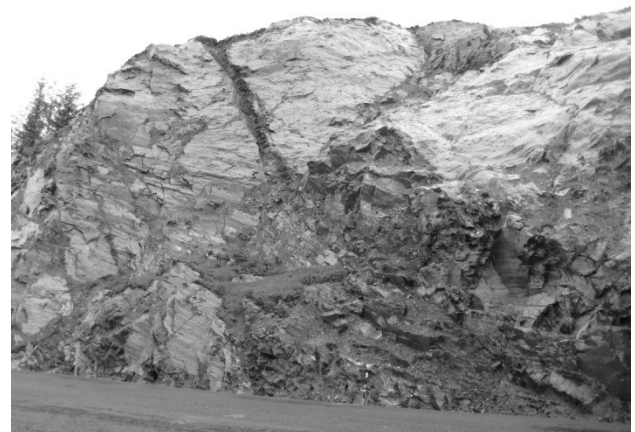
Figure 7. Slope following excavation with large potential wedge/plane failures removed.

wedge/plane failure was subsequently removed (Figure 7). This reduced the requirement for the contractor to revisit the cutting after completion of excavation and the need for remedial works that would require maintenance over the life of the rock slope.

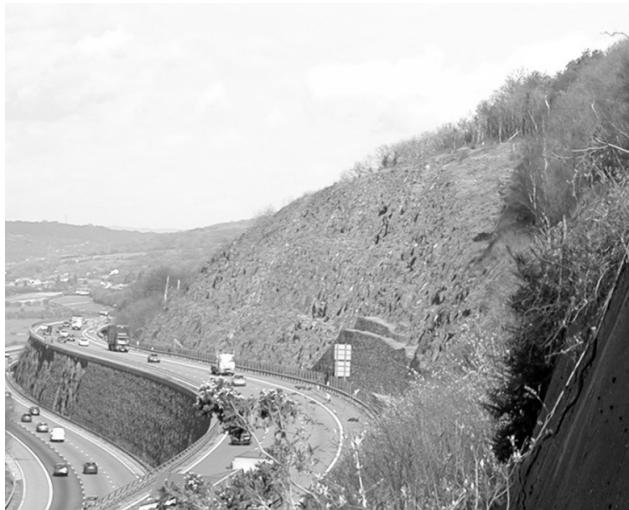
Figure 8. M5 Wynhol Viaduct rock slopes, line of two benches just visible.

The cutting has an overall slope angle of 70° and has been excavated out of Carboniferous Limestone (Figure 8). The cutting appears to have originally been formed by blasting two benches into the hillside, unfortunately as excavation progressed the benches were reduced to typically less than 1m. This has produced a series of small broken benches that act like 'ski jumps' and project rock fall out from the rock face.

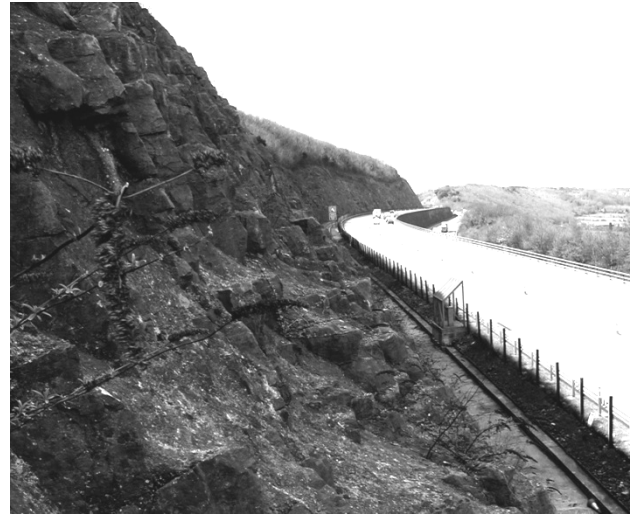
Figure 9. M5 Wynhol Viaduct rock trap.

The inspections identified where visible the existing remedial works, which consisted of approximately 4000 rock bolts, anchors, galvanised weldmesh, a 1.8m high rockfall catch fence and a 4m to 4.5m wide by 1.5m deep rock trap (Figure 9).

No information on the design or maintenance of the remedial works was available. The inspections suggested that the remedial works were generally well-constructed and had performed well over 30 years since their construction and installation.

The existing catch-fence was identified during the inspection as not being high enough to contain blocks that may originate from above the lowest berm. Therefore, the upper two benches were netted, effectively containing falling material close to the face. This allowed the material to shuttle down between the rockfall netting and the rockface, dropping out of the netting at the lowest berm on the slope, from which point the existing catch fence is high enough to contain any falling material.

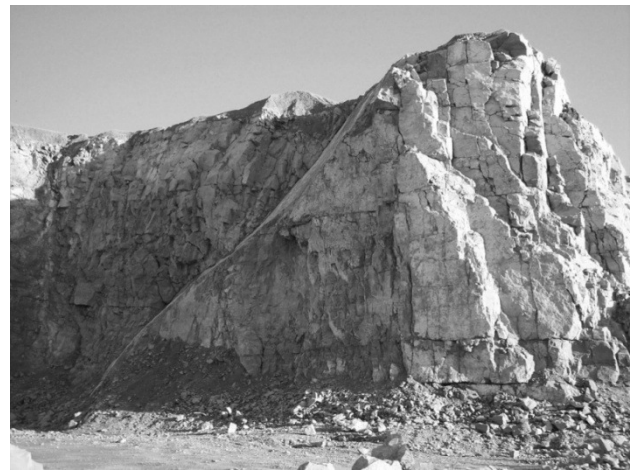
Figure 10. Red Slope (>15m with significant geotechnical features).

The team has produced “Traffic Light” hazard plans based on a three tier system. The system assigns each rock slope within a working area one of three colours (red, amber or green). Red slopes are rock faces that are greater than 15m in height and have significant geotechnical features present (Figure 10). Amber slopes are other slopes greater than 15m in height or less high slopes which have significant geotechnical features present. Green slopes are faces that are less than 15m in height and where there are no significant geotechnical features present.

Each of the three slope categories has a specific design and method to which they are worked and managed. All are agreed between the Geotechnical Specialist and the Quarry Management. The “Traffic Light” hazard plans are reviewed during the Appraisal and Geotechnical Assessment of the whole site.
