Experiments on the failure of slopes made of loose sand due to the rise in water level

Reza Imam

Vahid Masumi Fard

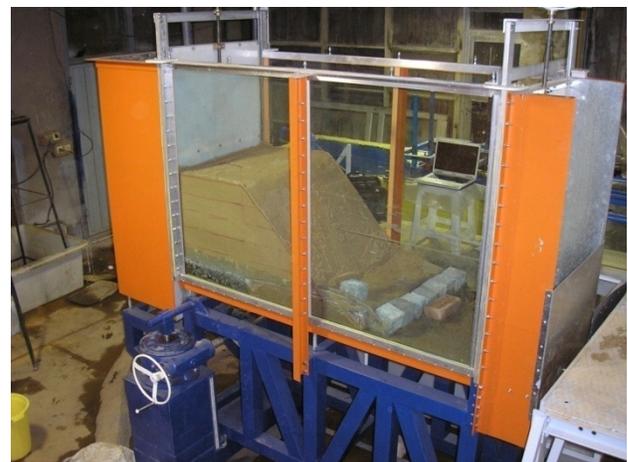
Figure 4. Overall view of the test tank

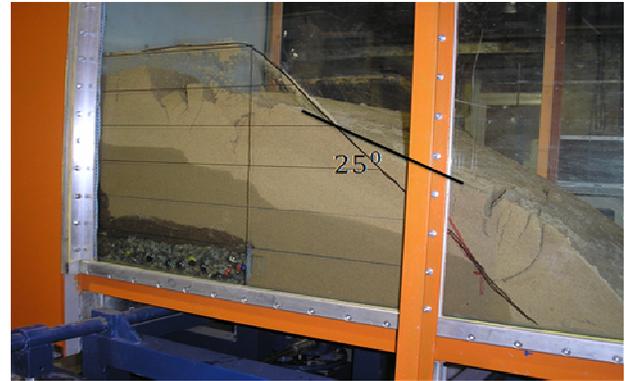
As the water level in the soil was rising, settlement in the crest of the fill was observed and gradually increased. In the fifth minute of the test, when water level rose to approximately 250 mm above the gravel layer, a sudden collapse of the fill occurred, and the slope decreased from 44 to 25 degrees with the horizontal. This collapse occurred when water level was still inside the slope and at a relatively large distance (approximately halfway) from its outer perimeters (Figure 8).

Figure 8. Slope after first collapse in Test No. 2

In Test No. 2, the first collapse occurred suddenly, and the slope angle after collapse was 25 degrees, 9 degrees smaller than the angle of repose of the sand. The sand was also very loose ($D_r = -28\%$) and prone to contractions similar to those observed in the CDS loading described in Section 3. However, the first collapse in this test occurred while the slope was not yet fully submerged; therefore, the contracted portion of the slope soil did not include the full slope volume. The subsequent rises in water level and the ensuing failures led to milder slope angles such that the slope finally stabilized at 13 degrees after all the soil was submerged.

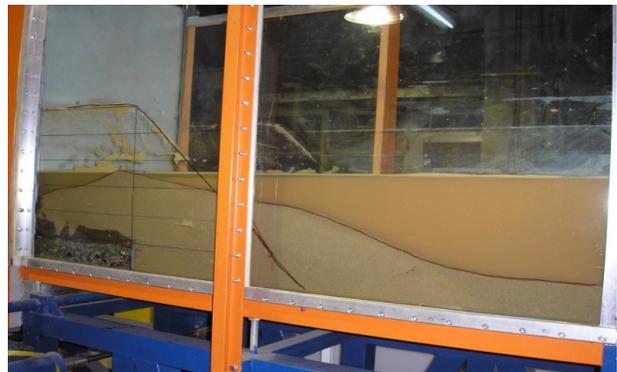
Two minutes later, when the water level had reached an elevation of 350 mm above the gravel layer (about 100 mm from the collapsed slope crest), a second collapse occurred, after which slope of the fill reached a 13 degree angle with the horizontal, and water overtopped the fill, leading to the submergence of the whole slope (Fig. 9)

Figure 9. Final slope at the end of Test No. 2

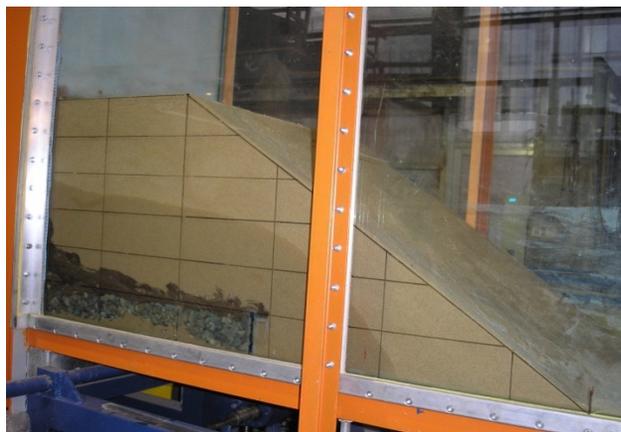
During the first 6 minutes of introducing water into the slope, the crest of the slope experienced slight gradual settling as water level was rising inside the slope, but no failure occurred (Figure 11). However in the sixth minute, when water level within the slope had reached an average of approximately 300 mm above the gravel layer, a sudden collapse took place, during which the slope of the fill changed from 34 to an average 24 degrees with the horizontal. The collapse occurred when the water level was still inside the soil, and the water front was at an approximate distance of 200 mm from the crest, and an average of approximately 100 mm from the face of the slope.

Figure 11. Condition of slope prior to the sixth minute in Test No. 3
