A Case History on a Challenging Encapsulated Geomembrane Containment System for a Lime Sludge Pond Facility

Andrew Mills, C.E.T., Brian Fraser, MBA, Chang Park, E.I.T.
Layfield Environmental Systems Ltd., Edmonton, Alberta, Canada

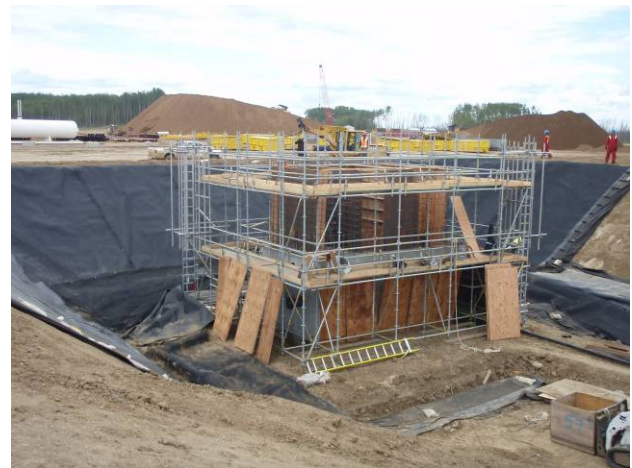
Figure 1: Liner installed under/behind Supernatant Sump. Note backfill protection under concrete structure.

- i) *complete rough excavation of the pond in the fall of 2008*
- ii) *Construct the Silencer support foundation, the Supernatant Sump, and the Discharge support foundations during the winter season 2008/09. These structures were designed to be "within the liner envelope". The liner was placed under each foundation and protected with sand and plywood until the embedded sections could be spliced into the over all liner*

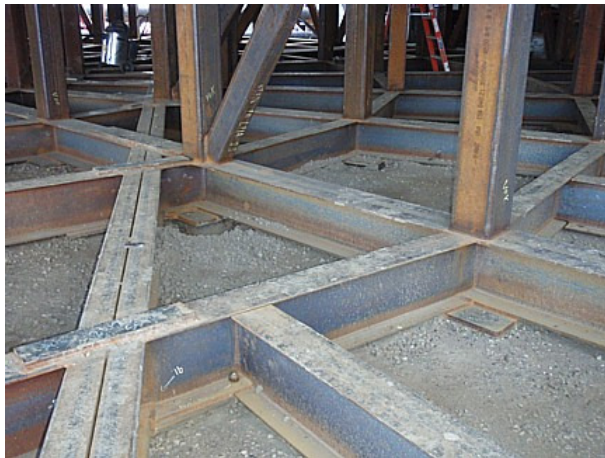
Figure 2: Support structure underneath the warm lime softener tank. With this type of detail only a spray-on liner will be effective.

The warm lime softener tank is supported on a network of piles with a 2m air space below the tank. A spill containment liner was needed under this tank however the number and proximity of the piles precluded use of a standard liner material. A sprayed in place polyurea liner was used under this tank.

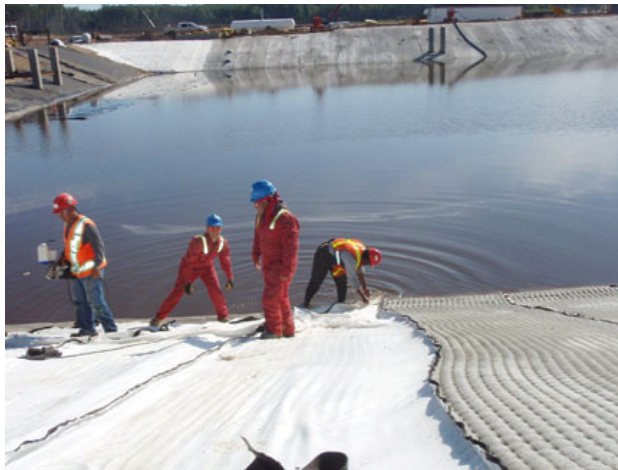
Figure 3: Installation of concrete filled fabric forms. Note that the pond is being water tested during this part of the installation.

Placing roller compacted concrete on the base of the pond was relatively straightforward. Placing a thin layer of concrete on a side slope is more difficult. On this project 100 mm thick fabric forms for concrete were used. These forms consist of two layers of fabric tied together with threads to create a uniform section. Sections of fabric forms are sewn together to cover the area required and then filled with a pumped structural grout. Once the grout hardens a solid layer of concrete is in place. On this project the fabric forms were

prefabricated into large panels prior to delivery and the sewn together on site. Because of the weight of concrete over the length of the slope fabric bulkheads needed to be placed inside the forms to limit the amount poured at any one time. In this project the forms were filled 1/3 of the way up the slope and then allowed to cure before the next section was filled.

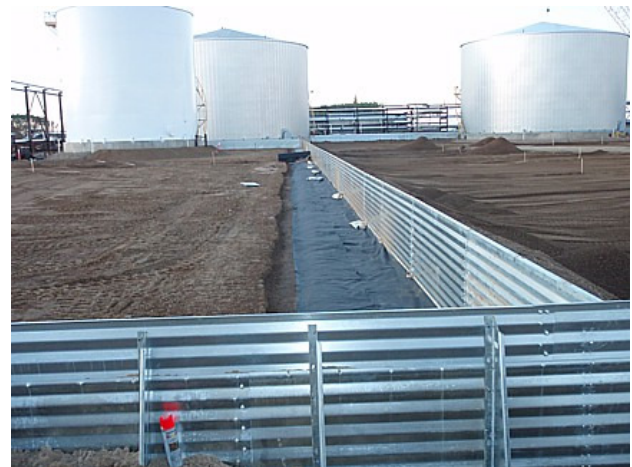
Figure 4: Steel containment berms showing external support posts and liner attachment to the bottom of the berm inside the wall.

Steel containment berms are made from sections of corrugated steel supported with posts or other structural sections. In this project the steel walls were 1.4 m high. A special ground plate that works with this system is placed on the ground and extends into the dyked area. Backfill on this ground plate and any spilled liquid from the tanks prevents tipping of the wall during a spill event. The ground plates are known as a zero ground disturbance system since they do not need piles.

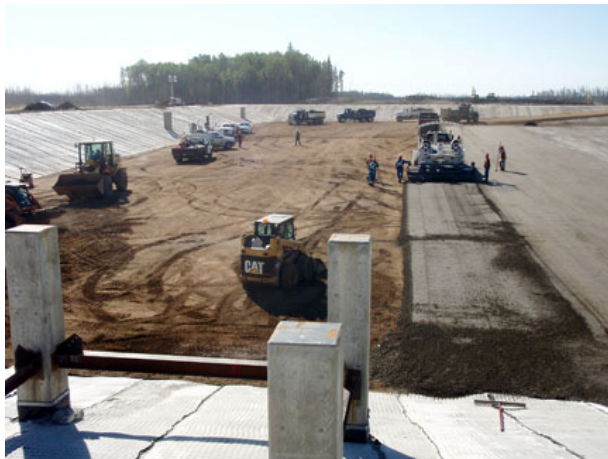
Figure 5: Installation of roller compacted concrete.

Fabric forms 100mm thick were used to place concrete on the slopes of the pond while 150mm of roller compacted concrete was placed on the base. A road way and turning pad was constructed with rig matting to provide a route for the dump trucks to get into the bottom of the pond. Once in the pond the trucks backed up in a straight line to the concrete placement machine without making any turns on the backfilled liner.

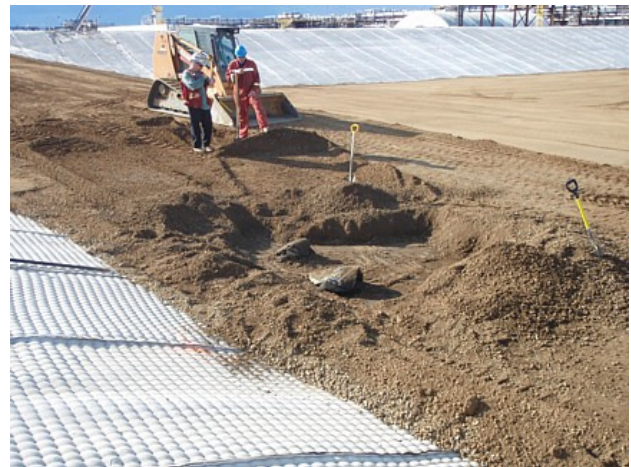
Figure 6: Damage to liner caused by forklift removal of the rig mats.

During the removal of the rig mats a forklift inadvertently put its forks through the backfill and damaged the liner system. The liner installer's site superintendent noticed the damage. The backfill was exhumed for 15 m on all sides of this damaged area and the liner layers were opened up to inspect each layer. Repairs were completed and then the backfill was replaced and then covered with concrete.
