# Jet grouting for the Highbury Interceptor Siphon access chamber

Paolo Gazzarrini, P.Eng.  
*Sea To Sky Geotech Inc., West Vancouver, BC, Canada*  
Andrew Port, P. Eng. and Garry Stevenson, P.Eng., P.Geo.  
*Klohn Crippen Berger, Vancouver, BC, Canada*  
Hein Steunenbergh, P.Eng. and Florence Ho, EIT  
*Metro Vancouver, Burnaby, BC, Canada*

The Highbury Interceptor Siphon consists of three concrete pipes conveying sewage under the North Arm of the Fraser River from Vancouver to the Iona Island Wastewater Treatment Plant in Richmond, BC. The eastern pipe of the siphon was successfully lined with the Cured-In-Place-Pipe (CIPP) method in the summer of 2009. Jet grouting was used to create an access chamber to the pipe, located about 9 m below ground level on the Iona site. The nature of the soil, Fraser River sand overlying deep silt, and the presence of a high water table ruled out conventional dewatering and construction methods for the access chamber. Jet grouting was chosen as the most viable method to construct the access chamber in these sub-surface conditions.

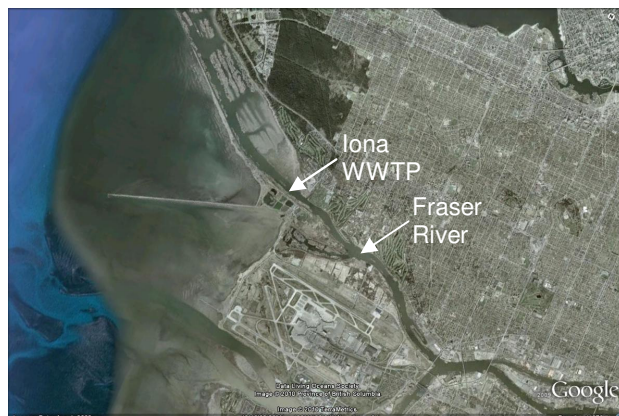
Figure 1. Iona WWTP location, Richmond

The Highbury Interceptor Siphon, constructed in 1959, consists of a reinforced concrete structure with three conduits conveying sewage under the North Arm of the Fraser River to the south bank where it transitions into three reinforced concrete pipes leading into the Iona Waste Water Treatment Plant. Figure 1 shows the location of the project at the edge of the Fraser River delta. Figure 2 shows the site arrangement.

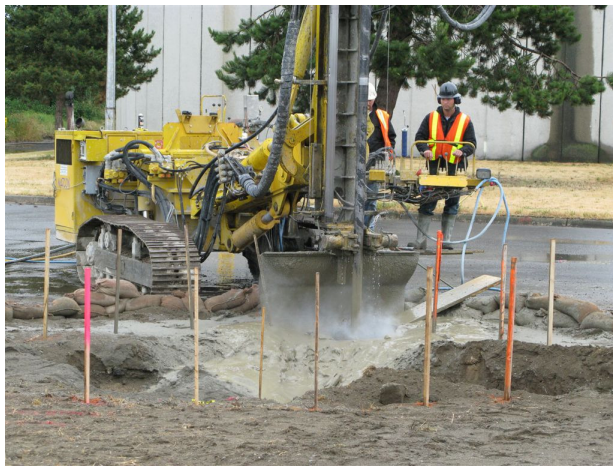
Figure 7. Drill rig excuting chamber wall column

The jet grouted columns were installed in June and July 2009. The contractor initially chose to install the wall columns with the split-space method sequence (primary, secondary, tertiary columns), followed by the bottom slab using a sequential ("fresh on fresh") sequence. One additional column, compared to the design layout, was installed. Figure 7 shows drilling for a chamber column, while Figure 8 shows the mud pit and grout plant arrangement.

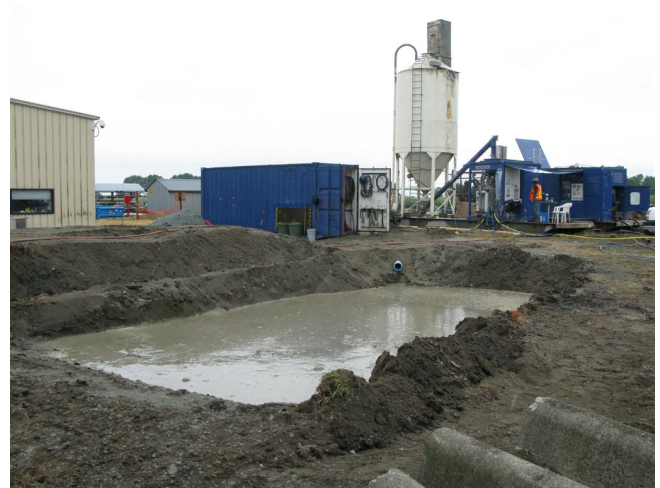
Figure 8. Mud pit and grout plant

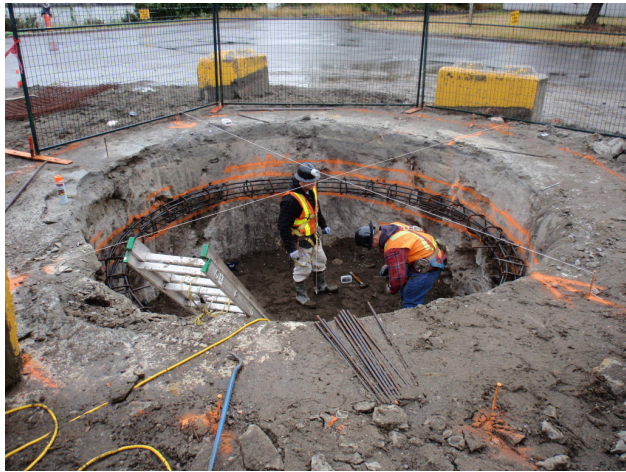
Figure 9. Shoring ring installation in upper shaft

After completion of the columns for the wall and bottom plug, the contractor started excavation inside the shaft with a conventional backhoe on about July 5, 2009. Figure 9 shows the upper shaft being prepared for the first ring of reinforced shotcrete. The first observation, during the excavation of the first few metres, was that the thickness of the wall was larger than specified; 1.1 to 1.2 m vs. 0.80 m specified minimum. The large column diameter had an impact on construction as some soil-cement had to be excavated by hand to achieve the minimum specified clearance at the siphon pipe. However, this was not an onerous undertaking due to the low compressive strength. The contractor's design called for internal bracing (reinforced shotcrete rings) every 1.5 m from the top, but considering the increased thickness of the wall and the much higher compressive strength obtained, omission of the bracing was accepted after assessment by the contractor's engineer, with the exception of the first ring immediately below the ground surface.

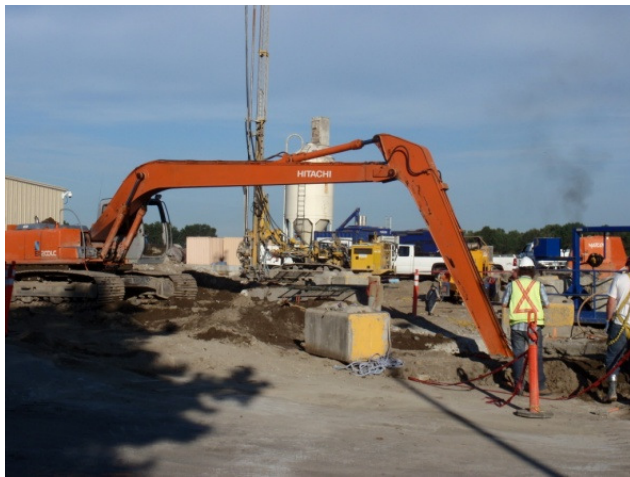
Figure 10. Excavation with long-arm backhoe

Excavation at depth was performed with a long-arm backhoe excavator and, at the bottom, with a vacuum truck. Figures 10 and 11 show early excavation and the nearly-completed chamber. The chamber columns were watertight. However, as excavation was nearing completion on about July 14, 2009 a small leakage of water occurred at the crown of the siphon, where the connection between the bottom of the jet grout wall columns and the top of the siphon pipes was not adequate to prevent the inflow of water. This was due to the fact that the jet nozzles are approximately 200 mm above the bottom of the bit; since the jet shoots horizontally and not downward, it was not able to seal adequately around the crown of the siphon pipes.

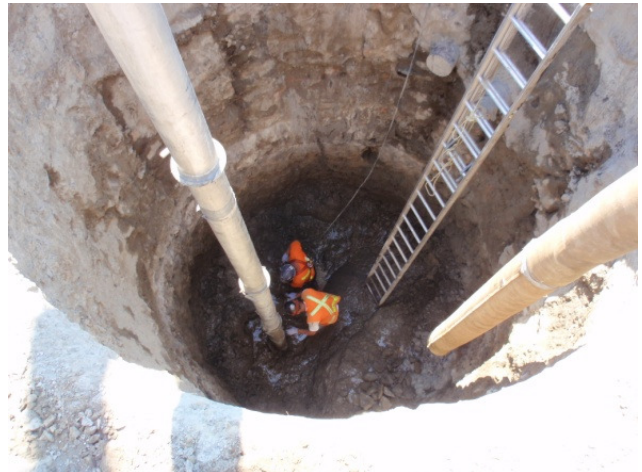
Figure 11. Completion of shaft using vacuum line

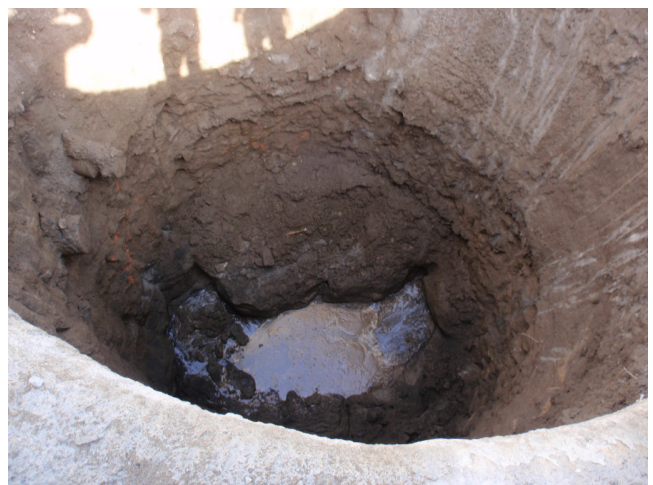
Figure 12. Missing column, left side of base

A second, more serious problem was discovered as the excavation was extended below the crown of the siphon pipe. At this time it became evident that a column was missing, as can be seen in Figure 12. Water and sand under pressure started to run in from the area of the missing column and in a few minutes the shaft was filling rapidly. The excavation was backfilled to prevent excessive piping of sand into the chamber. The Contractor initially tried to seal the area by grouting through a grout pipe drilled to the vicinity of the leak. However, it was not possible to achieve a positive seal that would withstand the water pressure.

After discussions and assurances regarding the status and position of the siphon, the obstruction was drilled, the hole was advanced to design depth, and the missing base slab column was jetted. On July 27, 2009, about 35 days after the first column was installed, and about 22 days after excavation began, the excavation was completed. The top of the siphon was subsequently cut on August 1, 2009 with success and the lining installed on schedule. See Figures 13 and 14. Once the access chamber was sealed around the siphon, the top half of the siphon (from the crown to the springline) inside the chamber was removed over a 3 m length to provide access for the lining process. Following liner installation, a permanent manhole, constructed within the construction chamber, completed the work.

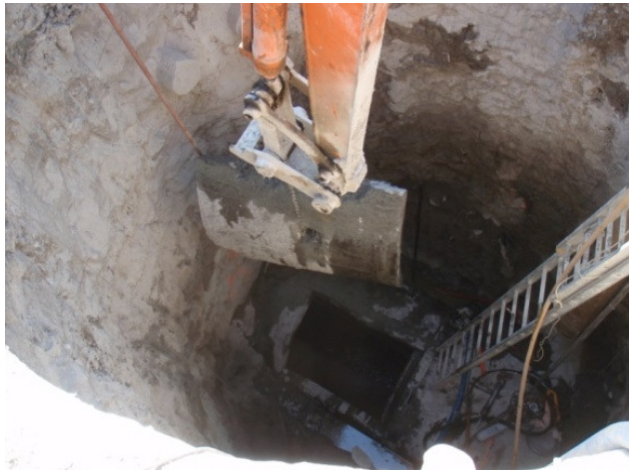
Figure 13. Completed chamber with siphon exposed

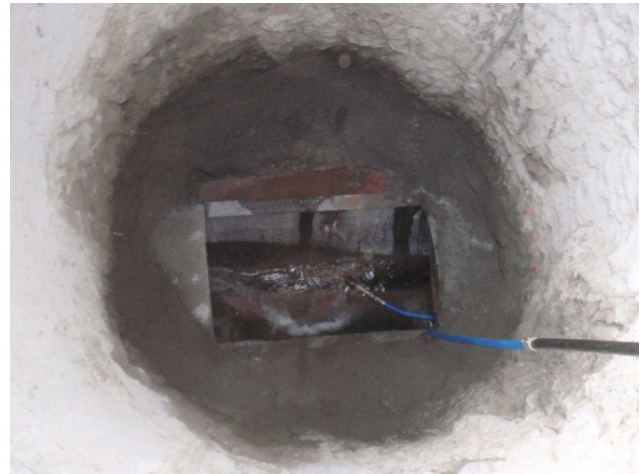
Figure 14. Final opening of the siphon
