Design and Construction of Shore Line Fortification to Protect Main Line Railway Port Hope, Ontario

Colin Alston

Alston Geotechnical Consultants Inc., Formerly Alston Associates Inc., Markham, Ontario, Canada

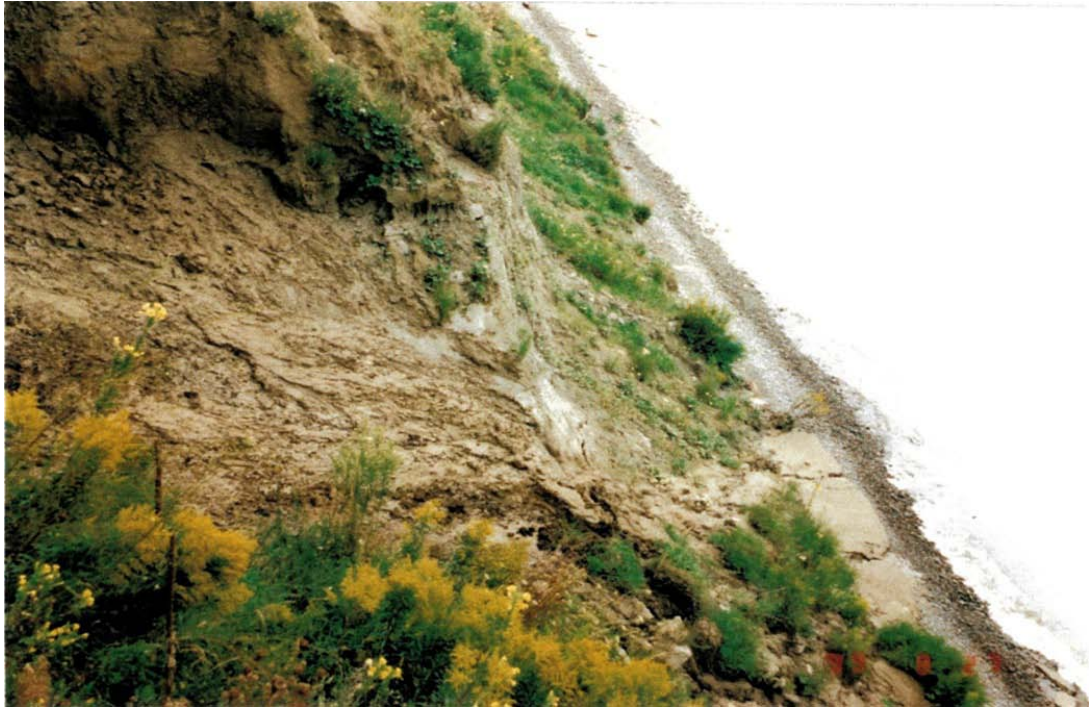
Figure 3. Seepage at Base of Silt/Sand Stratum

metres and in places, extend above the interface of the lower silty clay fill silt to sand to close to the ground surface. Apparent cohesion in the silt to sand soil provides support to the roof of the developed chasms, until gravitational forces overcome the apparent cohesion and collapse occurs. This mechanism results in regression of the portion of the slope which is in the upper soil unit. A photograph showing outwash of soil at the base of a chasm at the slope face is shown in Figure 4.

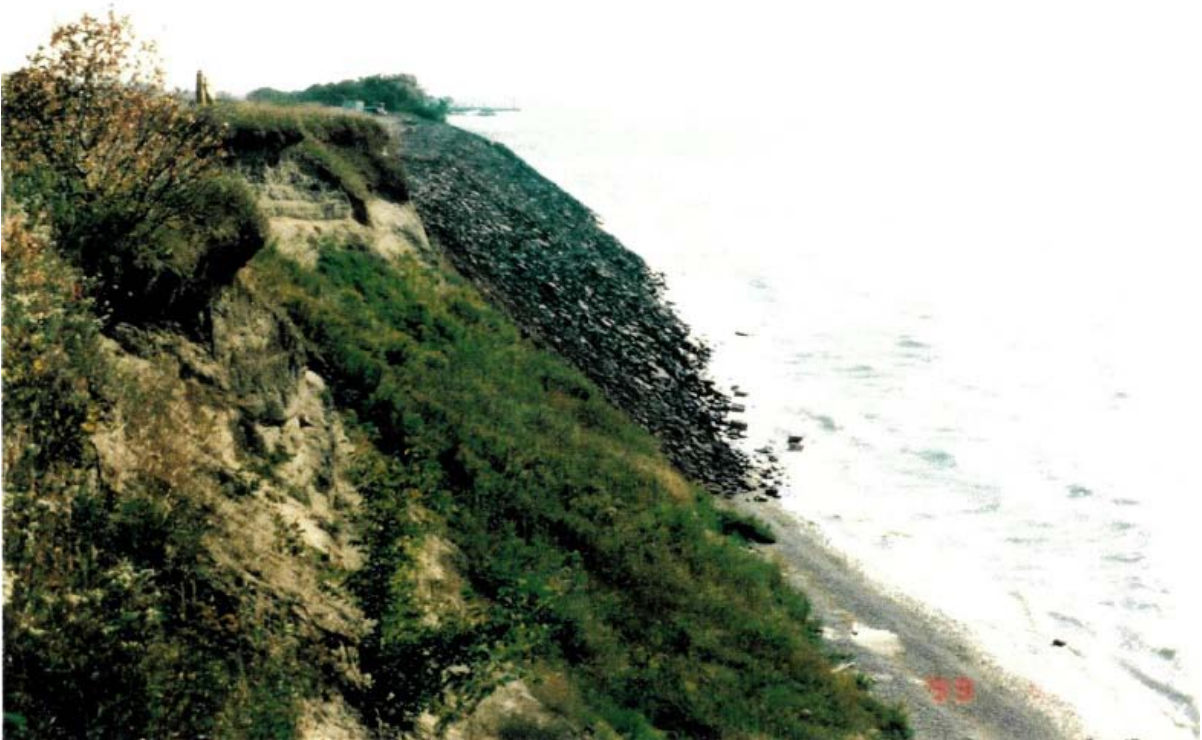
Figure 8. Completed Dynamic Revetment

The rockfill used for construction of the stabilizing revetment was end-dumped from trucks near the crest of the shoreline slope and pushed over the crest with a small dozer. The rockfill was placed in sufficient quantity to enable the material to establish intimate contact with the slope, and to develop its natural angle of repose. A photo illustrating the completed revetment is given in Figure 8.
