# Characterization of armour stone breakwater through a freeze-thaw resistance approach

Philippe Morin and Guy Dionne  
GHD, Rimouski, Quebec, Canada

## ABSTRACT

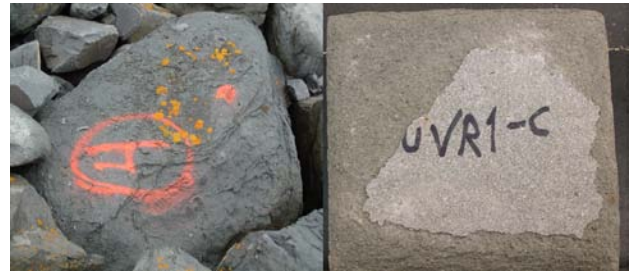
The before and after photographs of the rock slices are inherently quite eloquent for stone degradation; the test for resistance to freeze/thaw cycles appears to be more representative of the conditions observed on the deteriorated stones along the main wharf and the breakwater, particularly on stones made of sandstone and dolomite.

The photographs reveal noticeable damage along the edges of the sandstone rocks. Although the percentage of loss does not appear as significant, the degradation of the sandstone with respect to the freeze/thaw cycles is visually noticeable on some of the observed slices. Figures 2 and 3 illustrate examples of degraded stones observed and sampled on the structures compared to samples from their respective quarry having been subjected to the freeze/thaw test.

Figure 2. Photographs of disaggregated sandstone from the breakwater (left) and after the freeze/thaw test (right)

The sandstone rock slices, despite representing a relatively small percentage loss (0.90 on average) were also visually more altered at the end.

Regarding altered and crumbly sandstone observed on the breakwater, the test of resistance to freeze/thaw cycles conducted on its quarry samples was able to partially reproduce in the laboratory the alteration that could be observed on the breakwater armour stones.

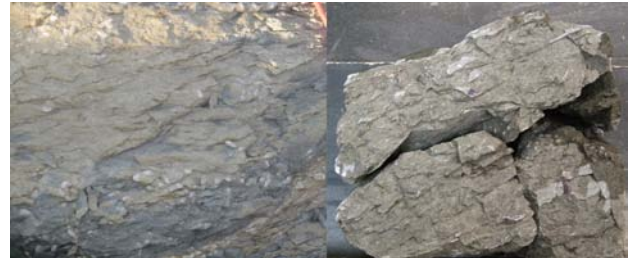
The results show that the dolomite samples are far less resistant to the freeze/thaw cycles as opposed to the other two quarries.

Figure 3. Photographs of disaggregated dolomite located on the wharf (left) and after the freeze/thaw test (right)

The freeze/thaw resistance test (ASTM D5312) proved very useful for the analysis of stones originating from the quarries. Thus, the deterioration phenomena observed during our visits to the various structures have successfully been recreated in the laboratory. Photographs for several slices of rock originating from the dolomite quarry that were put in place on the Rivière-au-Renard's wharf showed an accelerated deterioration following the 56 cycles of freeze/thaw.

According to the laboratory tests on samples from the dolomite quarry, it appears that these stones produced should not have been put in place on Rivière-au-Renard's wharf. The test for resistance to freeze/thaw cycles clearly revealed that the dolomite did not resist well enough to freeze/thaw cycles. Even crystalline fossils consisting of calcite, despite generally a mineral known not to be of a high resistance and that dissolves faster than its host rock, resisted better than dolomitic matrix. Moreover, even if the fossils present in the rock resist better to freeze/thaw, the presence of the latter also causes additional plans of weaknesses in the rock.

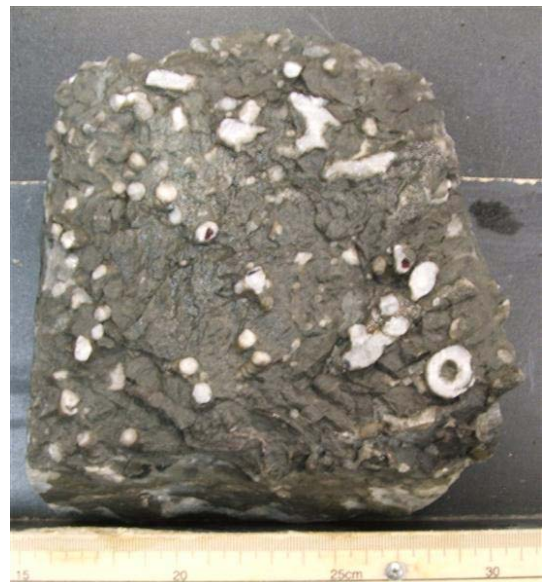
Concerning the dolomite rock slices, the percentage of loss at the end of different cycles does not seem to depend on the amount of fossils they contain since samples having a larger percentage loss were not necessarily those with a significant amount of fossils. Considering the dolomitic nature of the rock's matrix, it would appear more relevant to associate dolomite or one of its components to the low resistance of these slices of rock. This fact can easily be verified when observing Figure 4 which represents the state of the rock after 56 freeze/thaw cycles. It shows that mainly the dolomitic matrix was disaggregated and not the calcareous fossil compounds, which show a positive relief.

Figure 4. Photograph of a fossil rich dolomite sample after the freeze/thaw test.
