# Instrumenting and Monitoring a Slow Moving Landslide

Matthew Schafer, Renato Macciotta, Michael Hendry & Derek Martin  
*Department of Geotechnical Engineering – University of Alberta,  
Edmonton, Alberta, Canada*  
Chris Bunce & Eddie Choi  
*Canadian Pacific Railway*  
Tom Edwards  
*Canadian National Railway*

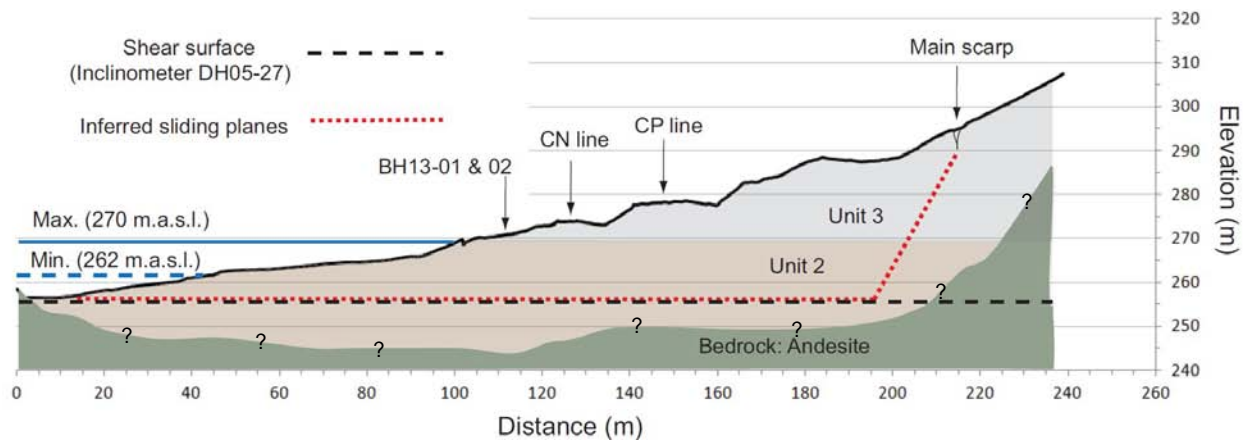
Figure 2: Section view of the Ripley Landslide showing stratigraphy of the slide and the distinct failure surface which occurs in glaciolacustrine clay deposits (after Hendry et al. 2014).

Figure 2 shows a simplified cross section of the landslide. The instrumentation discussed in this paper is located downslope from the CN line at an approximate elevation of 272.8 m. At this elevation, there was a veneer of alluvial floodplain sediments (0 m to 2.3 m depth), underlain by a layer of glaciolacustrine sediments (2.3 m to 30.5 m depth), and an andesitic bedrock. The glaciolacustrine deposits encountered were deposited following two different periods of glaciation. The first

deposit occurred in the Pleistocene and can be found below 10.5 m depth. The remaining glaciolacustrine sediments are assumed to have been deposited prior to the Pleistocene glaciation.

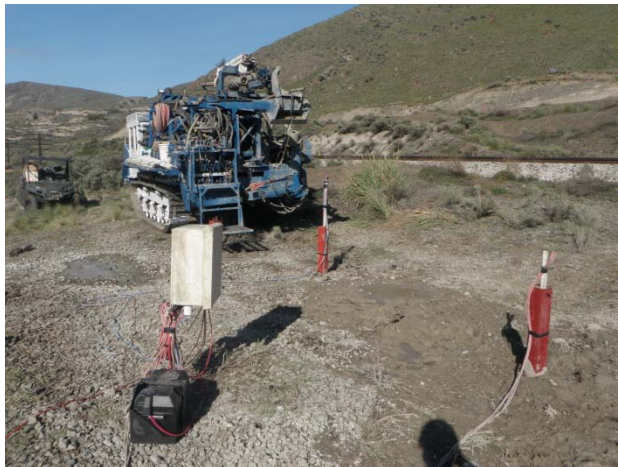
Figure 4: Piezometer and Shape Accel Array installation at the Ripley Landslide in April 2013.

Figure 4 shows the finished instrument installation and data logging equipment.

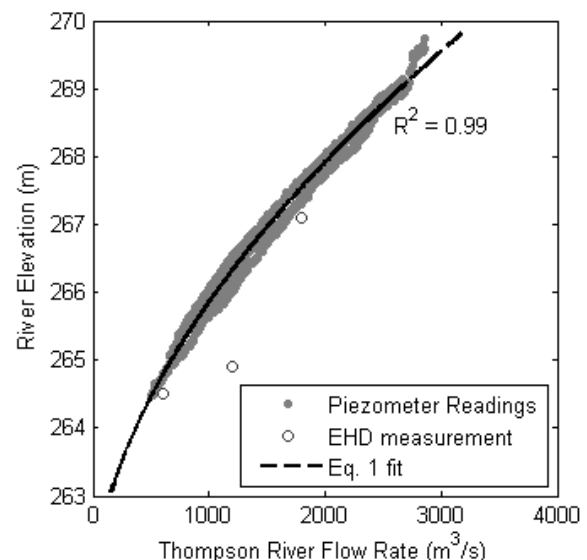
Figure 6: Correlation between river elevation measurements and flow rate of Thompson River at the Ripley Landslide.

The measured water levels are presented in Figure 6 with the revised rating curve. The three river elevations used to calibrate the previous rating curve are also plotted (EHD Consulting Ltd. 2008).

The revised rating curve has a higher datum by approximately 1.1 m. The previous rating curve was calibrated based on the three plotted values from EHD Consulting Ltd. (2008). Note that one of those measurements is an outlier and it is well below the curve developed from the piezometer measurements. The previous rating curve datum was skewed by this low point. The cause of the anomalous point is unknown. The data at higher flow rates also departs from this trend. This could be attributed to unsteady flow conditions at high discharge volumes (Dottori et al. 2009). A comparison of the recorded river level to the level predicted by the revised rating curve yielded a maximum difference of 0.3 m. This agreement led to the conclusion that the rating curve could be used to predict the river level throughout the year.

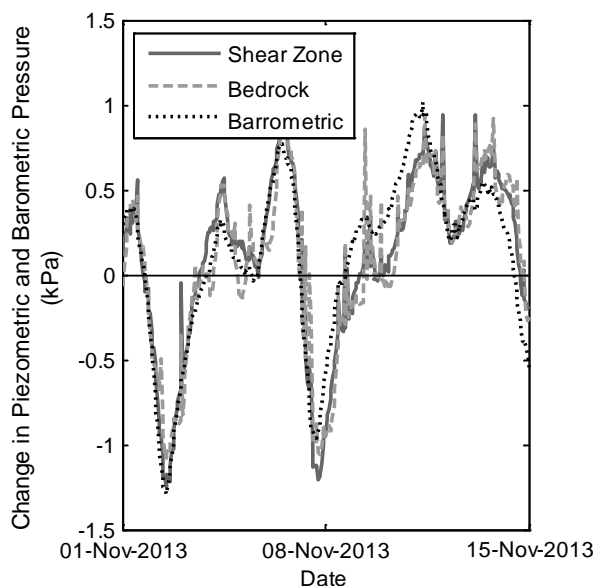
Figure 7: High Frequency Variation of Pore Pressure and Barometric Data

The raw pore pressure and barometric pressure data (Environment Canada 2013) were filtered using a 10-day moving average which removed the high frequency variation of each data set. The difference between the raw data and the filtered data was then compared to determine if the high frequency variation of pore pressure corresponded to the high frequency variation of barometric pressure. Figure 7 shows a portion of this data.

The value of barometric variation was multiplied by a scalar factor of 0.8 to match the amplitude of the pore pressure variation. The high frequency variation resulting from barometric pressure change can be compensated for by subtracting the barometric variation from the raw pore pressure data.
