CATHEDRAL MOUNTAIN 2014 ICE FALL AND DEBRIS FLOW

¹Arenson, L.U., ²Bunce, C.M., ³Gauthier, D., ⁴Guthrie, R., ³Hutchinson, J., ¹Jakob, M., ⁴McGregor, C.

¹BGC Engineering, Vancouver, Canada; ²Canadian Pacific, Calgary, Canada; ³Queens University, Kingston, Canada; ⁴SNC-Lavalin, Calgary, Canada

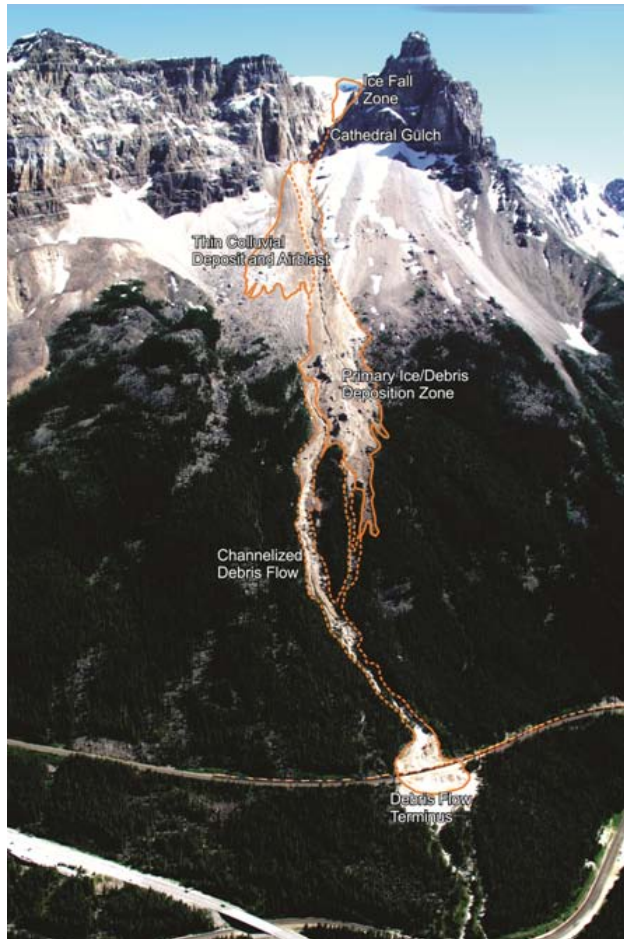
Figure 2. Overview of Cathedral Gulch showing the debris flow and two of the three CP tracks and the TransCanada Highway. The glacier is just visible above the Gulch.

At 06:30 on July 10, 2014, the CP rail traffic controller reported that a signal fence above the railway at Laggan 128.2 had been tripped (D. Symborski, personal communication, July 14, 2014). The cause was an ice fall from the Cathedral Glacier which had been channeled down Cathedral Gulch and transformed into a debris flow that ultimately crossed the uppermost level of the CP mainline (**Figure 2**).

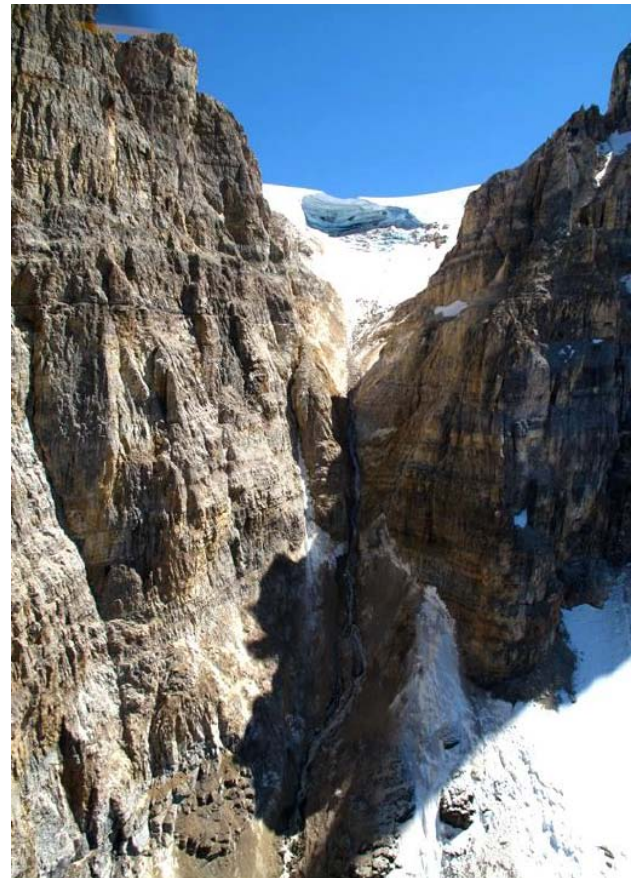
Figure 4. The ice fall into Cathedral Gulch.

A wedge-shaped piece of ice broke off the glacier and fell into Cathedral Gulch (**Figures 3 and 4**). The volume of the wedge was estimated as 100,000 m³ based on visual assessment. The mass of ice broke apart over bedrock below and mixed with sediment on the landing slope. The ice fall allowed the supra-glacial lake to drain and initiate a debris flow downslope. Entrainment was limited, however, as most of the material was derived from the main V-shaped gully. On the upper colluvial slope, the debris flow was largely confined to a channel less than 100 m wide, with only a thin layer of sediment deposited on the surrounding slopes. The majority of ice and debris deposition occurred at a slope break above the tree line between the elevations of 2,000 and 2,400 m (**Figure 2**). Water and debris continued to flow downslope through the historical debris flow channel and the trees.

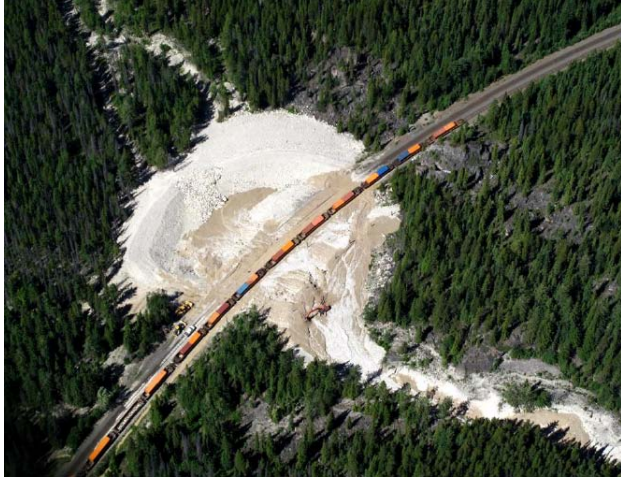
Figure 5. Sediment basins above and below the CP tracks. The first basin and the tracks were overrun.

Sediment overwhelmed the first debris basin upslope of the track, then overran the first level of the CP mainline and deposited into a second debris basin downslope (**Figure 5**) built to protect the two lower tracks and the TransCanada Highway. While much of the debris flow

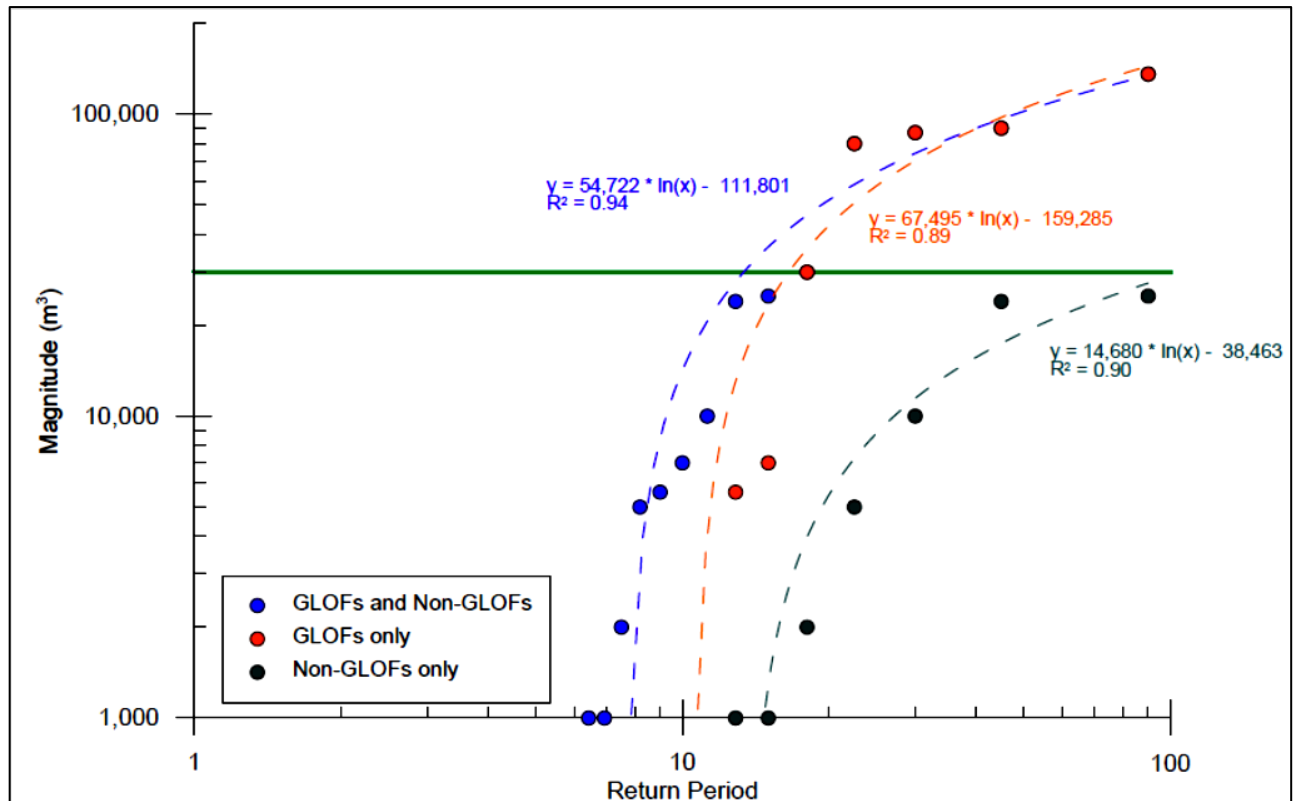
Figure 8. Magnitude-cumulative frequency (MCF) curves for Cathedral Gulch debris flows. The green line at a magnitude of 30,000 m³ identifies the designed capacity of the upper debris basin.

In recognition of different data populations, the MCF method was applied to the events thought to be rain-fall generated and those that were assumed to be GLOF-generated debris flows. The decision as to the triggering mechanism was based largely on the literature (Jackson, 1979, 1980 and Jackson et al. 1989 as well as CP's records that referred to the most likely triggering mechanism). A logarithmic function was fitted to the data. Errors of up to 30% for such volumetric estimates can be expected but are not shown.

Figure 7 indicates that for a given volume, GLOF-triggered debris flows are more common than non-GLOF debris flows. Based on information from CPR, the design capacity of the debris basin upstream of the mainline is 30,000 m³. Table 1 indicates that nearly six GLOF-triggered debris flows of this size would occur for every one non-GLOF-triggered debris flow and that the projected design capacity will capture GLOFs for return periods well below that of non-GLOFs.
