Rockfall protection along Highway 403 in Hamilton, ON: A recent re-assessment and application of emerging site investigation methods

David F. Wood

David F. Wood Consulting Ltd., Sudbury, ON

Ontario Ministry of Transportation, Downsview, ON

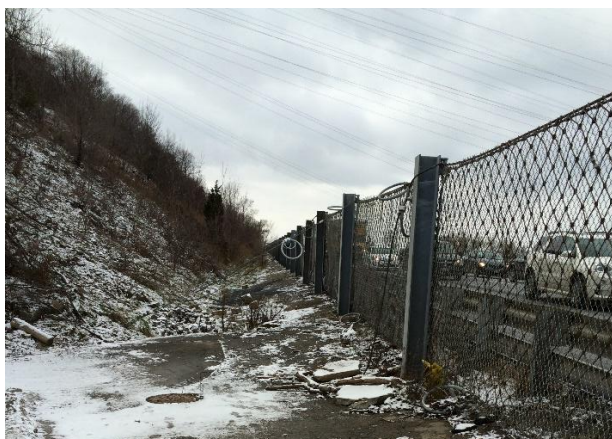
Figure 2. Typical site conditions at highway level, showing the talus slope, ditch, catchment fence, and travelled lanes.

escarpment, within the limits of the City of Hamilton. Engineered rockfall hazard protection extends for approximately 1.5 km through this area, with a combination of a 500 kJ capacity rigid catchment fence and a narrow ditch/clear zone (Figure 2). Following a number of 2-5 m³ rockfall events in 2012, some of which impacted the fence and reached the shoulder of the eastbound lanes, a detailed assessment of the efficacy of the existing protection was proposed by the Ontario Ministry of Transportation.
