3D DATA COLLECTION FOR RAPID ROCK FALL RESPONSE SITUATIONS

Lato, M., Gauthier, D., Quinn, P.
BGC Engineering, Toronto, ON
Hutchinson, D.J., Kromer, R.
*Department of Geological Sciences and Geological Engineering,
Queen's University, Kingston, ON, Canada*
Edwards, T.
CN Rail, Edmonton, AB, Canada
Riopel, J.
IOC, Sept Îles, QC, Canada

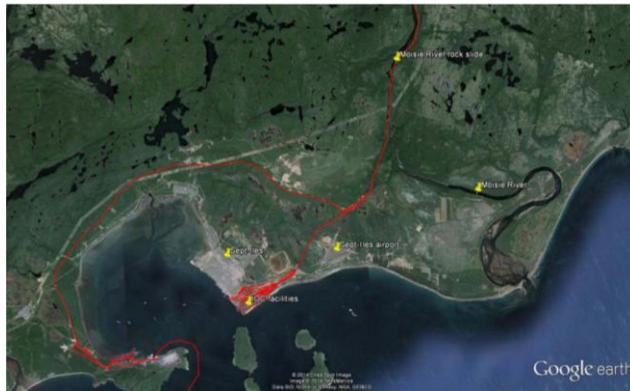
Figure 1. Site map of the Wacouana Mile Post 14.6 rock slide with respect to Sept Îles, QC. Railway tracks in red.

On 8 November, 2014 a rock slide occurred along the east side of Moisie River approximately 20 km NNE of IOC facilities in Sept-Îles, Quebec, at mile 14.6 of the Wacouana Subdivision (Figure 1). The rock slide originated from a WNW-oriented rock slope above the railway track. The rock slide caused damage to the railway infrastructure and resulted in the derailment of an empty ore train travelling northbound (Figure 2).

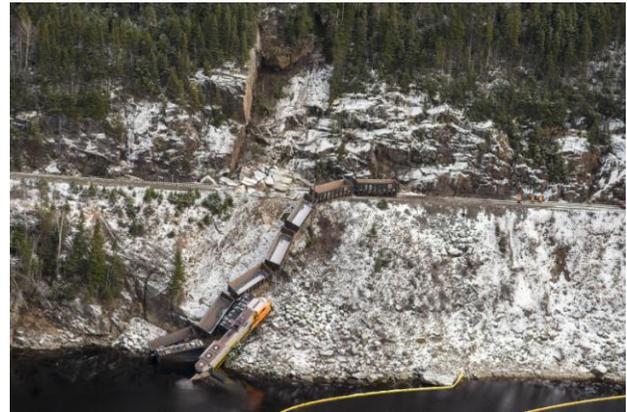
Figure 2. Photograph of the rock slide and train derailment site taken from helicopter on 12 November 2014 (track north is to the left).

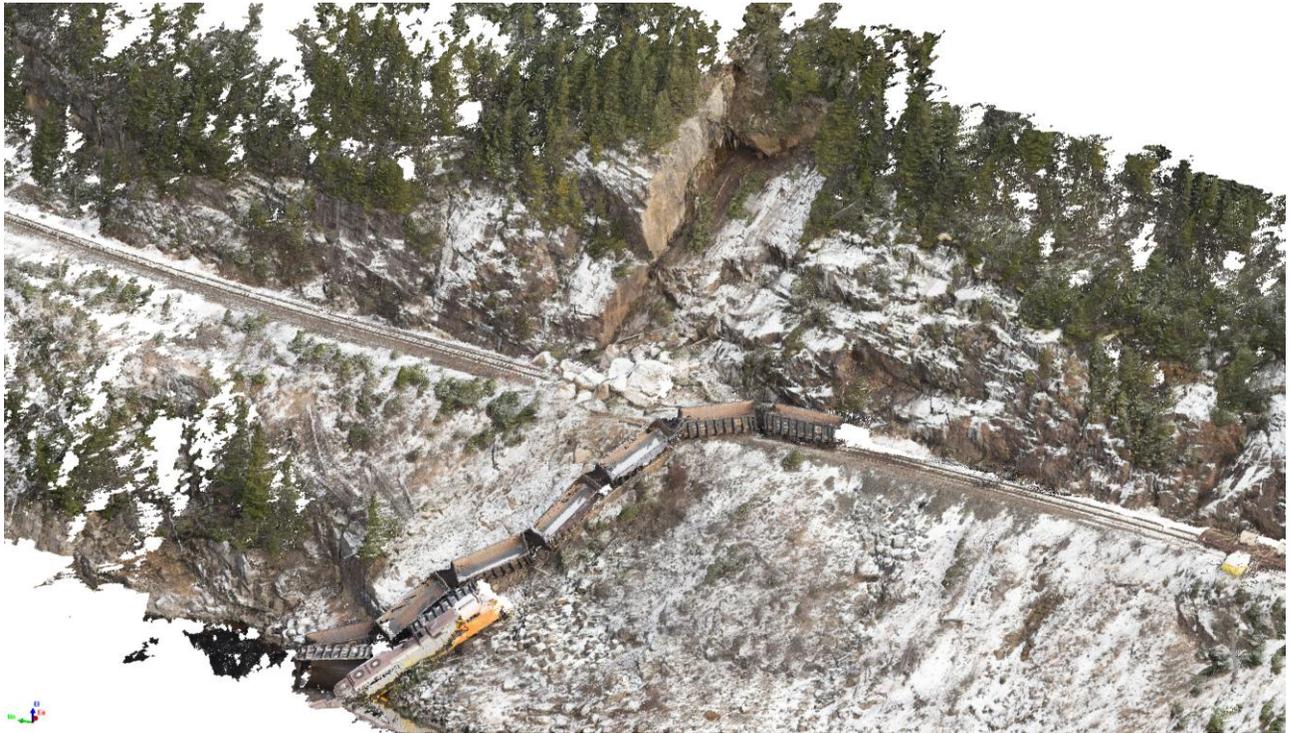
Figure 3. 3D photogrammetry point cloud model of the rock slide and train derailment site

The OAP model was developed within 24 hours of data collection and was used on site during the assessment and analysis phase of the investigation.

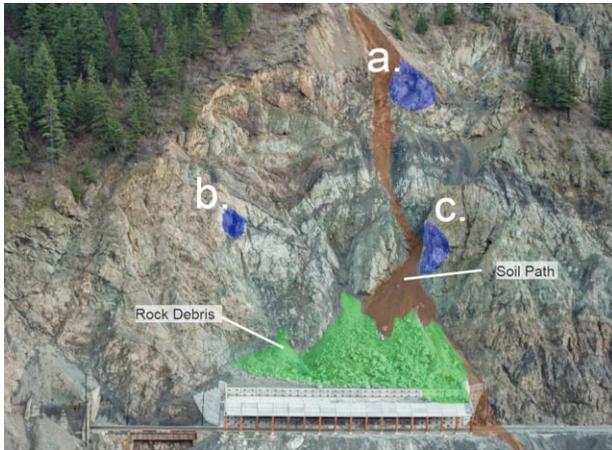
Figure 7. Annotated photograph of the rock fall source zones and depositional regions.

The volume of material loss from the primary source zone (zone "a" in Figure 7) due to the 11 December, 2014

landslide is estimated to be approximately 3,300 m³ of rock and 900 m³ of soil. The proportion of rock versus soil is inferred from pre-landslide imagery and may vary from actual conditions. The deposited material in the accumulation zone above the rock shed barrier wall is approximately 5,900 m³, with an additional 15 m³ on top of the rock shed structure, and one rock with an estimated volume of 2.5 m³ on the ground on the downslope side of the tracks. There are two smaller failure zones (identified in Figure 6 and Figure 7) with source zone volumes of approximately 200 m³ and 250 m³. Both of these smaller failures appear to have occurred in rock (not soil).
