# Secant Piled Shaft Construction and Microtunnelling in Sand

Aiden Horan

Scott Peaker P. Eng.

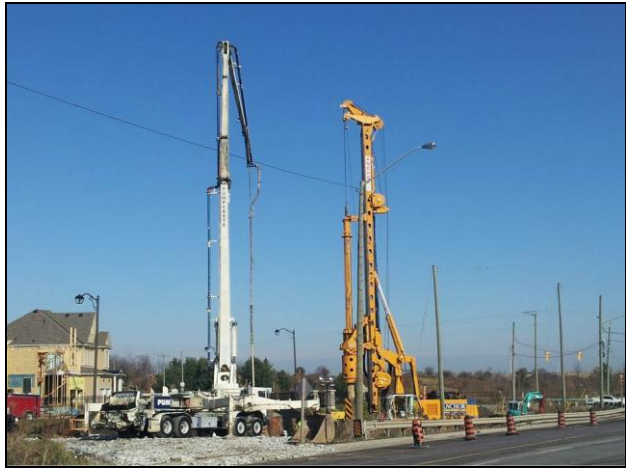
Figure 3.1 - Bauer BG36H & modified 42m (boom length) concrete pump with a 20m long tremie hose attached

As mentioned in Section 1, the shafts were built with secant piles. 1.18m diameter piles were bored to a depth of 18m using a Bauer BG36H piling rig. Excavation of the material below the ground water table was done with a single cut drilling bucket. A steel liner was advanced ahead of the drilling bucket to prevent ground loss. The drilling bucket then excavated the material inside the steel liner. The concrete strength in both the primary and secondary piles was 15MPa. No additional reinforcement was used in any piles and the shaft was self-supporting. There were no supporting walers or tiebacks used. All piles were advanced through a cast in place surface drilling template to ensure accurate positioning of the pile centroids and the Bauer BG36 was equipped with on-board inclination sensors to ensure good interlocking.

For placing the concrete into the excavation, a specially modified 42m (boom length) concrete pump truck with 20m long tremie hose was used. A photograph of the piling rig and the modified concrete pump truck can be seen in Figure 3.1.

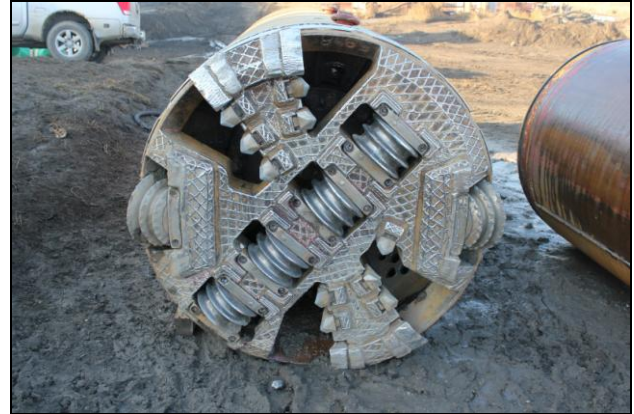
Figure 4.1 - Herrenknecht AVN1200TC with mixed ground cutting wheel attached

The Herrenknecht AVN1200TC, shown in Figure 4.1, complete with a mixed ground cutting wheel was used on the project. The mixed ground cutting wheel has the ability to excavate all soil types from cobbles and boulders to fine silts and clays.

The mixed head contains picks and scoops for fine grained soils which need to be pulled from the parent material and cutting discs for boring boulders and larger, harder obstructions. The openings on the head are medium sized (approximately 250mm opening) so as to allow larger objects fall into the excavation chamber behind the cutting wheel where a rotating arm further crushes these particles down to approximately 50mm in diameter. These particles are then small enough to be transported by the hydraulic slurry circuit to the solids separation plant at ground level. The mixed ground head

The AVN1200TC is the smallest size TBM that an intermediate jacking station (interjack) can be used with. Although the crossing lengths on the project were relatively short (91m & 78m), the ability to install an interjack on any tunnel length in such high risk ground is advantageous. Should the jacking forces after a given distance become too large or show a trend that more jacking force than normal is needed, the interjack can be installed at any point to help.

Access to the rear of the cutting wheel is provided on the AVN1200TC through a central access door. This door can be opened anytime throughout a tunnel drive to inspect the cutting wheel, change the cutter discs, remove obstructions or look at the excavation face. The ability to change the cutting tools from inside the TBM grants the project an additional lease of life that is not possible on smaller sized TBM's. This feature has been the difference between tunnel success and failure in the past and has eliminated the need for a rescue shaft. By upsizing a tunnel at the design stage to incorporate this feature, the chances of tunnel failure or the need for a rescue shaft can be reduced.

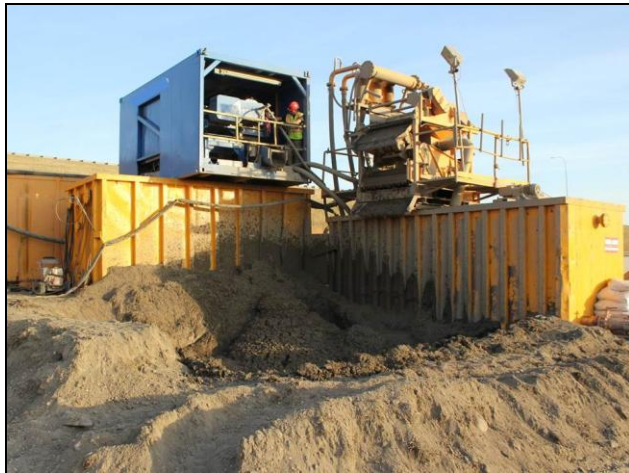
Figure 4.2 - Typical 3 stage solids separation system

The solids separation system consisted of a three part solids removal process. The primary separation system consists of a high G force shaker deck which removes solids down to ~0.45mm in diameter. Slurry water directly from the TBM head is pumped over the first deck layer meaning this deck removes solids ranging in size from 50mm to 0.45mm. The secondary stage of separation involves the use of high pressure hydro-vacuum cyclones which apply a centrifugal force to the slurry water. The cyclones are usually vertical in orientation with the bottom of the cyclone being tapered. The taper increases the velocity inside the cone which causes larger particles to separate from the solution and discharge to the bottom. The cleaner water is caught in an upward spiral in the middle of the cone and is discharged back to the holding

tank. The secondary system is capable of removing solids down to approximately 45µm. The third level of treatment is the centrifuge decanter. The centrifuge operates on the principle of accelerated settling. The slurry water entering the centrifuge is dosed with a liquid polymer in order to create large enough flocs to settle once the centrifugal force is exerted on the liquid. Clean water from the centrifuge is fed back to the holding tank and the cycle is repeated. A continuous and efficient operation of the separation system will mean that the same water can be recycled time and time again for use in the conveyance of cuttings from the TBM. A picture of a typical three stage separation system can be seen in Figure 4.2.

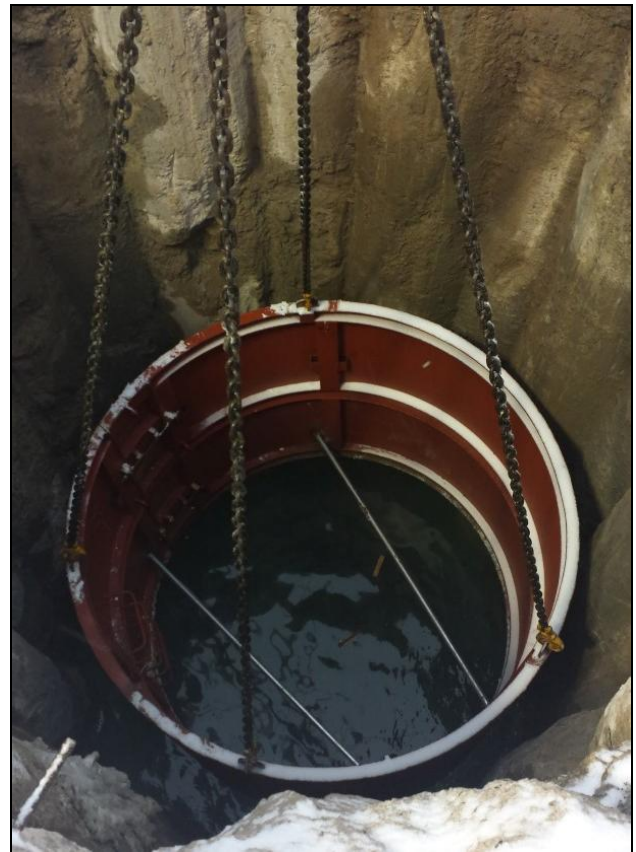
Figure 5.1 Lowering a steel circular form to sit on the tremie plug – concrete poured on outside of steel form

During the inspection of the base and the secant pile interlocking in the R1 shaft by divers in December 2013, it was found that there was an approximately 300mm sq. void along one interlock on the north east of the shaft. The diver could insert his arm and reach to full extension without encountering soil. Even with a 1m long probing tool and his arm at full stretch, he was not able to make contact with any soil. Visibility for the divers was zero and he was relying on touch alone for exploration. It was evident that a void existed outside the shaft although it was thought at the time to be localized. The location of the void in the interlock was at a depth of approximately 14m below the ground surface. The shaft had not been pumped down at this stage and any ground loss had most likely occurred while excavating with the telescopic clamshell. An existing 600mm diameter high pressure watermain was running 1m to the north west of the R1 shaft. The watermain was 3m deep and ran parallel to Mayfield Road.

It was decided that the best course of action was to pour the tremie plug in the shaft and then pour an additional secondary concrete skin inside the secant piles, and on top of the tremie plug to act as a bandage on the

open void. All remedial works had to take place underwater. A picture of the circular steel formwork used to form the underwater patch can be seen as it is being lowered into the R1 shaft in Figure 5.1. The annular space on the outside of the form and the inside of the secant piles was then filled with concrete using a tremie pipe mounted to a 42m concrete pump truck. A diver was at the excavation base for the entire concrete pour and was responsible for guiding the tremie pipe around the formwork and ensuring an even rate of rise. He also placed concrete into the void area. The underwater patch was successfully poured and the opening sealed with concrete.

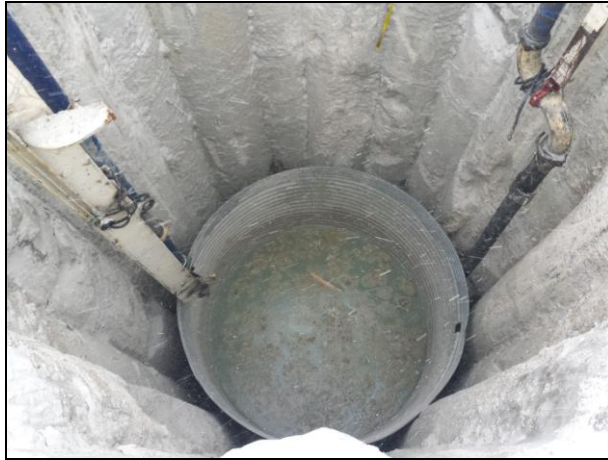
Figure 5.2 - 3.3m diameter corrugated steel culvert pipe used to reline shafts

After returning from the Christmas break in January 2014, a large void was noted at ground level to the north east of the R1 shaft. The volume of this void was approximately 7m<sup>3</sup> and tapered towards the shaft in a half-conical shape. This void at ground level was filled with U-Fill concrete upon discovery. Up to this point, the extent of ground loss was not known. As a precaution, the contractor proposed lining all shafts internally with an additional skin of concrete from the top of the tremie plug to above the water table which was considered the danger zone. Both reception shafts would be relined before any dewatering took place. Given the circular form shown in Figure 5.1 is just 2.5m high, another method of forming the secondary skin had to be used. It was decided to use

3.3m diameter corrugated culvert piping placed vertically to support the concrete. A photograph of this pipe can be seen in Figure 5.2. In order to prevent the culvert pipe becoming unbalanced, two concrete pumps filled the annular area on opposite sides simultaneously. The corrugated steel pipe was also used to line the full height of the R2 shaft even though no problems were uncovered during diving inspections.

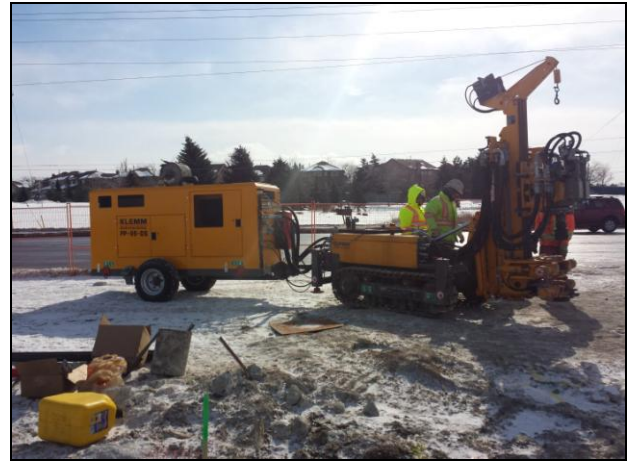
Figure 5.3 - Klemm 702-2 vertical drill used for remedial grouting

Although no voids were discovered during the CPT phase, grouting was required at the R1 location in the eventuality that undetected voids still existed. Pumping out of the shaft water could not take place until it was known that any voids around the shaft had been filled. A Klemm KR 702-2 drill rig was used to drill two 200mm diameter cased holes to a depth of 19m - just below the secant pile depth. This drill rig is shown in Figure 5.3. Throughout grouting, the previously installed UMPs were being constantly monitored to watch for any signs of movement as a result of the grouting operation. As each casing was retracted, liquid grout was poured into the hole until the top of grout was at ground level – then another casing would be removed. This method continued until all

augers had been removed and the top of grout in the hole remained static at ground level. Two holes were drilled and filled in this fashion until both holes had a stable grout elevation. A total of approximately 5.7m<sup>3</sup> of grout was gravity-fed into

the ground. The volume of the drill holes totaled just 1.2m<sup>3</sup>. Therefore, an additional 4.5m<sup>3</sup> of grout had been introduced to voids in the ground. No movement had been observed on the UMPs throughout the grouting operation.

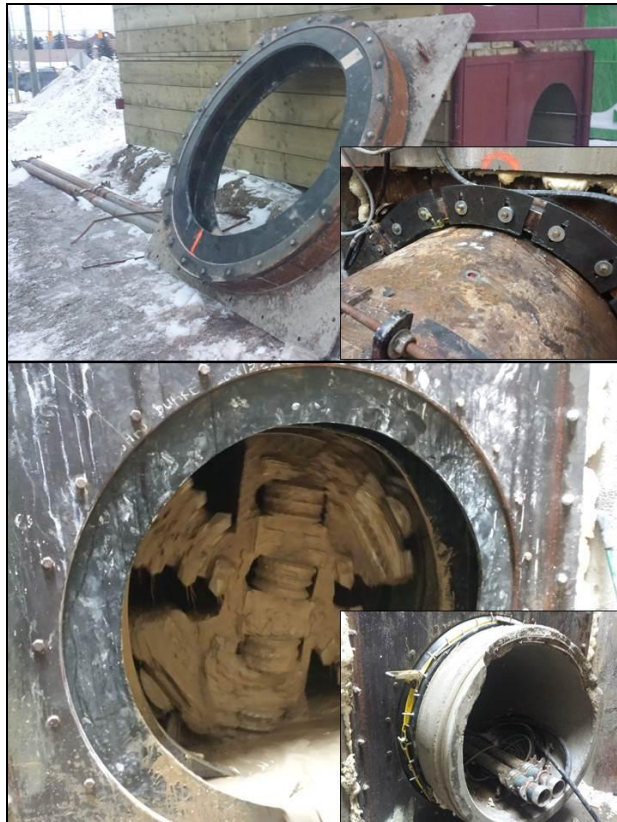
Figure 5.4 Tunnelling launch (top) and reception (bottom) seals

At entry and exit points particularly for deep alignments, the possibility exists for the large confining pressures which are normally kept in equilibrium (at rest) to become exposed to atmospheric pressure which is much less than what is needed to maintain equilibrium. If the seal is breached, the area of high pressure (the ground) will tend to move to the area of low pressure (the shaft). The result is ground loss. A great deal of effort must therefore be spent on keeping both of these zones apart. For this reason, custom launch and reception seals were fabricated to facilitate the safe entry to, and exit from the ground. Double rubber seals were used and are shown in Figure 5.4.

When the TBM is entering the ground from the launch shaft, the natural tendency is for the rubber seal to bend in the same direction as the TBM is moving – in this case towards the virgin ground. This inherently makes the seal at the launch shaft a strong one as the rubber has to

double back on itself before allowing the ground pressure to exit into the launch shaft. Additionally, movable stiffener plates which are shown in the top photograph of Figure 5.4 are closed around the TBM body once the wider cutter wheel has entered through the seal. These plates further prevent the seal blowing back due to ground pressure at the launching side.

As the TBM enters the receiving shaft, the natural tendency is again for the rubber to bend onto the pipe in the direction the TBM is advancing. In other words, the rubber seal moves out into the shaft around the pipe. This is the weakest possible position for a portal seal as it does not require much pressure on the retained side to push its way past the rubber and into the shaft.

Problems were encountered with both receptions whereby ground pressure was able to force its way past both rubber seals. After the failure of the first reception seal, a significant amount was spent modifying the reception seal for the second tunnel. These modifications included the reduction of the internal diameter of the rubber sheets so the sheet would stretch out further on the TBM upon entry. It provided more of a gripping area should additional banding be required around the circumference to stem the inward flow to the shaft. Another precaution taken was that when the TBM hit the receiving shaft pile, it cored into the pile a distance of about 200mm so that it would not sink and then all boring was suspended for one shift. Extremely thick bentonite lubrication with a marsh funnel time of approximately 130 seconds (although difficult to measure at this viscosity) was batched at the launch shaft and injected into the annulus around the TBM head and trailing tube while they were stationary. It was believed that if we could permeate viscous bentonite a distance into the surrounding ground immediately outside the shaft – creating a circumferential filter cake – that it would help support the earth during the critical receiving process. Although the reception of the TBM for the second tunnel was initially less troublesome, significant ground loss eventually occurred once the first concrete pipe emerged through the rubber seal. The rough concrete pipe surface had dragged some dried sand with it and when it emerged through the rubber seal, it allowed water to jet out thereby washing out the sand while feeding it with more from behind.

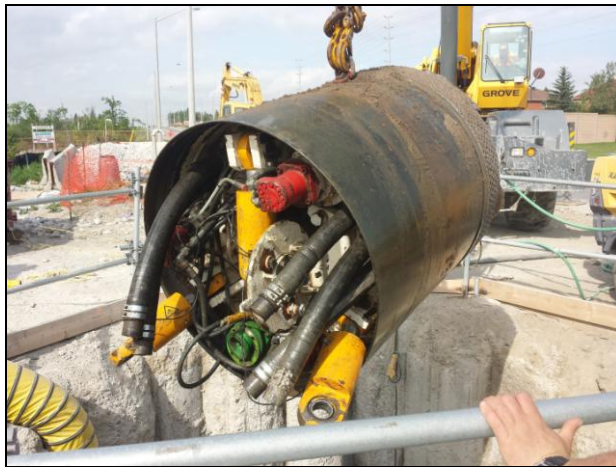
Figure 5.5 Split TBM being removed from R1 (cutting wheel facing away from photograph)

A point worth noting which amplified the ground loss issue beyond what it may have been is that because the reception shafts were now smaller due to the installation of the "bandage" at the bottom of R1 and the steel culvert liner in R2, the TBM could not be removed as one full piece which is the norm. The TBM length is 3.2m. It has an articulated joint in the middle for steering corrections. It is impossible to remove a 3.2m long TBM (1.5m in diameter), from a 3.2m diameter shaft, therefore the radical decision was taken to split the TBM at its steering

joint once it emerged through the reception seal so it could be removed in two 1.6m long pieces. The splitting of a microtunnelling machine at ground level is a complex and arduous task involving heavy equipment, highly trained personnel and many man hours – let alone performing it at the bottom of a 15m deep shaft in less than factory conditions without the proper equipment - twice. The TBM was split in three hours on both occasions, however, during these three hours continuous ground loss was occurring around them as they worked. It is only when the first concrete pipe emerges through the reception seal that the inflow of sand, silt and water can be stemmed permanently. A standard TBM reception should take in the order of 2 – 3 hours. Due to the smaller shaft sizes and splitting the TBM, the receptions on the project took about 8 hours. A photo of the front of the TBM after splitting and being removed from R1 is shown in Figure 5.5.
