# Engineering geology, electrical resistivity tomography and displacement monitoring of the Dawson City landslide, Yukon.

Marc-André Brideau

*BGC Engineering Inc., Vancouver, BC*

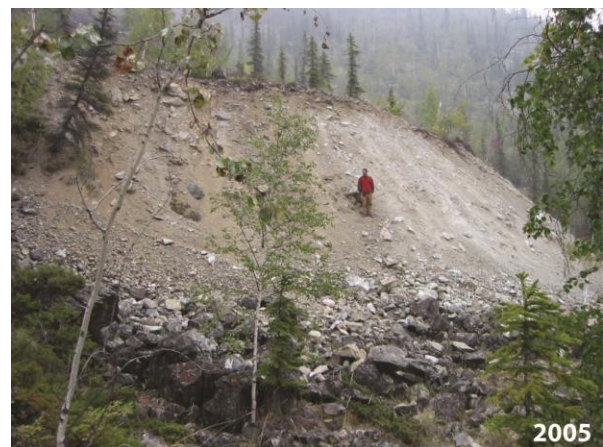
Figure 4: Fresh steep-sided front of the mobile section of the landslide deposit (see Fig. 1 for location).

accumulated at the base of the headscarp. A popular hiking trail crosses the debris talus below the headscarp. The surface of the landslide debris has a boulder carapace that terminates in a steep-sided gravelly front (Fig. 4).

and sand to gravel-sized material that is actively sloughing (Fig. 4). The lower part of the landslide debris was quarried for aggregate in the 1970s and subsequently recontoured. Historical air photographs (NAPL A22199-99,100) show that the distal edge of the debris deposit originally displayed pronounced arcuate ridges.

Three soil samples were collected from the steep-sided front of the landslide deposit shown in Fig. 4. The grain size distribution characterized the samples as a well to poorly-graded gravel. The plastic limit of the fine portion of these samples was between 36 and 45% and the liquid limit was between 69 and 79%, resulting in a plasticity index ranging from 20 to 43% water content. The linear shrinkage was estimated in one sample to be approximately 1%. XRD analysis of the silt and clay-size particles revealed the presence of talc, chrysotile and lizardite.

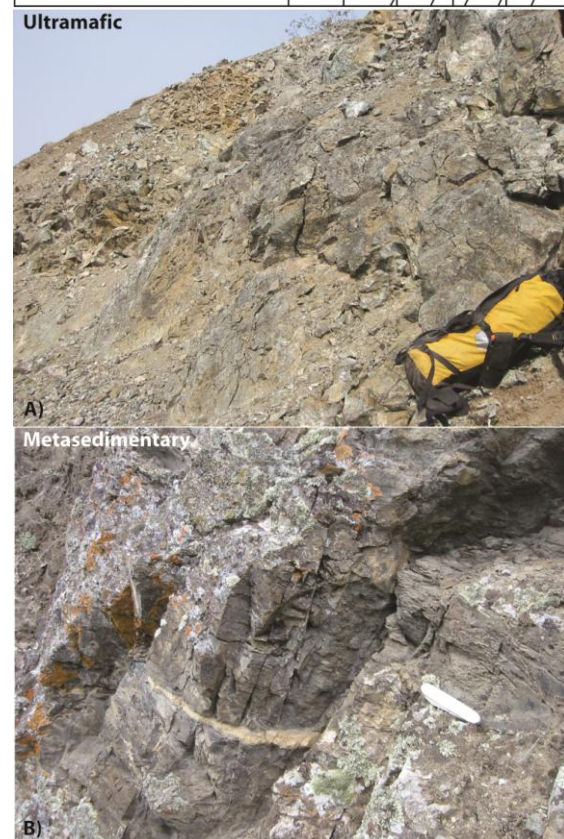
Figure 6: Rock mass quality of the two main geological units at the Dawson City landslide (see Fig. 1 for location).

The geological strength index (GSI) is a classification system that incorporates field observations of the structure and discontinuity surface conditions to quantify the rock mass quality (Marinos et al., 2005). The GSI estimates obtained at the Dawson City landslide vary from 60-70 for the blocky rock masses with good surface condition to 10-20 for the disintegrated rock masses with

poor surface condition (Fig. 6). The spatial distribution of the GSI estimates failed to values reveal a pattern as both the lowest and highest were recorded in the northwestern side scarp and in the headscarp regions of the landslide.

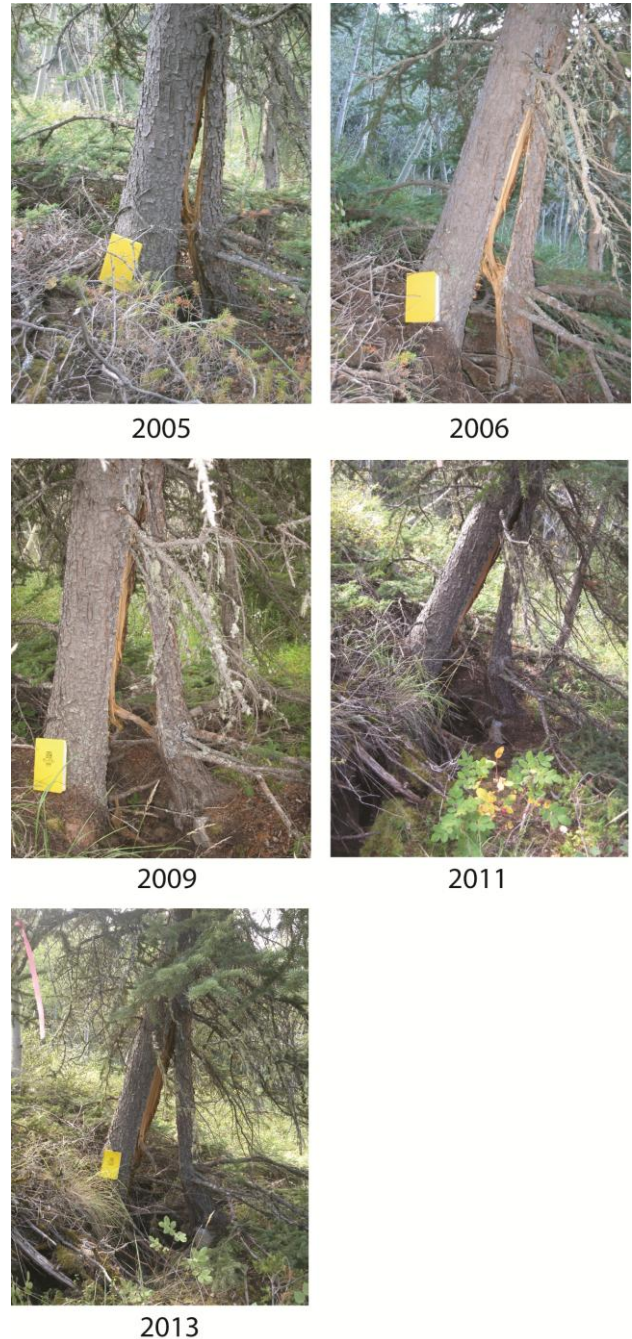
Figure 7: Time series of a split tree in the unstable section above the current headscarp (tree is located at Stn. B in Fig. 1).

An approximately 180 m long tension crack with geomorphic evidence of ongoing movement (disturbed soil and vegetation) was identified by Brideau et al., (2007a and b) upslope from the current headscarp. The volume of the unstable rock mass is tentatively estimated between 45,000-90,000 m<sup>3</sup>. This represents a length of 180 m with a width of 50 m and a depth between 5-10 m. It should be emphasized that this range of volumes is an approximation. Several trees located along this feature have had their trunks split (Fig. 7). Table 1 summarizes the displacement rates measured at stations A, B, C. The rates show that downslope movements of 2-12 cm/year have occurred along a 40 m section of the tension crack.
