# Coquitlam Ultraviolet Disinfection Facility Geotechnical Investigation, Design and Construction Challenges

Anthony Fuller, M.A.Sc., P.Eng., Naresh Koirala, P.Eng.  
Golder Associates Ltd., Vancouver, BC, Canada

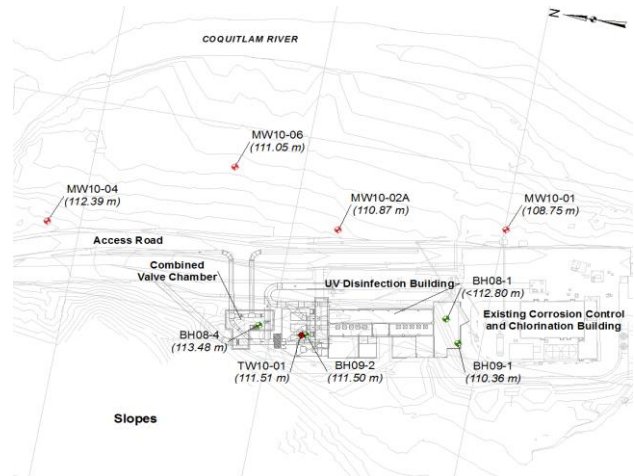
Figure 3. Site plan showing borehole and monitoring well locations.

A preliminary borehole investigation was carried out to obtain subsurface information over the site. It consisted of four mud rotary boreholes (Figure 3). Drilling was carried out using a B-53 mud rotary drill rig equipped with H-rods, open hole advance and a 100 mm diameter tricone drill bit. The Standard Penetration Test (SPT) was conducted in accordance with ASTM D1586-08A at 0.75 m to 3 m intervals within all boreholes in order to collect samples and obtain penetration resistance data on the underlying soils. The boreholes were drilled to depths, which varied from 5.5 m to 13.9 m below the existing ground surface. Two 19 mm diameter PVC standpipe piezometers each with 1.5 m screen were installed in order to allow monitoring of the groundwater level at these locations. Water levels were measured in piezometers manually using an electric water-level meter. Geotechnical index testing, including Atterberg Limits, water content determination and grain size analyses were carried out on selected samples obtained from the investigation.

The supplemental investigation conducted in January 2009 comprised two boreholes (BH09-1 and BH09-2), drilled to 26 m in depth using a truck-mounted Sonic ATV drill rig (Figure 3). Sonic drilling utilizes a dual-cased single tube core barrel system that employs high frequency mechanical vibration to obtain continuous core samples of the soils. Standpipe piezometers were installed in both boreholes to depths of 24.4 m and 15.2 m, both with 3.1 m long screens. Single-well-response tests were conducted in both boreholes to measure hydraulic conductivity of the material within the recharge zone of the piezometer screen.

A total of four monitoring wells were constructed at the locations shown on Figure 3. A track-mounted sonic drilling rig was utilized to advance 150 mm diameter casing to depths ranging from 7.6 m to 18.3 m below ground surface. These were drilled in order to monitor groundwater drawdown at specific distances from the test well, and to obtain additional subsurface information near the Coquitlam River.

A steel-cased Test Well was constructed on the site within the proposed excavation area (Figure 3). A truck-mounted air-rotary drill rig was used to construct a 150 mm diameter steel well to a depth of 25.0 m. The well was completed with a 2.4 m long section of 0.25 mm slotted stainless steel screen installed between 22.2 m and 25.0 m. The Test Well was designated TW10-01.

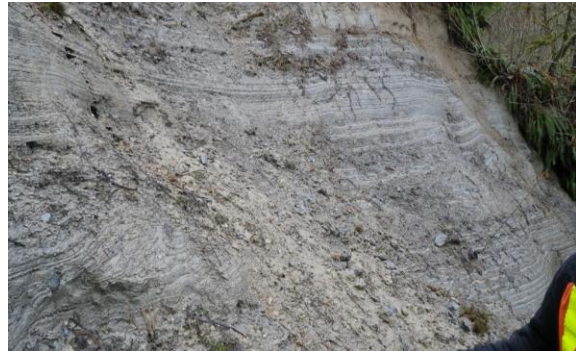
Photograph 1. Surface exposure of varved silt at foot of north slope. Note alternating dark and light layers and gravel.

Field reconnaissance included visual inspection of the site, the terrain and exposures of soils within the valley walls. Till-like and glaciolacustrine varved silts were observed at the foot of the valley wall and on the terraces (Photograph 1). Prominent banding of the soils with alternating lighter and darker silt, clayey silt and sandy silt layers was observed. Occasional gravel and cobble inclusions embedded in the varved silts visible within the exposures indicated drop stones were likely to be present within the body of the silt. Poorly drained swampy conditions were evident at the foot of the slopes. The site for the proposed UVD was a sparsely vegetated fill platform, likely formed by stock piling spoils from excavation for the construction of the adjacent structures. (Photograph 2).

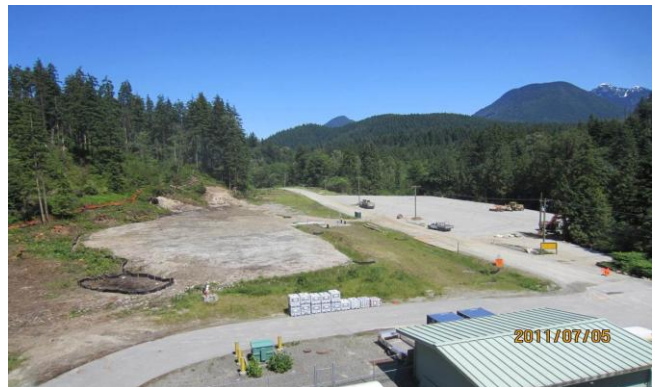
Photograph 2. View of pre-development site looking north. Chlorination building in foreground.

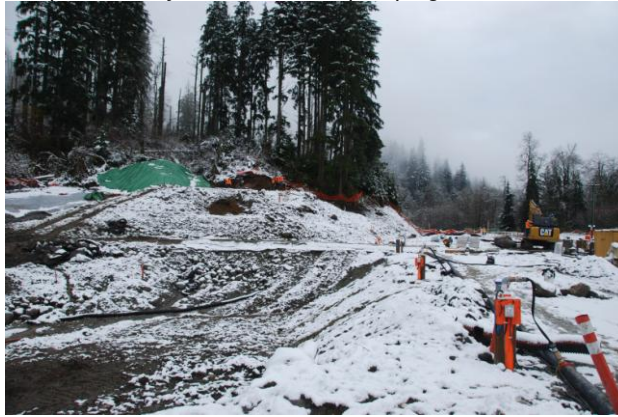
Groundwater control was accomplished with perimeter dewatering wells seated within the deep underlying sand. These were equipped with eductor pumps within wells which pumped to a manifold on surface (Photograph 3). Dewatering wells were installed about a month in advance of full excavation in order to allow piezometric levels to stabilize and to develop some depressurization within the low-permeability silt. Estimated pumping rates based on

Photograph 3. Perimeter dewatering wells.

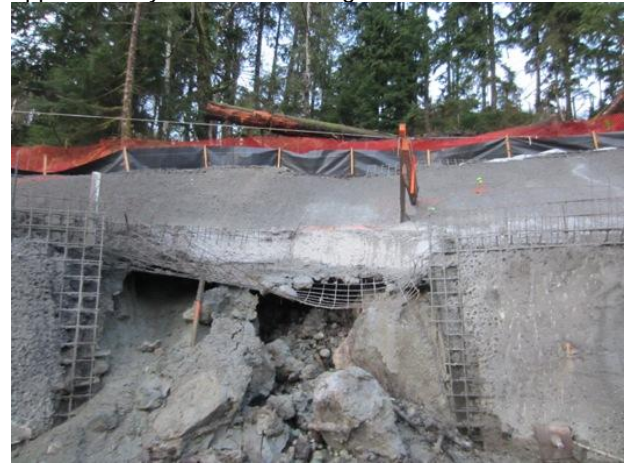
Shoring along the north side of the site required special attention given the significant cut heights and the uncertainty in the subsurface soil and groundwater conditions underlying the slopes which were not accessible for investigation during design. Initial attempts by the contractor to use conventional shotcrete and shoring were unsuccessful, due to severe face instability, loss of ground behind the shotcrete and challenges with managing run off (Photograph 4).

Photograph 4. Collapse of shotcrete facing due to erosion from surface/subsurface flow.

Secant piles (600 mm diameter) were selected during construction to complete the shored excavation in this area. Soil anchors were drilled on 1.8 m centres through the secant piles. Secant piles were drilled to approximately 0.5 m below subgrade elevation.
