A case study of frost action on lightly loaded piles at Ontario solar farms

Pierre-Philippe Levasseur
Golder Associates Ltd., Mississauga, Ontario, Canada
Michael L J Maher
Golder Associates Ltd., Whitby, Ontario, Canada
J. Paul Dittrich
Golder Associates Ltd., Mississauga, Ontario, Canada

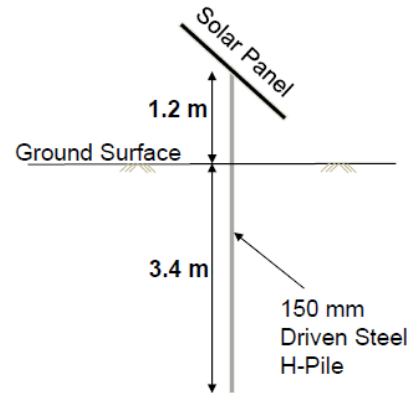
Figure 1. Typical solar panel support pile (Sites A and B).

More than 13,000 piles and 12,000 piles were installed to support the solar panel arrays at Site A and Site B, respectively. The piles consist of 150 mm (6 inch) driven steel H-piles. The piles are approximately 4.6 m (15 ft) long and are embedded to a depth of 3.4 m (11 ft) below ground surface, with a stick-up of 1.2 m (4 ft) above ground surface. The solar panels are attached at a fixed angle to the pile stick-ups (Figure 1). The ground clearance is to avoid snow accumulation over the base of the panel.

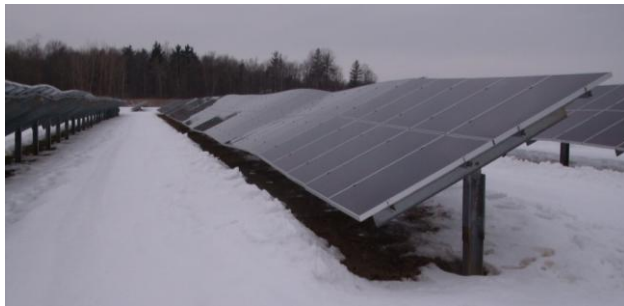
Figure 2. Example of Solar Panel Distortion.

The first winter following construction was relatively cold in southern Ontario. A freezing index of 669 °C-days was recorded for the winter at the closest weather station to the case study site (Environment Canada Climate Data), compared to the average (mean) freezing index of 530 °C-days. Extensive differential movement between adjacent piles supporting the solar panels was observed during the winter. This resulted in distortion of the solar panels (Figure 2). It is worth noting that a series of test piles (pipe piles) had been installed on one of the sites prior to the previous winter. These were monitored for movement and minimal heave was recorded.

The solar panel distortion was most likely the result of frost heave of the upper soils surrounding the support piles. The subsurface soils located within the frost penetration depth at the sites, particularly the silts (ML) and silty sands (SM), are highly frost susceptible. The frost susceptibility of these soil types (based on USCS soil classification) is classified as F4 in CFEM (2006) on a scale of F1 to F4, with F4 corresponding to the most frost susceptible soils. Frost susceptible soils within the seasonal frost penetration zone are subject to the development of ice lenses, resulting in overall heave.

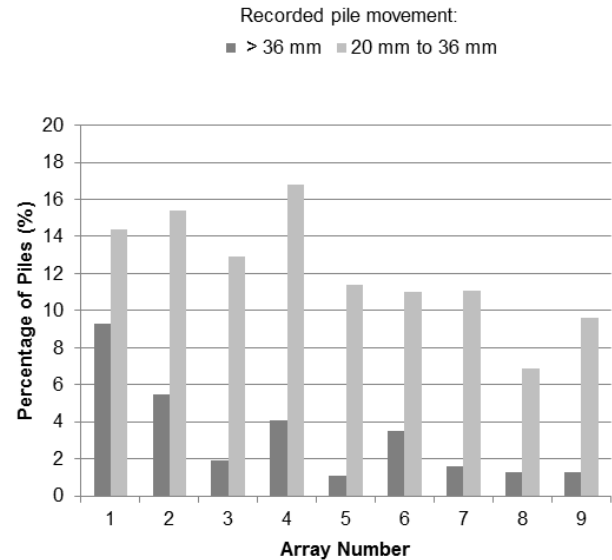
Figure 3. Percentage of piles with recorded movements (heave) in excess of 20 mm (Site A).

The distortion of the panels was more extensive at Site A than at Site B. Within the nine (9) solar panel arrays of Site A, between 1% and 9% of the piles had moved in excess of the structural tolerance of 36 mm between adjacent piles, and 7% to 17% of the piles recorded movement within the 20 mm to 36 mm range (Figure 3). At Site B, generally less than 2% of the piles within the eight (8) solar panel arrays had moved in excess of the structural tolerance of 36 mm, and less than 9% of the piles recorded movement within the 20 mm to 36 mm range (Figure 4).

More extensive pile movements were observed at Site A. The subsurface conditions summarized in Table 1 indicate that almost all solar panel arrays at Site A are underlain by soils with a F4 frost susceptibility (i.e. ML, SM) within the frost penetration depth. Further, Table 1 indicates that soil conditions below the frost depth (i.e. within the lower portion of the pile) are more competent at Site B than those at Site A, with markedly higher Standard Penetration Test (SPT) 'N' values. The more competent

conditions below the frost depth have likely provided more uplift resistance of the piles to resist frost action forces acting on the piles within the frost depth. It is also noted that, within Site A, the largest proportion of piles having moved out of tolerance (>36 mm) was observed within Arrays 1 and 2, where the groundwater levels are highest and have likely favoured more extensive development of ice lenses within the frost penetration depth.

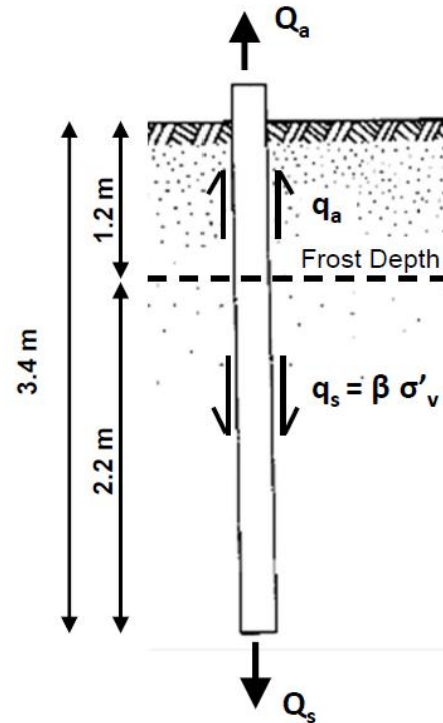
Figure 5. Illustration of (driving) adfreeze forces, Q_a and (resisting) shaft resistance forces, Q_s .

- the adfreeze force (driving force), Q_a , acting on the piles within the frost depth is equal to the shaft resistance (resisting force), Q_s , acting over the portion of the piles embedded below the frost depth (i.e. $Q_a \cong Q_s$, or Factor of Safety $\cong 1.0$, refer to illustration shown on Figure 5);
- the estimated shaft resistance coefficient, β , between the site soils and the driven steel piles (below the frost depth) is on the order of 0.7 to 1.0 (see below);
- the frost penetration depth is equal to 1.2 m (see below);
- the bulk unit weight of the site soils is 19 kN/m^3 ; and,
- the groundwater levels at the site range between depths of 0.2 m below the ground surface to below the pile termination depth of 3.4 m.

Based on the assumed parameters presented above, the ultimate shaft resistance, Q_s , acting on the portion of the 150 mm driven steel H-piles located below the frost depth at the case study site is estimated to range between 22 kN and 58 kN. For an equal adfreeze force, Q_a (i.e. corresponding to a Factor of Safety around unity, as evidenced by the pile heave event), the ultimate adfreeze bond stress, q_a , acting on the piles within the frost depth (see illustration on Figure 5) is estimated to range from about 30 kPa to 80 kPa. Table 2 provides a comparison of the back-calculated adfreeze bond stresses against values provided in literature. Table 2 shows that the estimated (back-calculated) adfreeze bond stresses having acted on the piles during the pile heave event are less than values recommended in the literature. This suggests that either a shallower design depth of frost penetration or adfreeze forces on average much less than those recommended in literature (or both) may have been utilized during the pile design for Sites A and B.

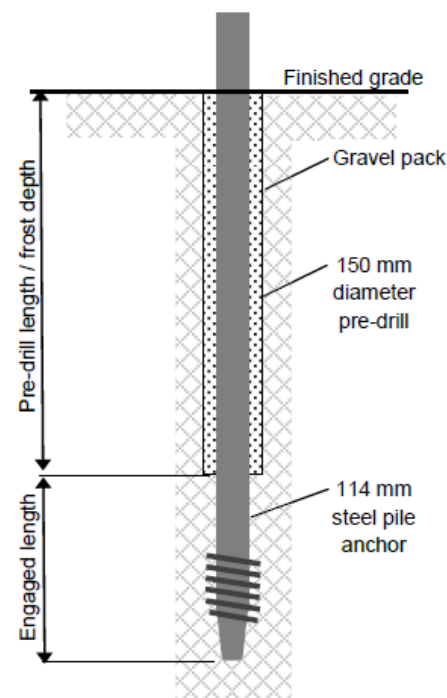
Figure 6. Illustration of earth screw design with pre-drill and gravel pack within frost penetration depth.

An example of difficult piling conditions resulting in failure to implement the intended foundation design was observed at a solar farm site in eastern Ontario. The subject site is underlain by hard silty clay till material containing cobbles and boulders. The foundation design included 114 mm diameter steel “earth screws” which are reportedly used in solar farm applications in Europe. The pile system consists of helical steel piles with small diameter helices. The pile installation for the eastern Ontario solar farm site included pre-drilling (150 mm diameter) within the frost penetration depth, the embedment of the helices within the till below the frost depth, and the backfilling of the pre-drilled annulus with a gravel pack (Figure 6). While the effectiveness of the gravel pack as a bond-breaker to reduce frost loads acting on the piles can be debated, piles constructed as per the design have performed satisfactorily in most cases. However, due to the difficult piling conditions, many pile locations were pre-drilled to the full pile depth and backfilled with gravel prior to the installation of the “earth screws” within the gravel. An excavated pile showing the gravel pack extending to the tip of the pile is shown on Figure 7. The excavated pile also showed notable wear of the helices when compared to the original pile condition. During the first winter following construction, a large proportion of the piles with helices installed within gravel backfill (i.e. within fully pre-drilled holes and not meeting the intent of the original design) have recorded significant heave movements.
