# Terrain analysis for high voltage transmission line routing using remote sensing techniques

Lynden Penner & Shayne MacDonald

*J.D. Mollard & Associates (2010) Limited, Regina, Saskatchewan, Canada*

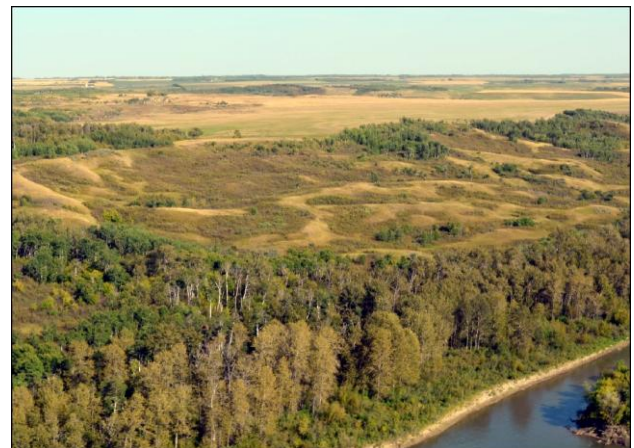
Figure 3. Photograph of historical retrogressive landslide

Figure 3 shows the typical appearance of slump block ridges in this type of failure. Many of the retrogressive failures in the study area appear to have been stable for a long period of time; however, air photo mapping and field reconnaissance confirmed that recent landslides have formed in retrogressive landslide terrain. Reactivated failures in the upper part of the slope (Figure 4) appear to be associated with groundwater seepage from overlying stratified sediments. In one instance a recent failure on the middle to lower slope is associated with bank erosion along the river shoreline.

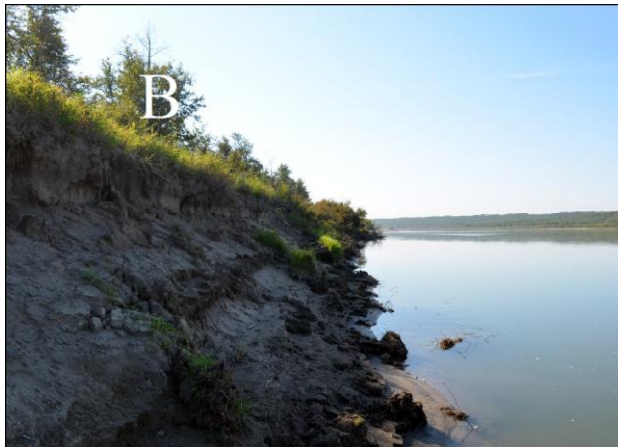
A field visit confirmed the general accuracy of the FlySask DEM. The low terraces are unvegetated or sparsely vegetated with herbaceous plants. Drift wood is present in large amounts in backwater areas behind the low terraces. Slighter higher terraces have small trees with large amounts of driftwood and flotsam caught in them. Even higher terraces have large mature trees with very little evidence of flotsam in them. Public consultation with local landowners also revealed that some of the lower areas experience significant flooding and only in very large discharge years have water levels exceeded the lower terraces and flooded out surrounding land. Figure 8 shows a photograph of the river bank of the North Saskatchewan River. Driftwood and flotsam seen in Figure 9 were observed in the trees above the slope.

Figure 8. Photograph of river bank. Driftwood is located above the bank at location 'A'.

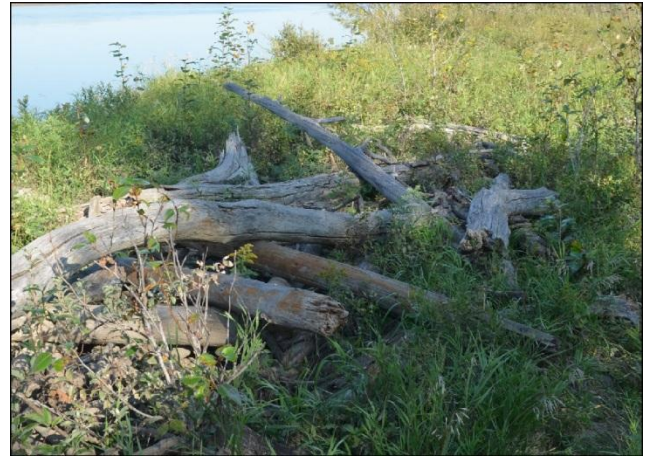
Figure 9. Photograph of driftwood. See location 'B' (Figure 5).

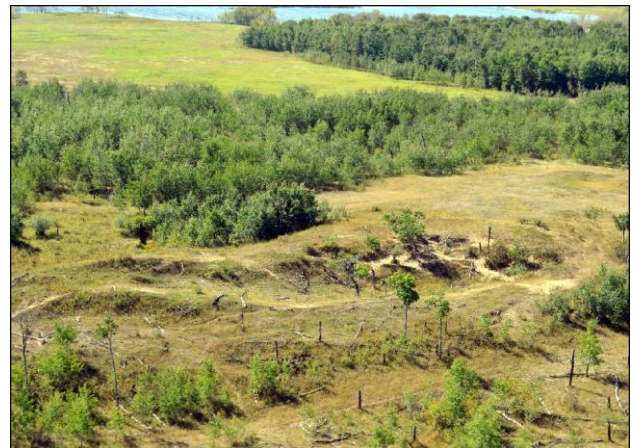
Figure 13: Blowout in a dune ridge on the east side of the river. This blowout is located in an area rated as having very high sensitivity to wind erosion.

Figure 12 shows a LiDAR slope raster in an area of aeolian terrain. Dune forms and blowouts are visible as narrow steep-sided ridges and hollows. Figures 13 and 14 show photographs of aeolian soils in the study area.

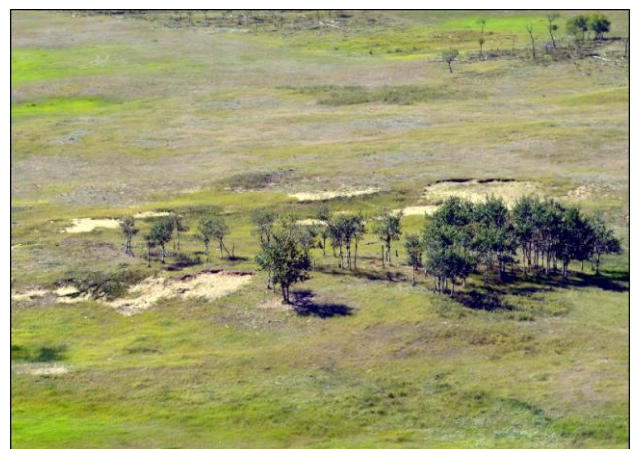
Figure 14: Blowouts on a gently undulating sand plain on the east side of the river. These blowouts are located in an area rated as having very high sensitivity to wind erosion.
