# The Practical Limits of Cold Temperature Geomembrane Installation in Northern Canada

Mills, A., Fraser, B., Gulati, D.  
Layfield Canada Ltd, Edmonton, Alberta, Canada

*Challenges from North to South  
Des défis du Nord au Sud*

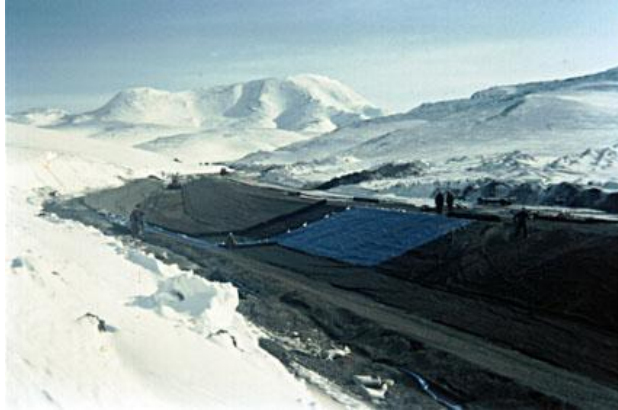
Figure 1. Winter install of RPE stream diversion in Alaska

Since the 1980s a material called Reinforced Polyethylene (RPE) has been fabricated to large sizes for winter installations. Projects using RPE included the stream diversion at an Alaska mine site in Figure 1 and many kilometers of irrigation canal installed in Alberta in the winter in Figure 2.

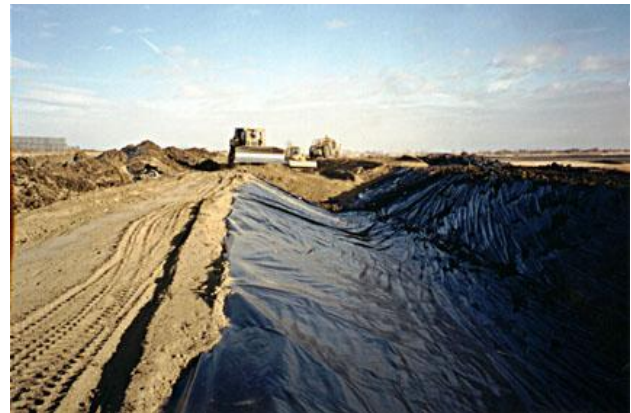
Figure 2. RPE irrigation canals in the winter in Alberta

Seaming of the RPE materials in the winter consisted of overlapping the seams 1.5m and then backfilling. Where additional waterproofing was needed a butyl tape was used in the overlap. For seepage control in fresh water applications these geomembranes were effective for winter installations.

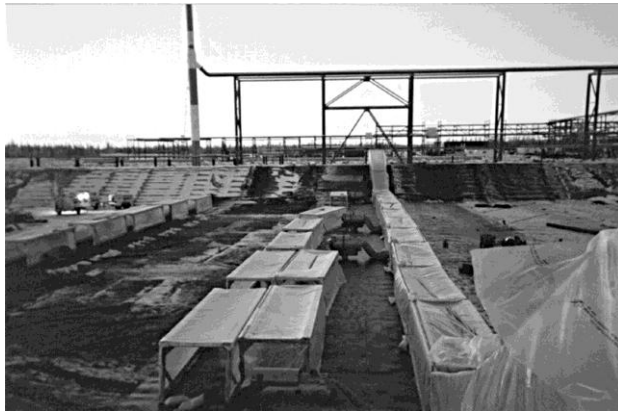
Figure 3. HDPE installation using temporary shelters.

Since 2008 winter installation has become a common practice in Canada. A couple of examples include Figure 3 which is an HDPE installation of a process pond for an oil sands project in northern Alberta. Temporary shelters were used to shelter the welding area. These shelters were helpful under certain conditions however the extra work to move the shelters did not justify their continued use.

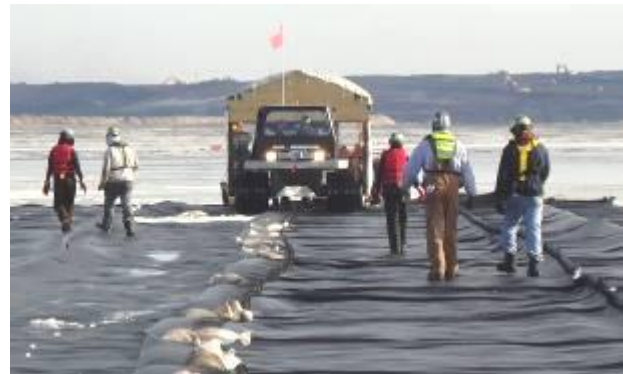
Figure 4. Placement of geotextile on frozen tailings pond.

Another significant winter installation showing the limits of winter weather is in Figure 4. This project was the installation of sewn high strength geotextile on top of a frozen tailings pond. Geotextile sewing machines are sensitive to the cold so this required heating sewing shelters in addition to cold weather deployment. This project was outlined in a paper presented at the Pan-Am CGS conference in 2011 (Mills, 2011).

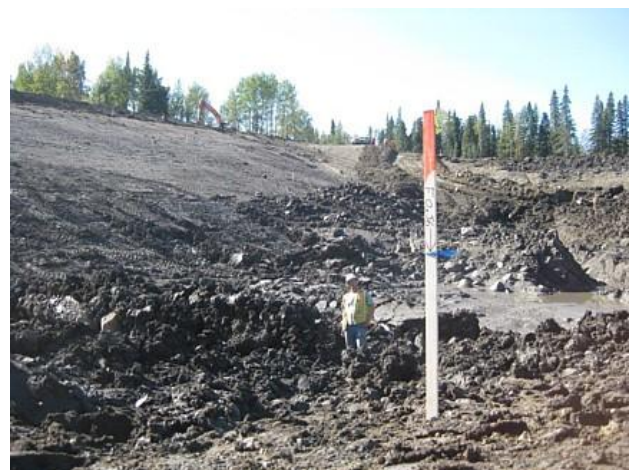
Figure 5. Subgrade preparation in wet conditions.

The project started on October 26<sup>th</sup> with crews on site to weld the HDPE pipe for the sumps. Because the crews were on site early for this preparatory work there is a good photo record of the site preparation. Figure 5 shows the condition of the subgrade in October and Figure 6 shows the final subgrade preparation. The earthwork crews did an excellent job on this project under difficult conditions.

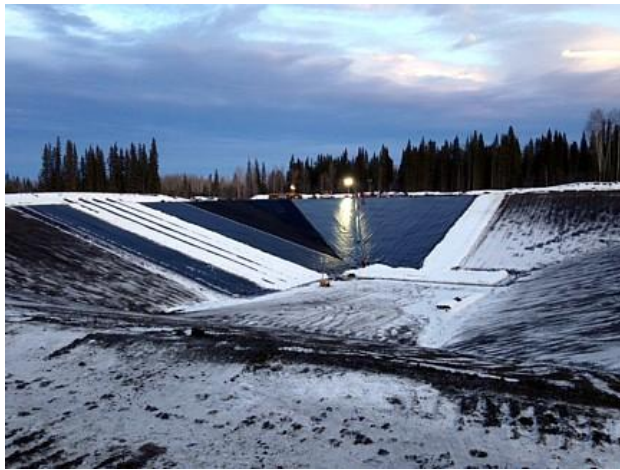
Figure 6. Installation under the lights.

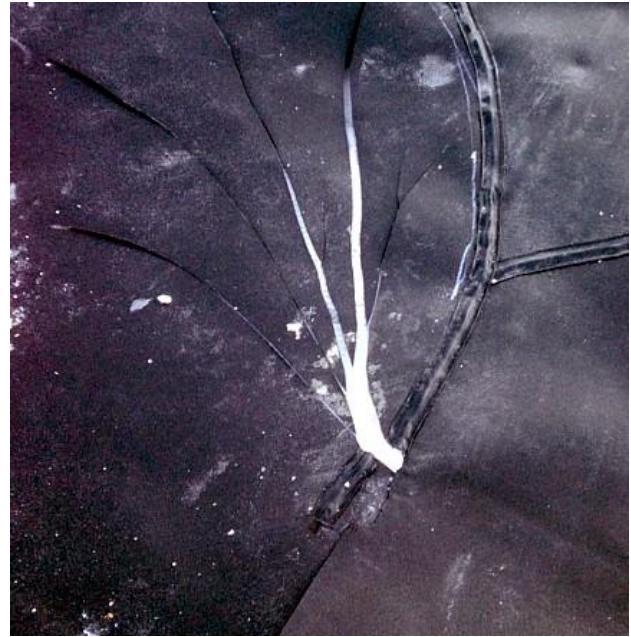
Figure 7. Cracking of the geomembrane.

The area where this cracking occurred was in a complex three-dimensional transition between the corner of the pond and the sump area. A repair was made in this area using smooth HDPE geomembrane.

Again the material was passing the material specifications but problems were occurring during installation. In Figure 7 the cracking is evident next to an extrusion seam. As outlined earlier extrusion seams can develop stresses in the geomembrane especially when cooled quickly. The conclusion was that the extrusion welds were placed at too cold a temperature. Additional temperature monitoring would be put in place to limit problems. Over the following week there were no welding issues as the field crews waited until temperatures warmed to -20C before welding.
