GEOQuébec
2015

Applications of remote sensing techniques to managing rock slope instability risk

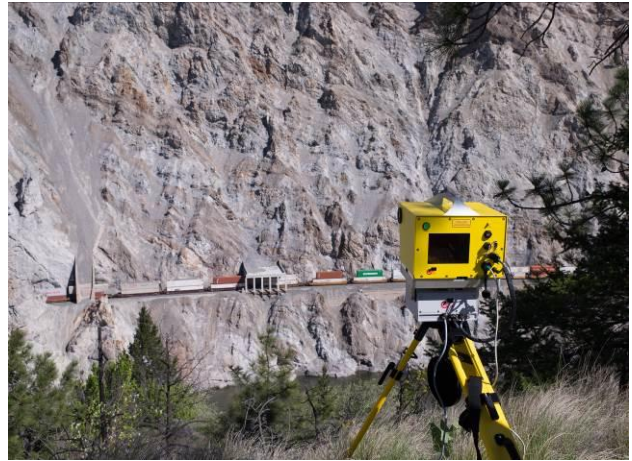
Figure 1: TLS setup in the White Canyon, approximately 350 m from the railway track.

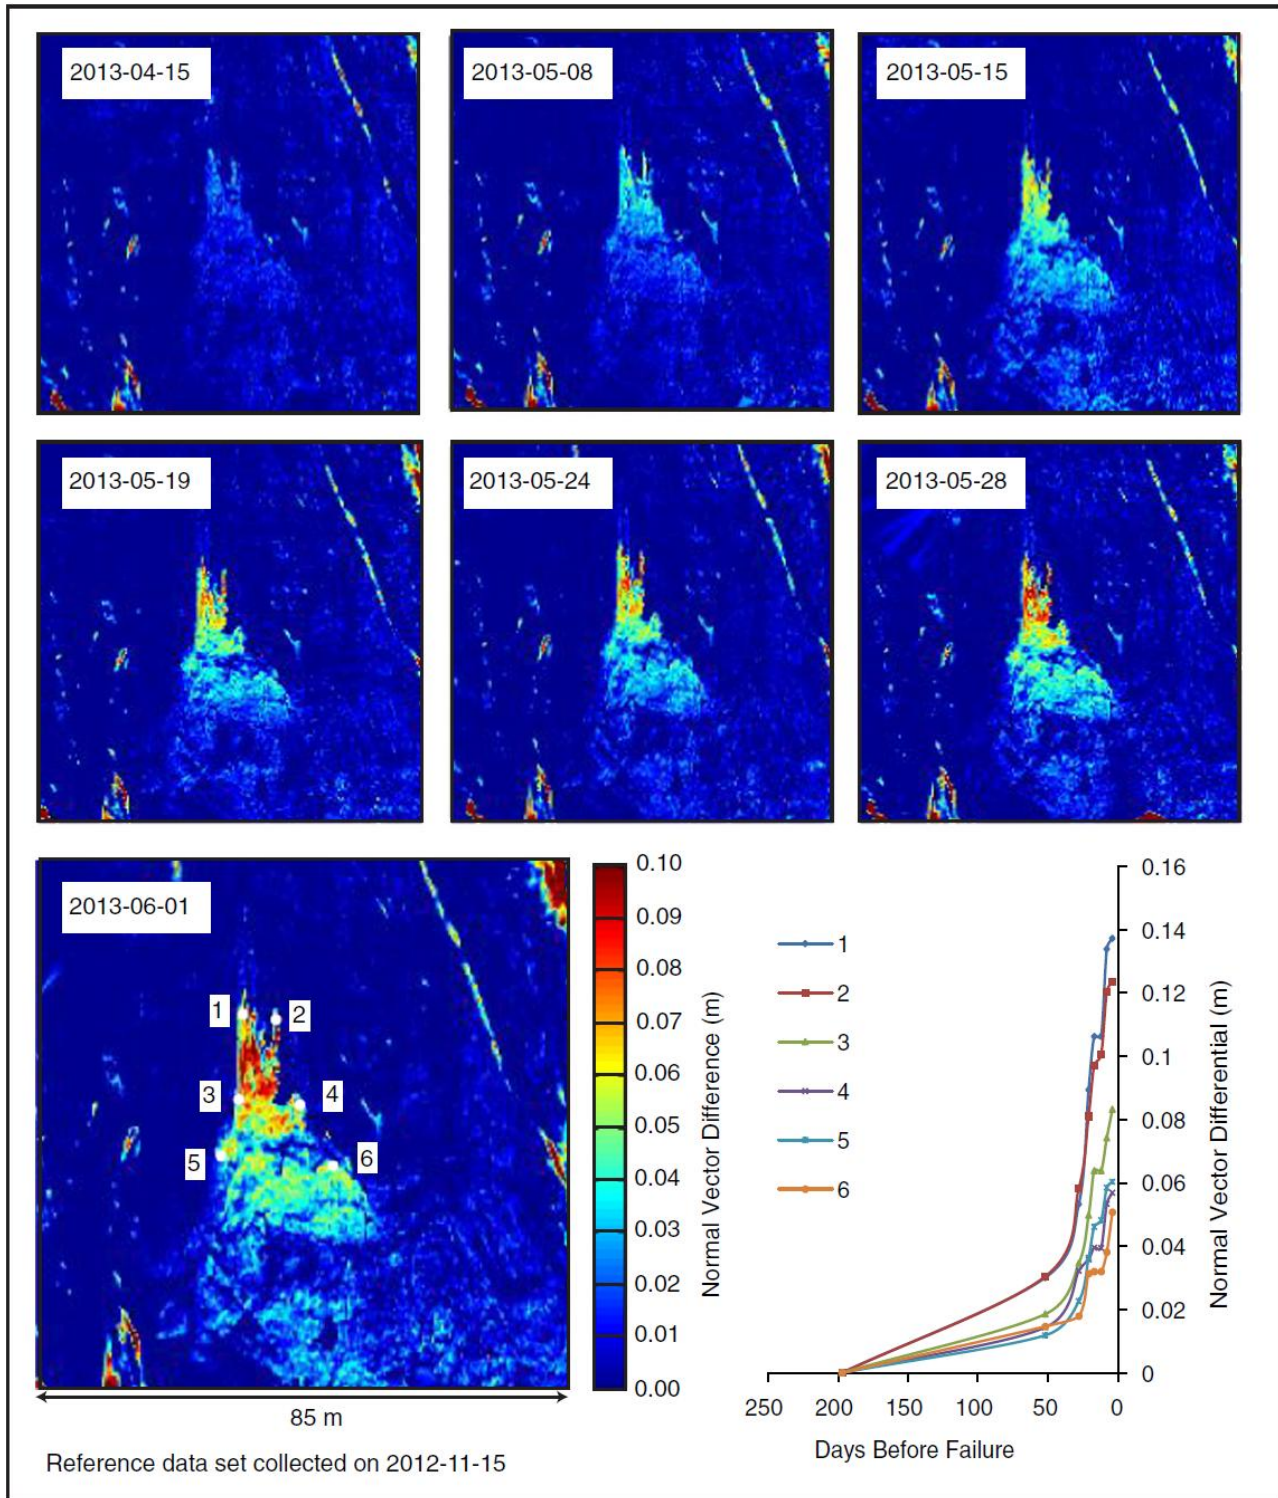
Figure 3: Filtered normal vector differences based on a reference data set collected on 2012-11-20 as compared to each successive scan for Mile 94.2 in the White Canyon, until just prior to the 2600 m³ failure. Bottom right graph of quantitative assessment of differences for points 1 to 6 (from Kromer et al. 2015) shows the larger movements of the top of the block relative to the bottom, and along the left versus the right side of the block.

Upon Kromer et al. (2015) application of the data processing techniques required to assess the specific slope deformation, it became apparent that deformation involving rotation and tilt was occurring prior to the failure, subsequently interpreted to be the result of opening of the back scarp fracture. In addition, it was observed that small volume blocks were moving and detaching from the rockmass around the perimeter of the eventual larger volume block failure (Figure 6). It is possible to track the velocity of movement of individual points on an object, from sequential data sets, as shown in Figure 7. This permits an evaluation of the rate of deformation and may form the basis for time to failure assessment in future cases.

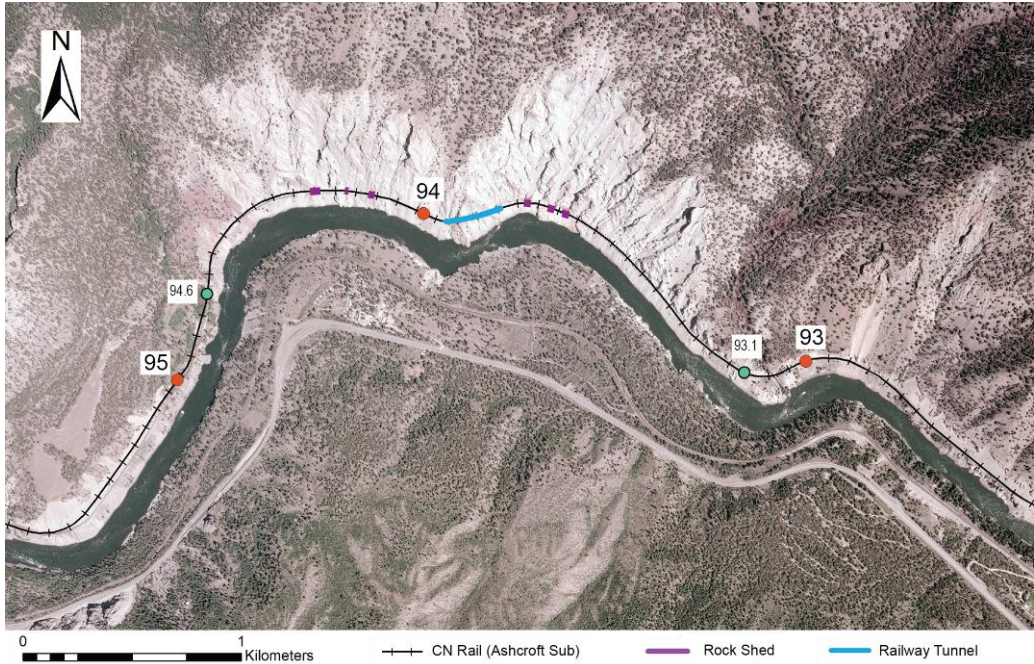
Figure 5: The White Canyon corridor extends from Mile 93.1 to Mile 94.6 on CN's Ashcroft sub. The location of the tunnel dividing the West and East portions of the slope, as well as the six rock sheds is shown.

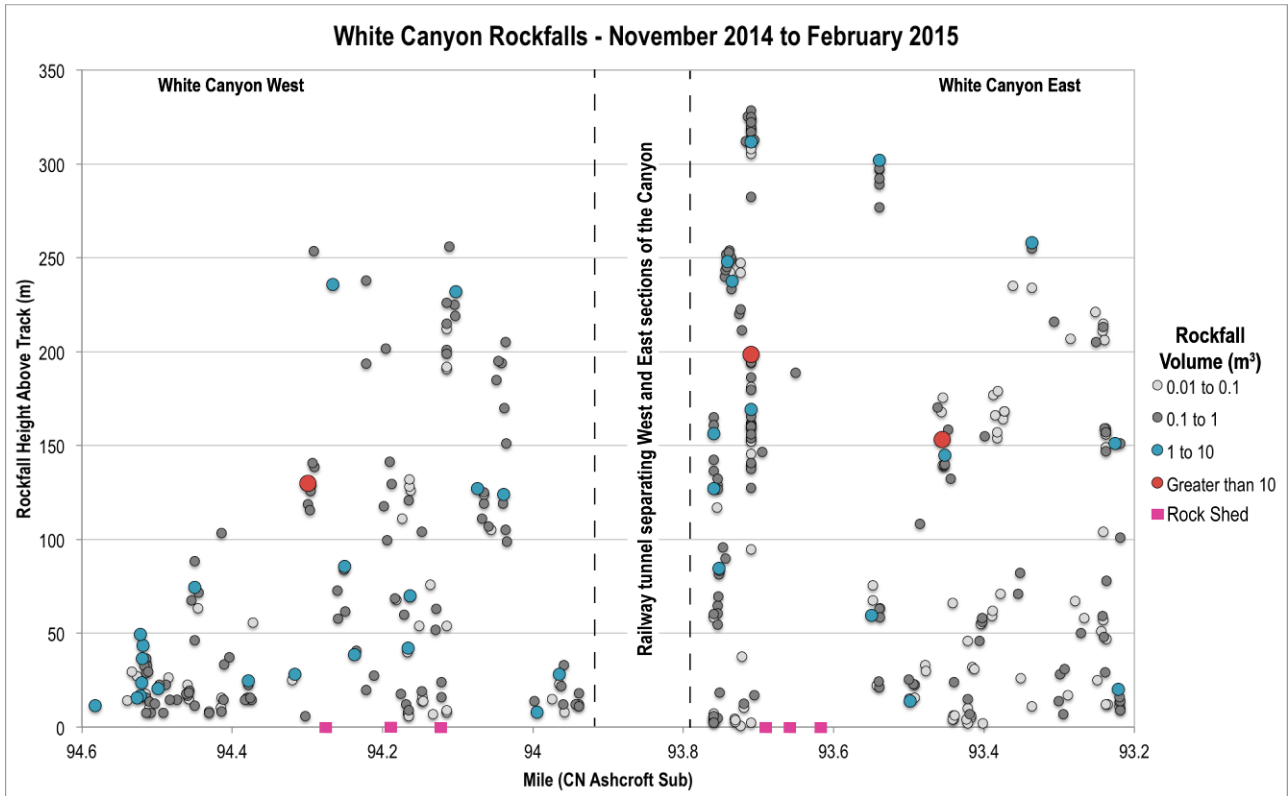
Figure 6. Distribution of rockfall source zones by mile, as determined from LiDAR change detection analysis comparing data sets taken in November 2014 and February 2015. Only the events recorded as initiating from rock outcrop are included in this figure. Movement in talus channels is ongoing, but is not recorded here.

A preliminary case study was completed to compare data obtained between November 2014 and February 2015 in the White Canyon, the details of which are discussed by van Veen et al., (2015). During this time period, 387 rockfalls were initiated from rock outcrops on the slope, as identified from LiDAR change detection analysis. The point of deposition of these rocks is not known, due to the number of different events cumulatively affecting the slope over the 4 months of elapsed time between data acquisitions. Slide detector fence (SDF) data for the corresponding time period shows 46 activations requiring repair to and reactivation of the warning system. At this time, the volume of rock required to damage the SDF enough to require repair is unknown, but it is assumed that smaller volume fall events would pass through the wires without triggering an activation. Activations could be the result of one or more rocks falling to track level, in one or more locations along the canyon. This could also be the result of ice-fall in these winter months.

Analysis of these LiDAR datasets provided insight into the spatial distribution of rockfalls of varying magnitude, as shown in Figure 5. With further analysis, it may be possible to discern patterns of precursor deformation and spatially significant patterns of smaller scale rockfalls providing early warning of impending larger scale failure events, particularly when additional information about rockfall events in the canyon is known. At this site, this information may be available from data collected from a prototype microseismic monitoring system and from rockfall information collected by track supervisors and maintenance personnel.

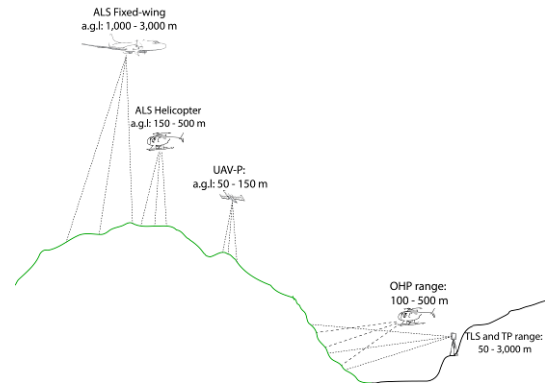
Figure7: 3D remote data collection platforms used for rock slope mapping and monitoring (from Lato et al., 2015)

The application of remote sensing approaches to rock slope stability assessment are affected by the frequency of measurement, the orientation of the scans and their spatial overlap, and range, accuracy and precision of the instrument used, and any adverse atmospheric conditions including smoke, fog and rain, for example. As noted previously, the data collection techniques utilized in this work include LiDAR and photogrammetry. These techniques can be deployed from several platforms using equipment which supplies data at different resolutions, as shown in Figure 7. The optimal selection of scan orientation, platform and equipment is discussed by Lato et al (2015), with a summary provided in Table 1.
