Highway Embankment Failure on Weak Ground – Case History

Z. S. Ozden
SNC-Lavalin, Vaughan, Ontario, Canada
D. Staseff
Ministry of Transportation, Toronto, Ontario, Canada

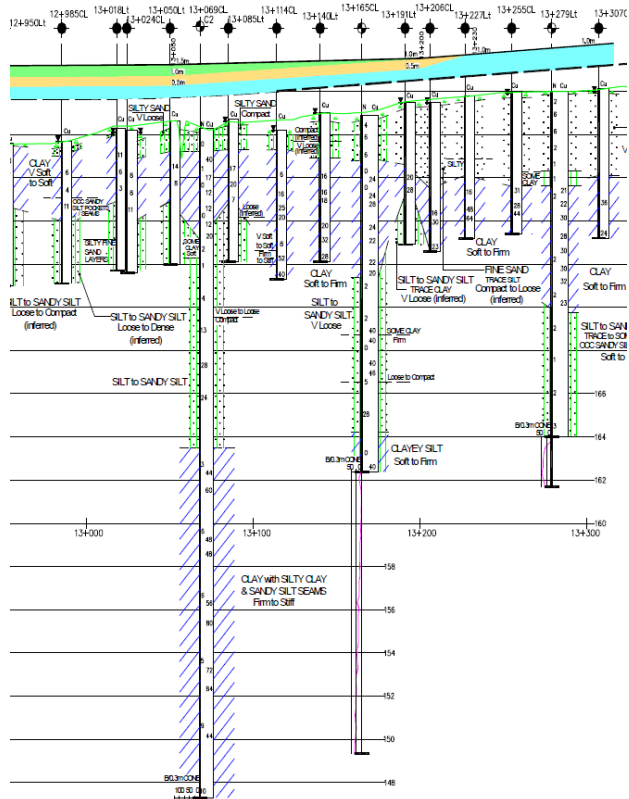
Figure 4 – Subsurface Conditions – 12+950 to 13+300

The failure section between Stations 13+080 and 13+160 was characterized by a veneer of peat (0.2 to 0.4 m thick), underlain by very loose fine sand with silt and silty fine sand zones. These extended to 0.9 to 2.1 m below the ground surface and were underlain by a clay to clayey silt deposit with measured in situ undrained shear strengths generally ranging from 6 to 25 kPa (Figures 4 and 5). The groundwater table was generally at the ground surface but during the summer months dropped to about 0.3 m below the ground surface.

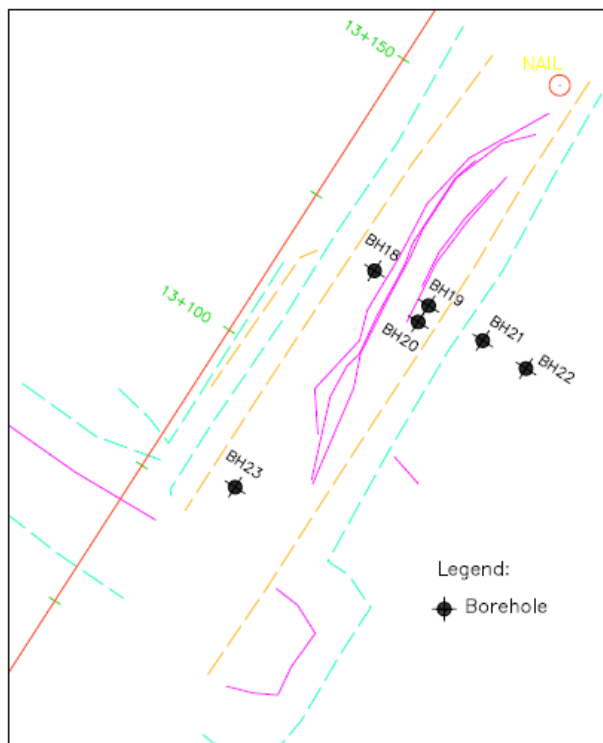
Figure 11 – Borehole Location Plan (NTS)

A field investigation was conducted in the failed area on May 12, 13 and 14, 2005 and this consisted of drilling six boreholes as shown in Figure 11. Five of the boreholes were drilled along the centre of the failure and the sixth borehole (BH 23) was placed outside the failure zone. The boreholes were drilled to depths of about 10 to 11.5 m below existing ground surface. Extensive field vane testing and continuous sampling by means of Standard Penetration Test method were performed in these boreholes. The findings of the boreholes are presented on the soil profile in Figure 12. Comparison of the undrained shear strengths measured in the boreholes in this investigation with the undrained shear strengths in the original investigation boreholes indicated that, in general, the newly measured undrained shear strengths were the same or higher than those used in the original design.

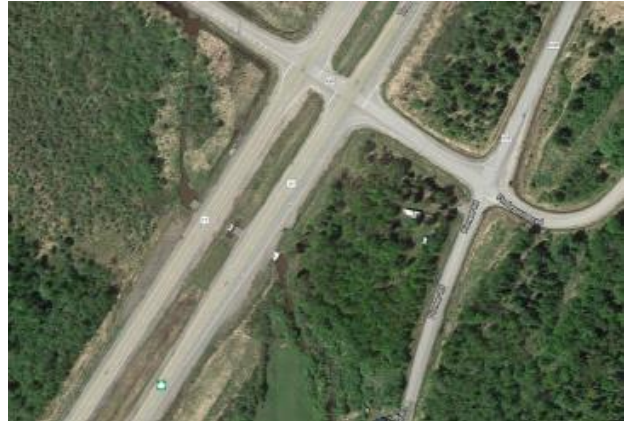
Figure 20 – Highway 17 in 2017 (Google Map)

Figure 20 shows the project site in 2017. The repaired section is in the lower left quadrant of the plan view.
