Cofferdam Failure - Geotechnical Lesson Learned

Silvana Micic, Stan Gonsalves & TaeChul Kim
Exp Services Inc., Brampton, Ontario, Canada

The existing Kabinakagami River Bridge located on Highway 11, approximately 32 km west of Hearst, Ontario, was replaced with a new bridge structure in 2008-2009. During construction of the West Abutment, the cofferdam failed and the construction was delayed. After the failure, the subsequent geotechnical investigation, commissioned by the Contractor was carried out in December 2008. Based on the results of that investigation, the Contractor contended that the borehole soil data shown in the Contract Documents was significantly different than what was actually encountered in the site during the sheet pile and H-pile installation. It was claimed that the existing soil conditions had contributed to problems encountered during the cofferdam installation and to its failure. Consequently, the third-party verification of the subsurface conditions in the area of interest was requested. To verify the subsurface conditions and clarify discrepancies in data collected during pre-failure and post-failure geotechnical investigations, the additional geotechnic

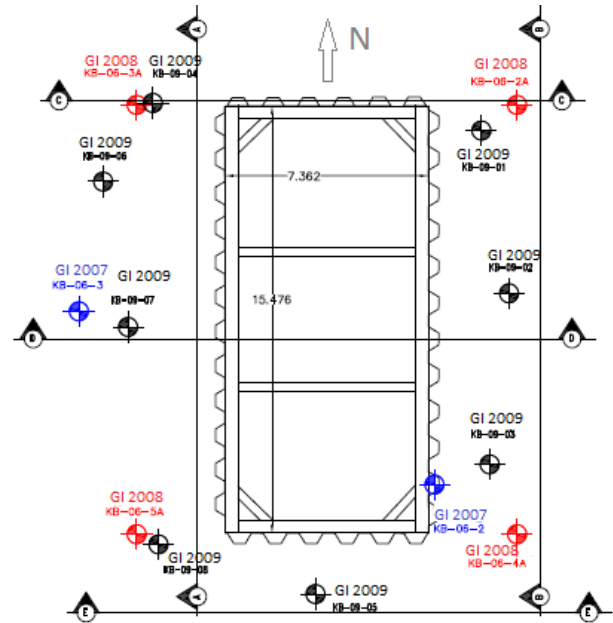
Figure 2. Borehole location plan around the cofferdam for three geotechnical investigations

The shoring and cofferdams for the abutments and piers of the new Kabinakagami River Bridge were designed by the Contractor based on the results of geotechnical investigations at the site performed in 2007 (GI 2007). According to shoring details for construction of the West Abutment, the cofferdam was 15.5 m long by 7.4 m wide as shown on Figure 2. The top of the cofferdam was

designed to be at Elevation of approximately 244.6 m. The sheet piles as parts of the cofferdam were design to be embedded into the soil up to the Elevation of approximately 237.0 m. The excavation level inside the cofferdam was planned to be completed at Elevation of 239.5 m. The Elevation of the existing ground was approximately 243.6 m, while the groundwater level was estimated to Elevation 243.0 m. The shoring drawing Revision No. 9 showed the design of the cofferdam with top struts and water.
