Remediation of Slope Failure in the Application of Lightweight Fill and Timber Piles on Highway 17 in Ontario

Tae C. Kim, Silvana Micic, & Stan Gonsalves
EXP Services Inc., Brampton, Ontario, Canada.
Ken Ahmad
Ministry of Transportation Ontario, Toronto, Canada.

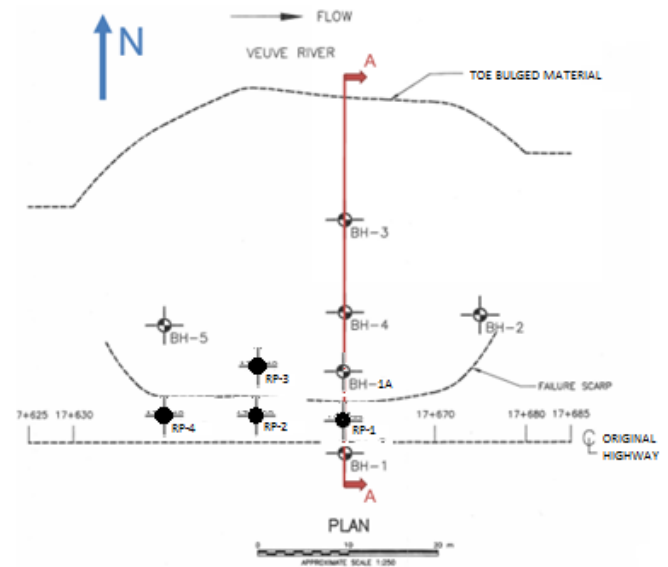
Figure 2. Location of boreholes

Following the original failure, the Geotechnical Consultant was invited and reviewed the site condition and performed a geotechnical site investigation. Five boreholes (BH1 to BH5) were drilled within the failure area on October 2004. After second failure, one additional borehole and four rock probes were advanced on February 2005. The location of all boreholes and rock probes are shown on plan on Figure 2.

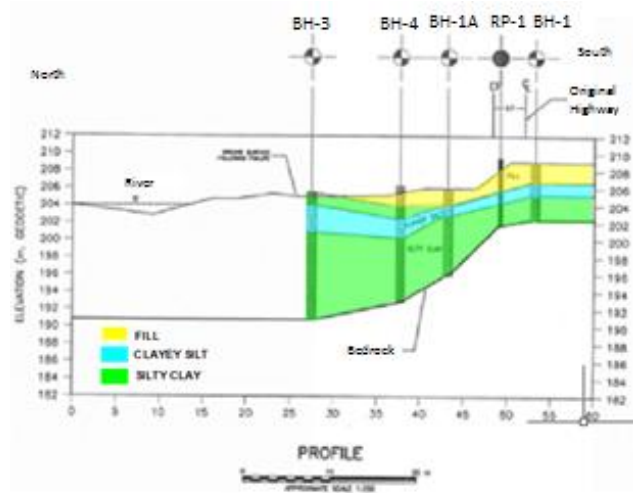
Figure 3. Section along A-A

The stratigraphy of the failure area generally consisted of granular and roadway fill overlying a thin layer of clayey silt and silty clay in the upper bank area and clayey silt at the lower bank area. The assumed bedrock geometry sloped down from the roadway to the north and also sloped down from the east to west across the limits of the failure. The thickness of the silty clay material ranged from 3 to 4 m near the east limit of the failure, 10 to 12 m near the centre of the failure and was approximately 15 m thick near the west limit of the failure. The intact undrained shear strength of the silty clay as measured by in situ field vane

testing, generally ranged from 16 to 48 kPa. Figure 3 shows the typical stratigraphy of section along A-A.

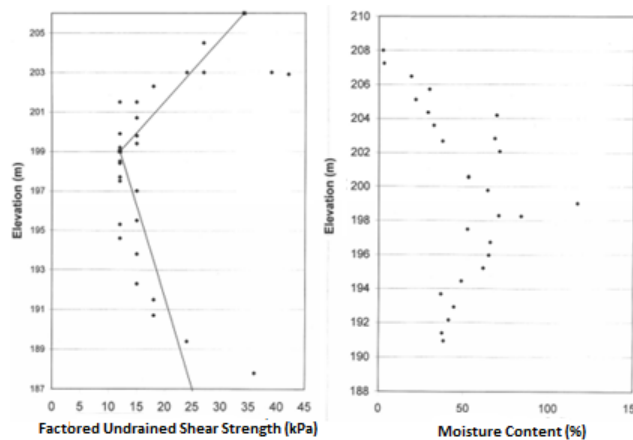
Figure 4. Profile of factored undrained shear strength and moisture content

The undrained shear strength profile for the intact shear strengths from all boreholes is shown as Figure 4. In general, there is a decrease in shear strength from ground surface to approximate Elev. 200 to 199 m and then a general marginal increase in the undrained shear strength with depth. This reflects the typical crust of higher strength and subsequent strength reduction followed by an increase with depth. From this figure, as idealized shear strength profile with depth has been assumed and consists of a decrease in shear strength with depth from ground surface to Elev. 199 m ($C_u = 12$ kPa at Elev. 199 m) and a general increase in undrained shear strength thereafter.

The moisture content generally increases near Elev. 199 m and then a subsequently decrease with depth. The maximum moisture content value of 117% was measured with BH-3 at Elev. 199m as shown in Figure 4.

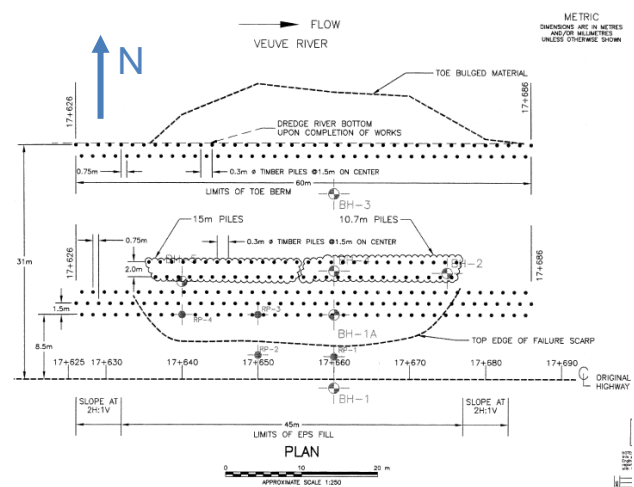
Figure 5. BH/RP locations with timber piles

One additional borehole and four rock probes were advanced within the failure area during the week of February 14 to 18, 2005. This new geotechnical information augmented the five boreholes drilled on October 2004. The location of all boreholes and rock probes is shown in plan on Figure 5. Within the failure area, one additional borehole and four rock probes were performed. The results of this new borehole (BH-1A) were similar to the results of the previous boreholes, i.e. granular fill overlying clayey silt and soft to firm silty clay as shown on Figure 3.

From the results of the borehole and rock probes, the suspected bedrock surface through the center of the failure

zone (Sta. 17+660) is relatively flat beneath the existing roadway at approximate Elev. 202 m. From approximately 3m north of the centerline of the original highway, the bedrock geometry slopes down at 1H:1V between RP-1 and BH-1A, at 2H:1V between BH-1A and BH-4, and approximately 5H:1V between BH-4 and BH-3, as shown on Figure 3. A similar bedrock geometry was observed at Sta. 17+650, with the bedrock surface sloping at 1H:1V between RP-2 and RP-3. At Sta. 17+640, the bedrock surface slopes at approximately 4H:1V between RP-4 and BH-5. All rock probes that are shown on Table 1.

- All pile had a minimum top diameter of 0.3 m
- The plan location and anticipated length of the 257 timber piles are shown on Figure 5. All piles were driven to refusal (Photo 4).
