Preliminary Design For Seepage Remediation at a Small, Remote Dam – Case Study of Lac La Ronge Dam in Northern Saskatchewan

Ryan Kozun & Allen Kelly
Clifton Associates Ltd, Regina, Saskatchewan, Canada
Imteaz Bhuiyan & Jasyn Henry
Water Security Agency, Regina, Saskatchewan, Canada

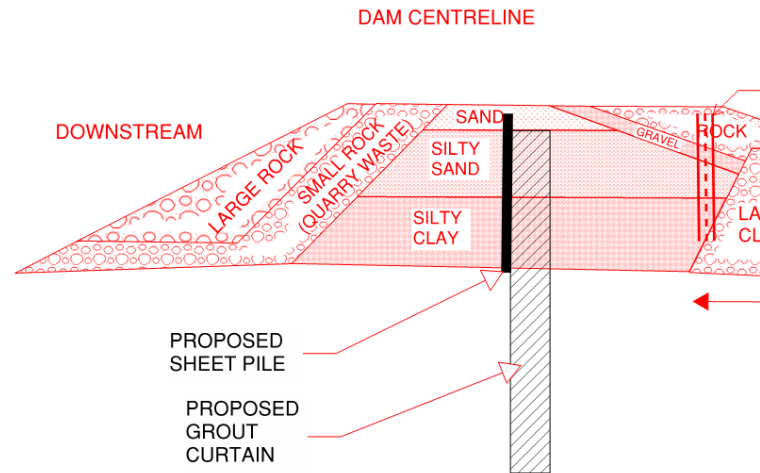
Figure 7.3. Recommended dam design section for seepage remediation

Given that the observed seepage flow was substantial but carried no fines would indicate the principal seepage pathway is not likely through the core but rather through the fractured bedrock. Accordingly, consideration of seepage control options focused on that pathway, acknowledging that gradients through the core must also be controlled.

Figure 7.3 provides the recommended design option. The subsurface information from the field investigation confirmed the principal seepage pathway is at the interface of the dam structure with the fractured bedrock zone. The most effective method to control the seepage through this area is a sheet pile wall driven into the fractured bedrock with injection of grout upstream of the sheet pile wall that extends beyond the fractured bedrock zone to the more competent bedrock below.

The sheet pile wall will provide seepage control within the dam embankment while the injection of grout will seal from the lower portion of the sheet pile wall through the fractured bedrock zone to more competent bedrock below.
