# Hazard identification, stability assessment and risk mitigation overview of near-surface openings and pillars at the former Mine Principale, in Chibougamau, Quebec

Eliane Cabot, Adam Coulson and James Tod  
*Wood, Environment & Infrastructure Solutions, Mississauga, ON, Canada*  
Scott McNicoll and Simon Delattre  
*Wood, Environment & Infrastructure Solutions, Montreal, QC, Canada*  
Henrik Rasmussen  
*Ministère de l'Énergie et des Ressources naturelles (MERN), Quebec, QC, Canada*  
Carl Gauthier  
*WSP, Quebec, QC, Canada*

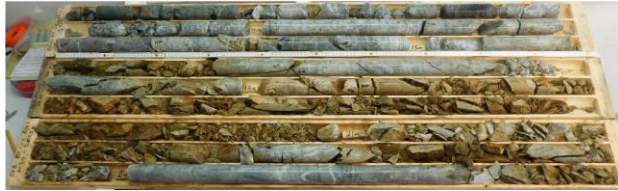
Typical NQ rock core (47.5 mm diameter) recovered from the mineralized crown pillars of a stope at the site can be seen in Figure 2.

Figure 2. Anorthosite and shear zone, Mine Campbell (BH16-MC-C5A, 0 to 25.2 m)
