## THE ENVIRONMENTAL IMPACT OF THE UNDERGROUND CONSTRUCTIONS. CASE STUDY – “MILLENNIUM BUSINESS CENTRE”

Eng. V. Ciugudean-Toma, S.C. METROUL S.A, Bucharest, Romania

Eng. I. Stefanescu, S.C. METROUL S.A, Bucharest, Romania

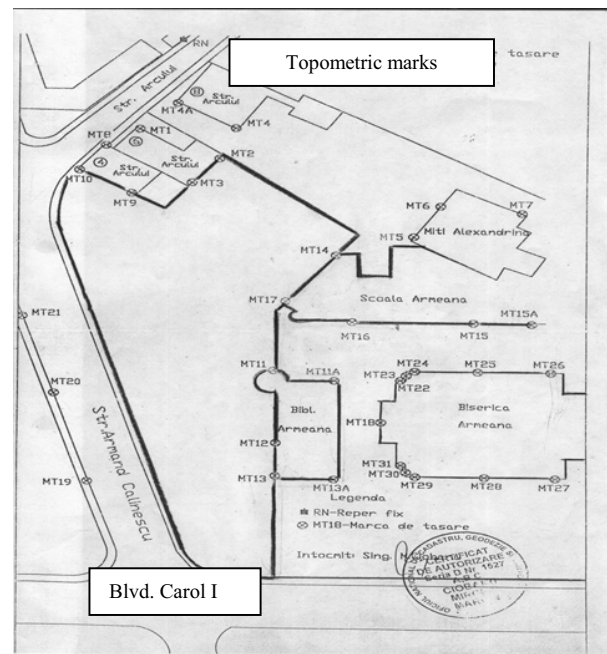
Figure 7. Topometric marks.

Considering the high density of buildings nearby Millennium Business Centre, and their ages (built on 1910-1915) but also the intense traffic on both thoroughfares, a topometric marks system has been installed in the area since the beginning of the works. These were mensurated and revealed the settlements values of the structures (figure 6).
